# VEHICLE INSPECTION REPORT

**MK13ZGS**

## Ford Fiesta 1.6 Titanium 5dr Powershift

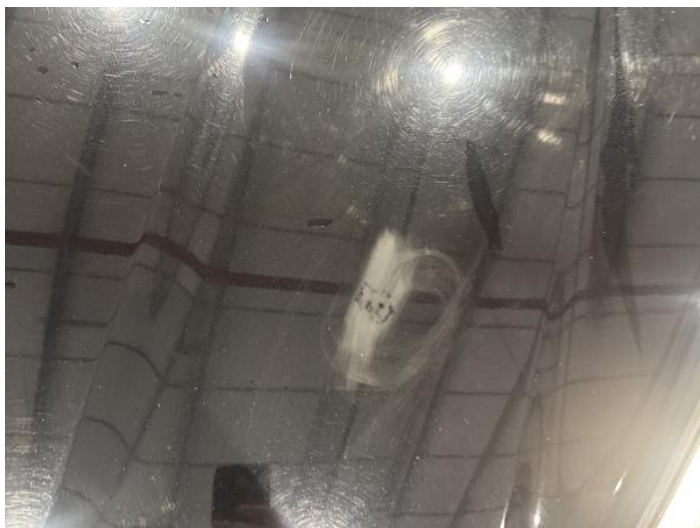
1: Bonnet  
Poor Previous Repair  
Poor Paint

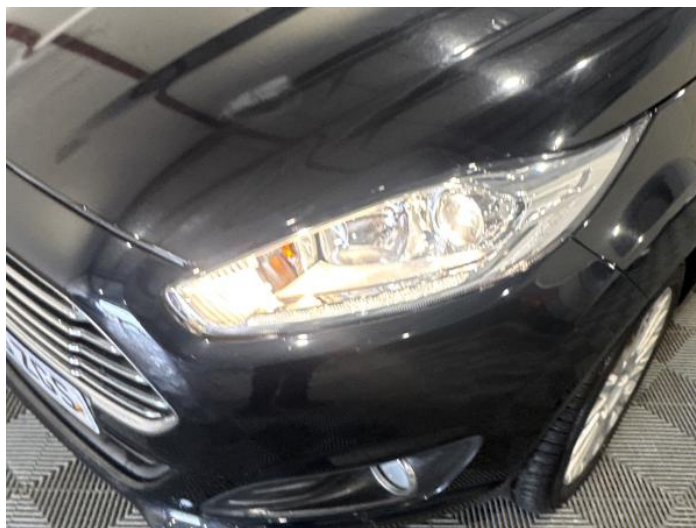
2: Bumper Front  
Chipped  
Multiple Chips

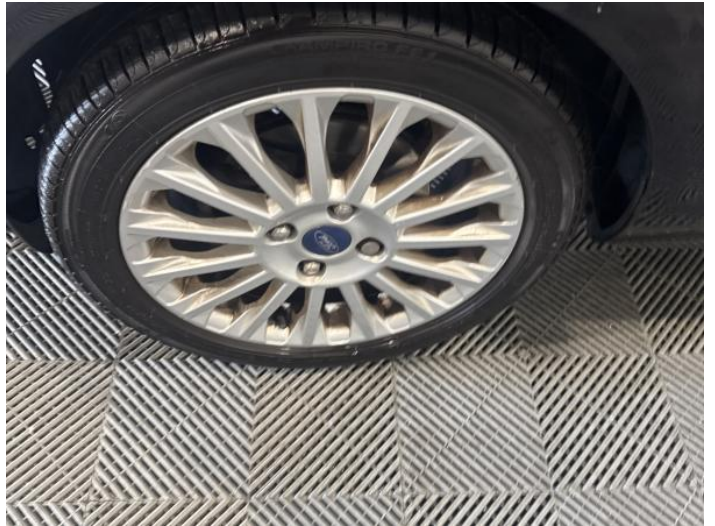
4: Wheel nsf  
Scratched  
Over 50mm

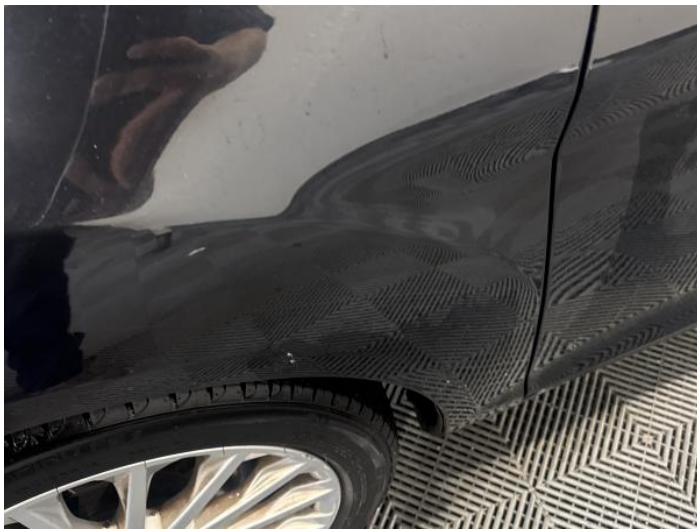
5: Wing nsf  
Chipped  
1 To 5

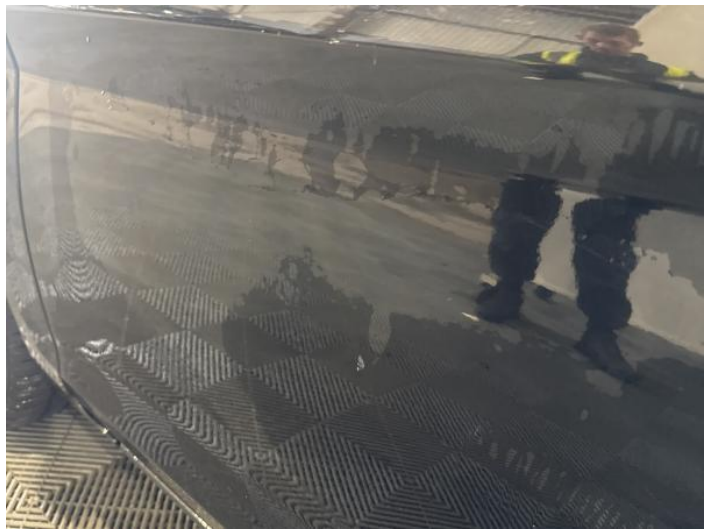
6: Door nsf  
Chipped  
Multiple Chips

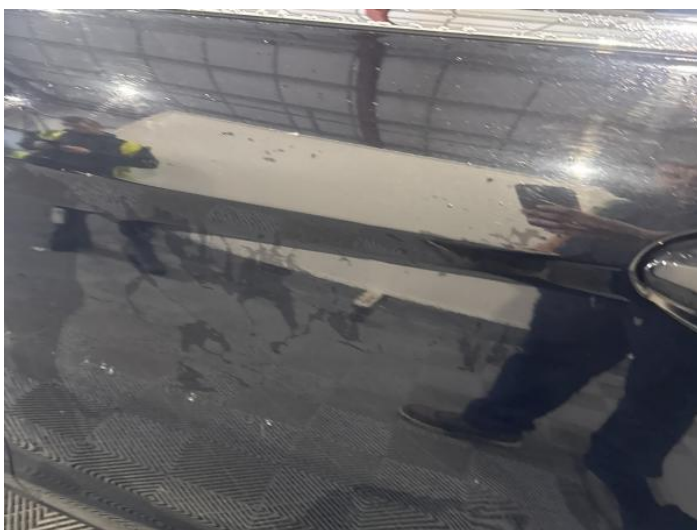
7: Door nsr  
Chipped  
Multiple Chips

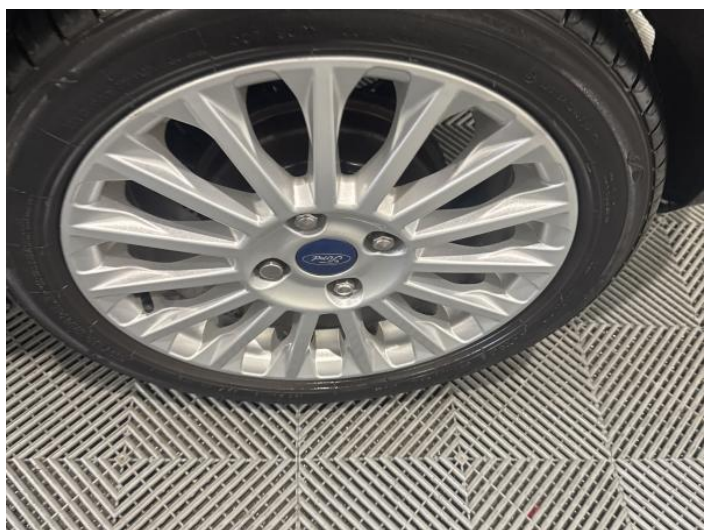
8: Wheel nsr  
Scratched  
Up To 50mm

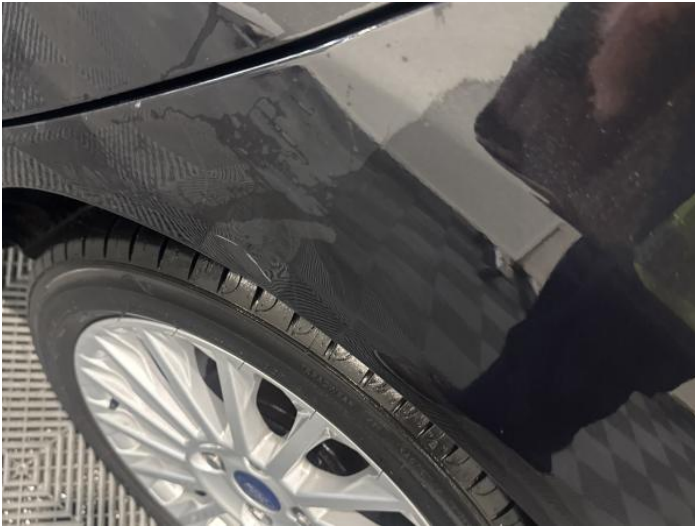
9: Qtr Panel nsr  
Dented  
With Paint Damage

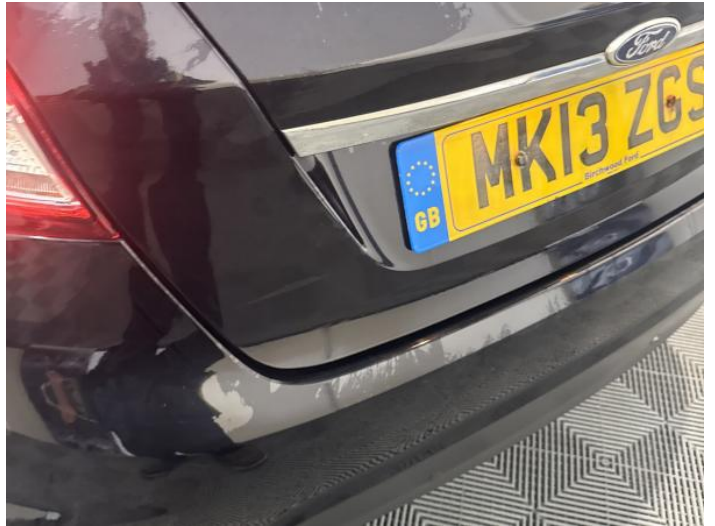
10: Bumper Rear  
Chipped  
Multiple Chips

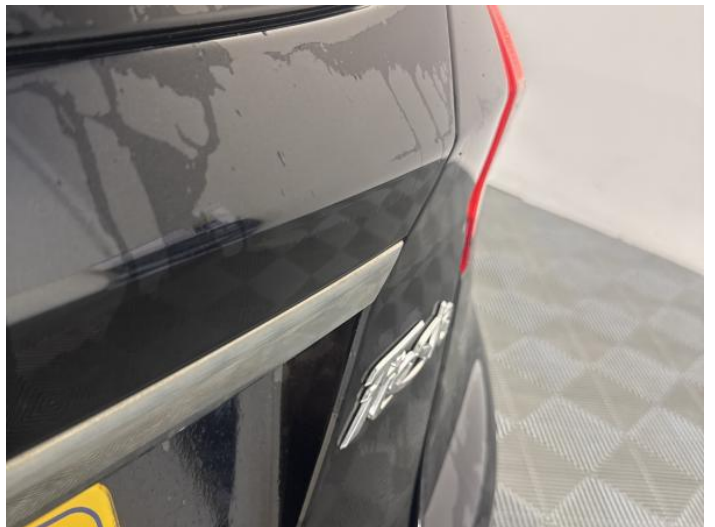
12: Boot Lid  
Dented  
Between 10mm + 30mm

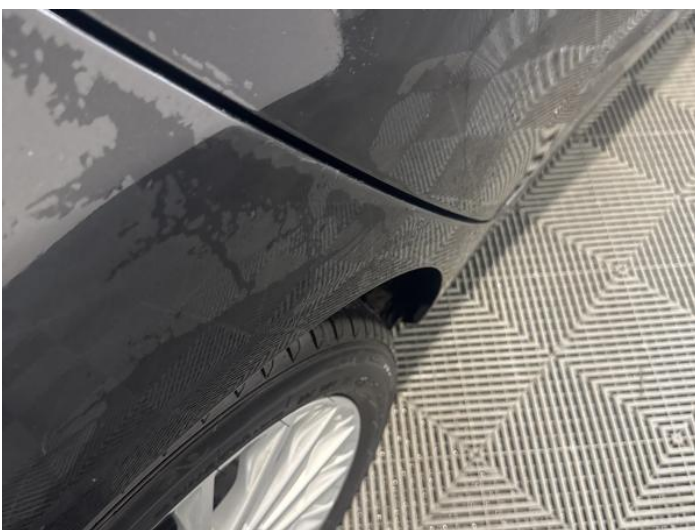
13: Qtr Panel osr  
Dented  
2 Or Less UpTo 10mm

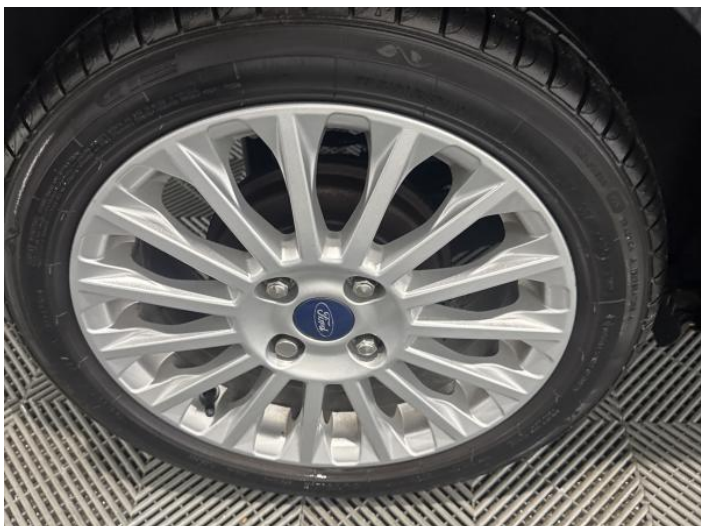
15: Wheel osr  
Scratched  
Up To 50mm

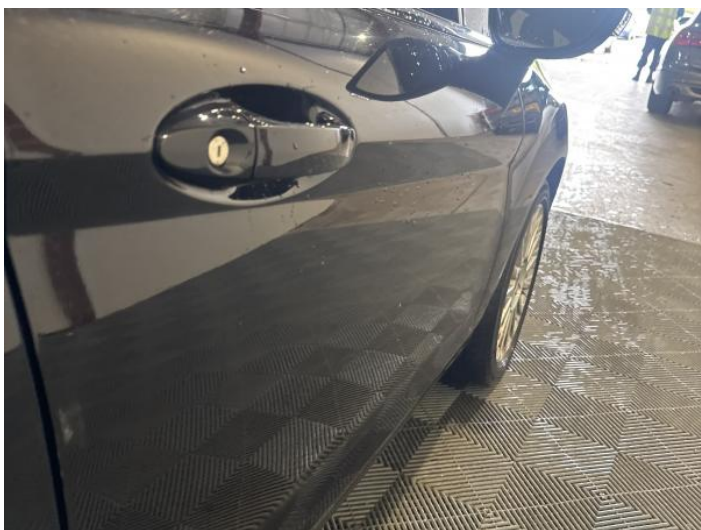
17: Door osf  
Poor Previous Repair  
Poor Paint

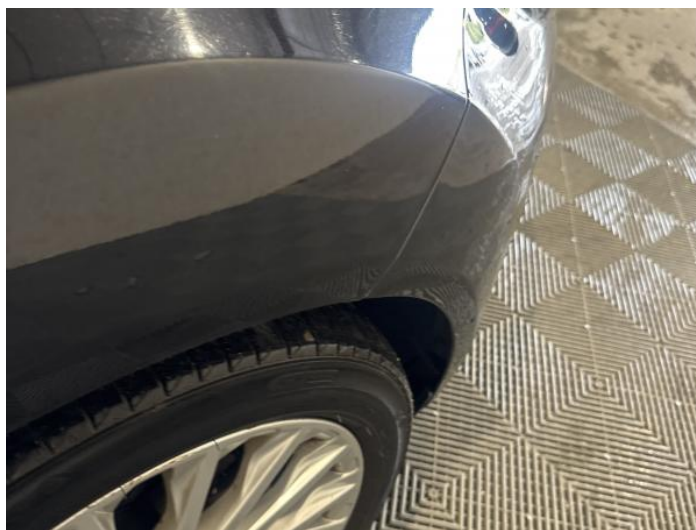
18: Wing osf  
Dented  
Between 10mm + 30mm

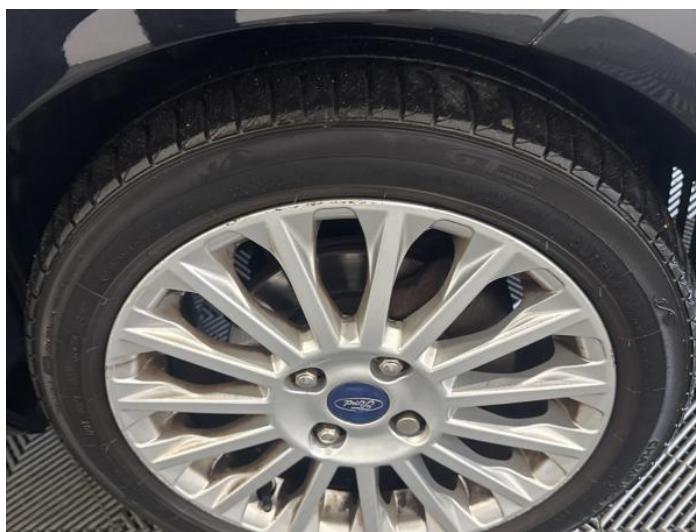
20: Wheel osf  
Scratched  
Over 50mm
