VEHICLE INSPECTION REPORT

KS63CVZ

Ford Fiesta 1.0 EcoBoost Titanium X 5dr Powershift

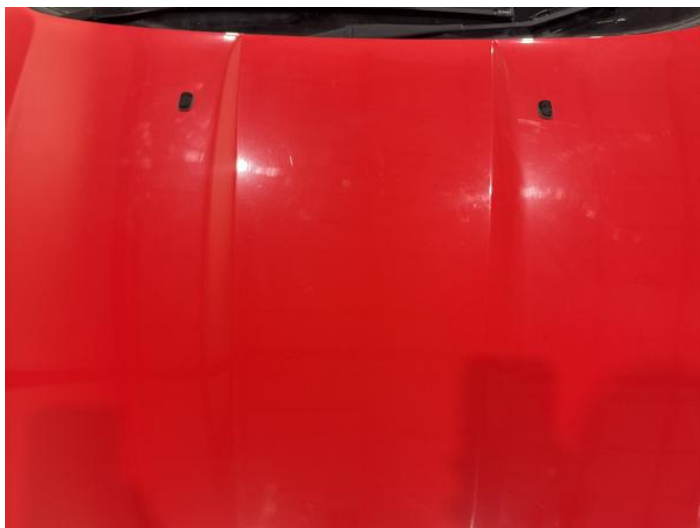
1: Bonnet
Chipped
1 To 5

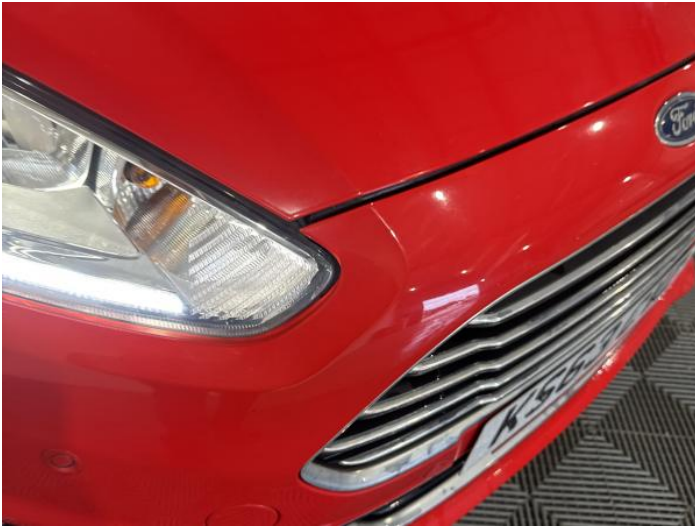
3: Bumper Front
Poor Previous Repair
Poor Paint

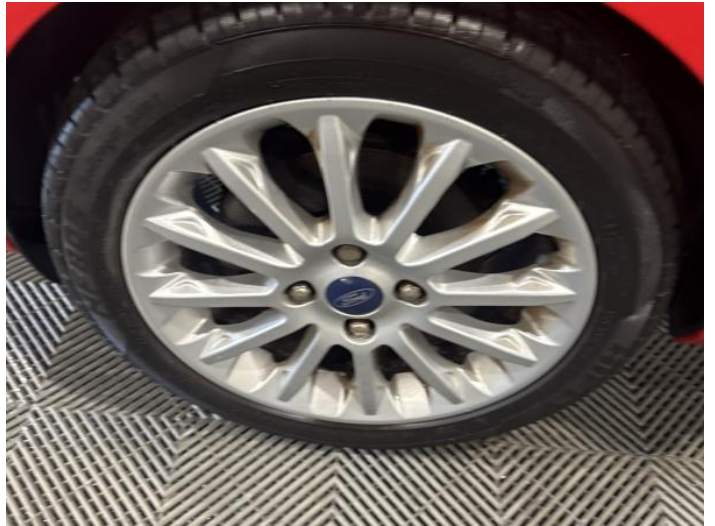
4: Wheel nsf
Scratched
Up To 50mm

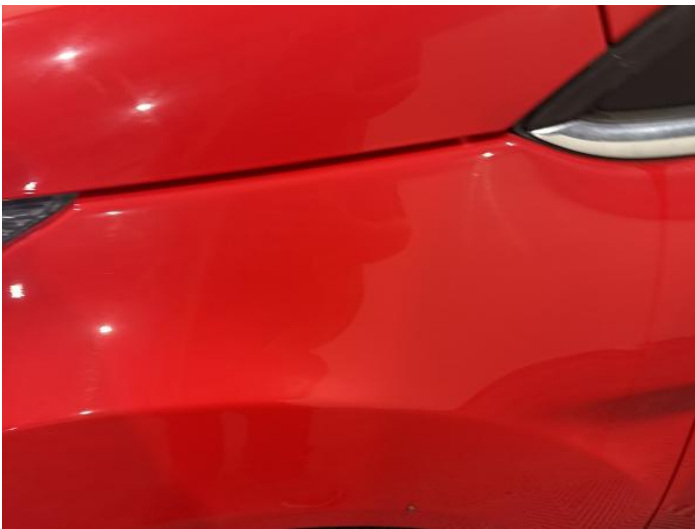
5: Wing nsf
Chipped
1 To 5

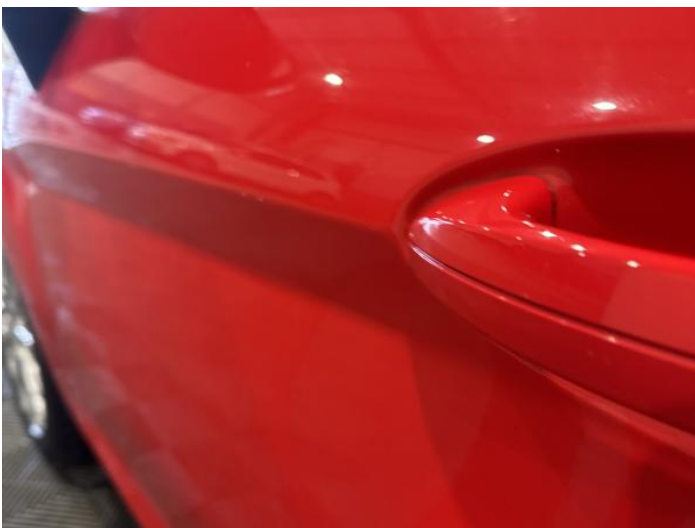
7: Door nsf
Dented
With Paint Damage

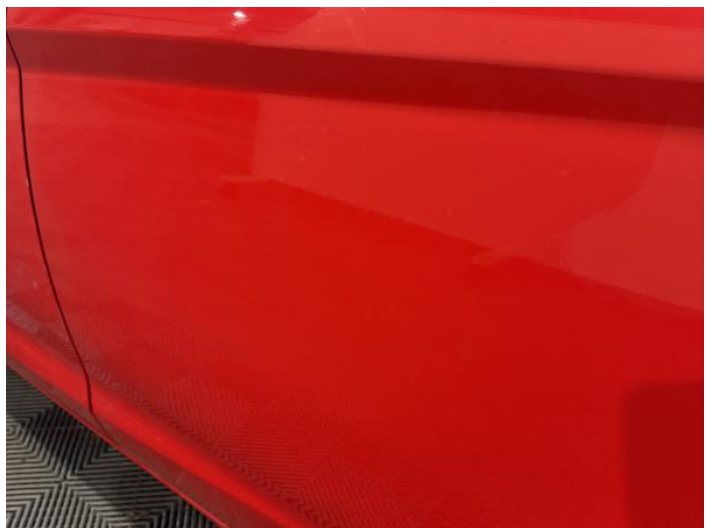
8: Door nsr
Dented
2 Or Less UpTo 10mm

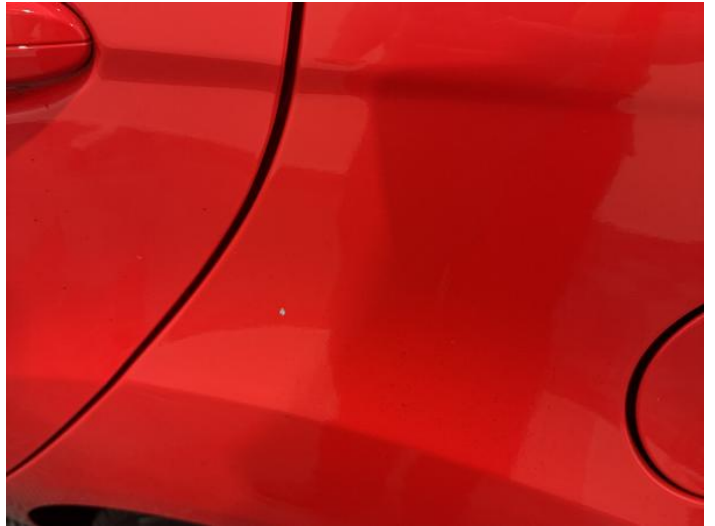
9: Door nsr
Scratched
Over 25mm Not Thru Paint

10: Qtr Panel nsr
Chipped
1 To 5

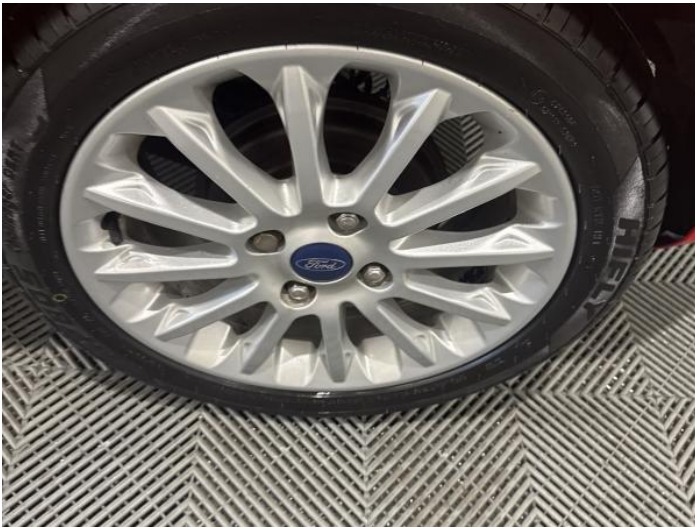
11: Wheel nsr
Scratched
Up To 50mm

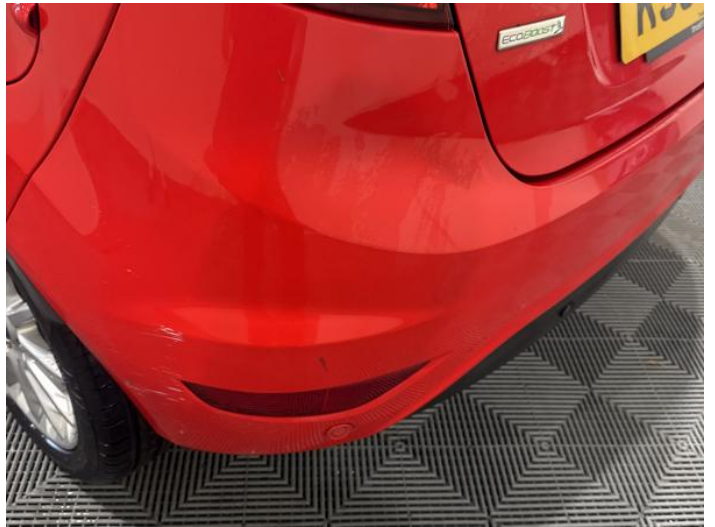
12: Bumper Rear
Scratched
25 to 100mm Thru Paint

13: Bumper Rear
Scratched
Over 25mm Not Thru Paint

14: Boot Lid
Scratched
Over 25mm Not Thru Paint

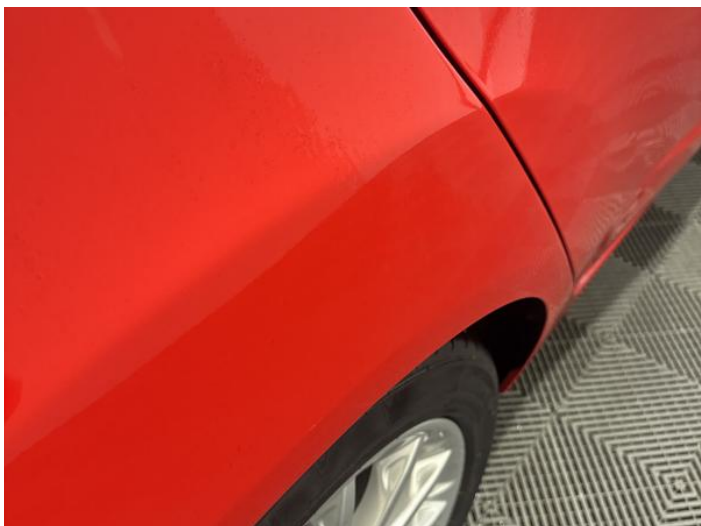
15: Qtr Panel osr
Chipped
1 To 5

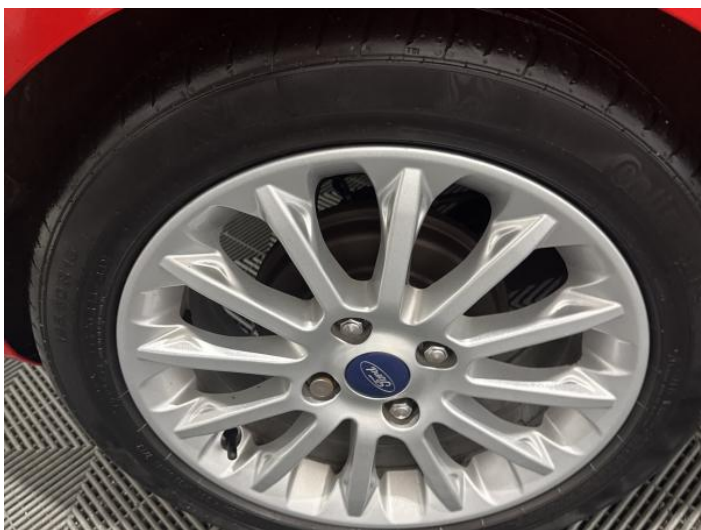
17: Wheel osr
Scratched
Up To 50mm

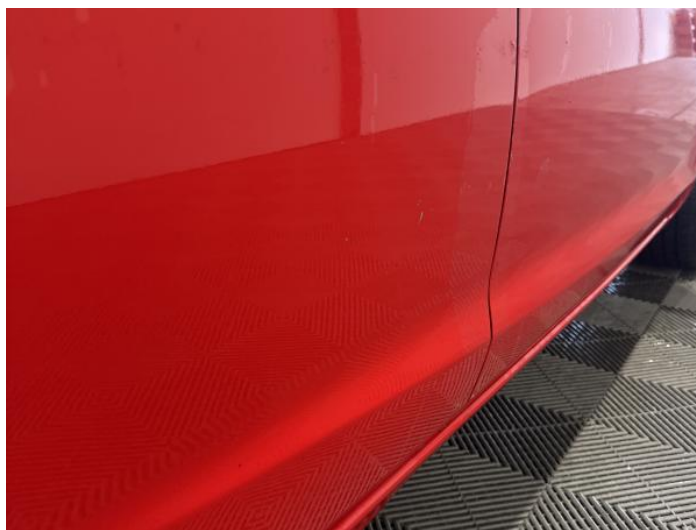
18: Door osr
Chipped
Multiple Chips

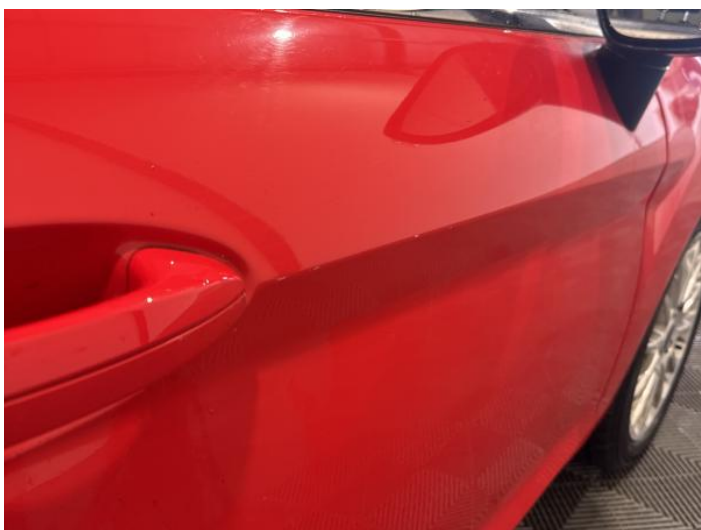
19: Door osf
Chipped
Multiple Chips

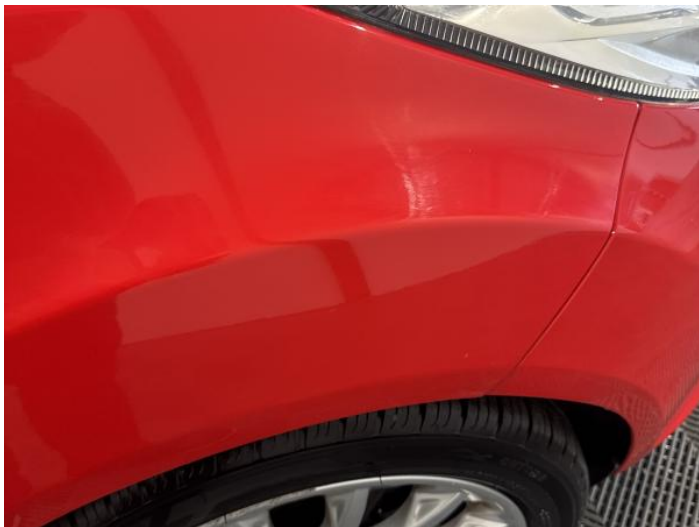
21: Wing osf
Chipped
1 To 5

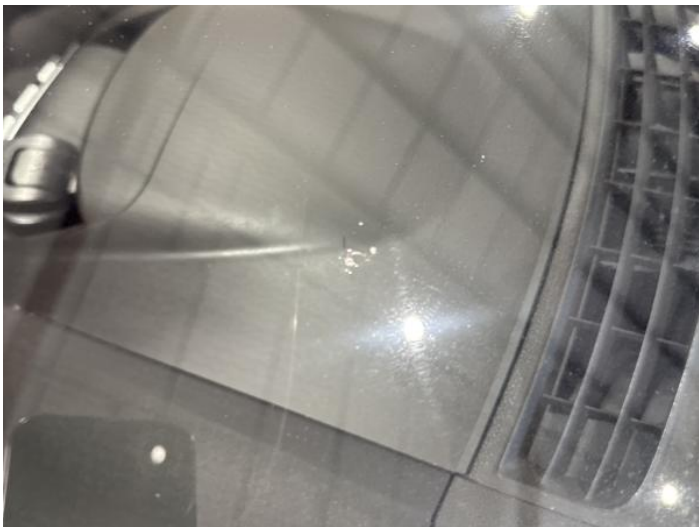
22: Screen Front
Chipped
UpTo 10mm

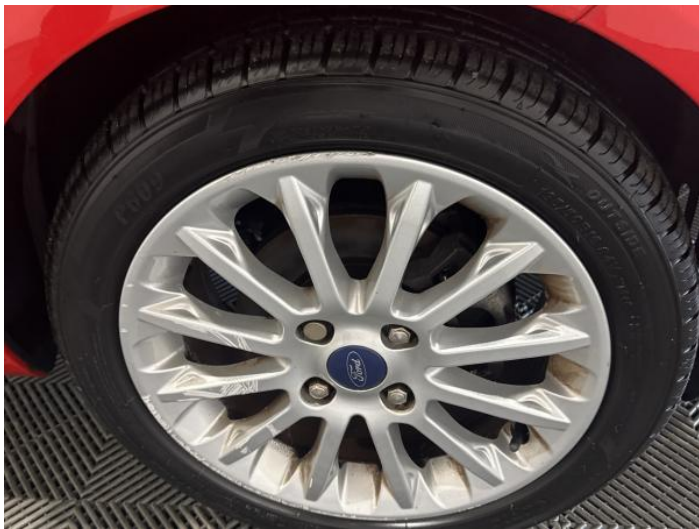
23: Wheel osf
Scratched
Over 50mm
