VEHICLE INSPECTION REPORT

CA65BZU

Volkswagen Golf Sv 1.6 TDI 110 SE 5dr

nama
GRADE
4

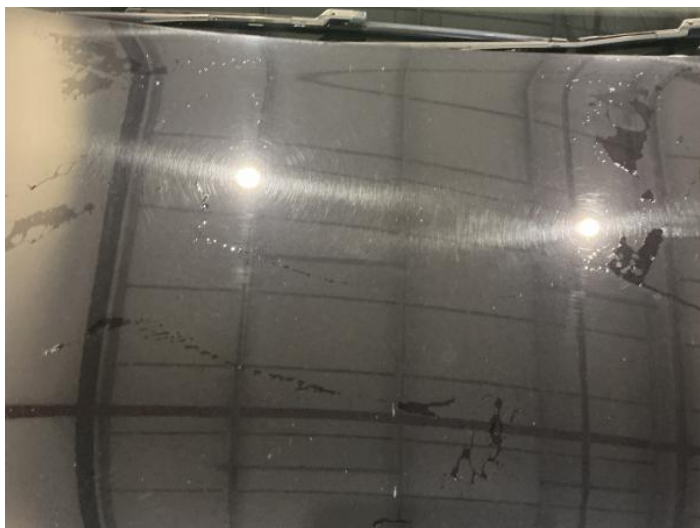
1: Bonnet
Chipped
Multiple Chips

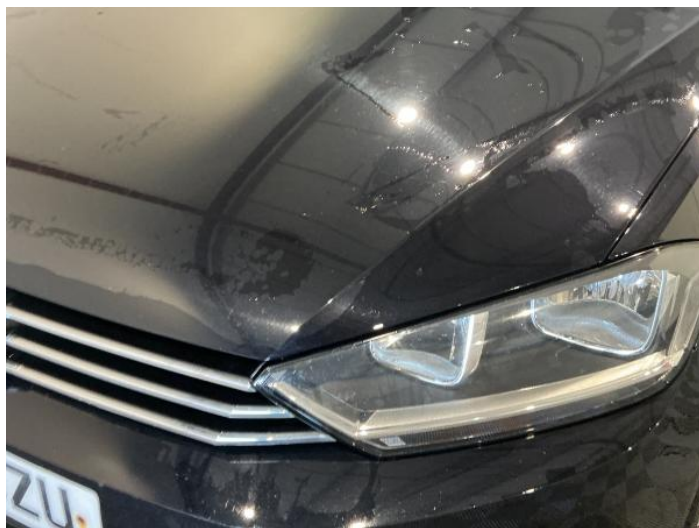
2: Bumper Front
Scratched
Over 100mm Thru Paint

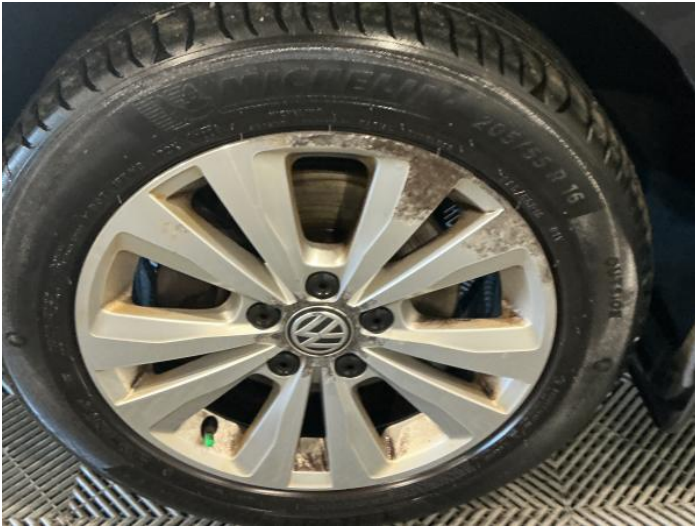
3: Wheel nsf
Scratched
Over 50mm

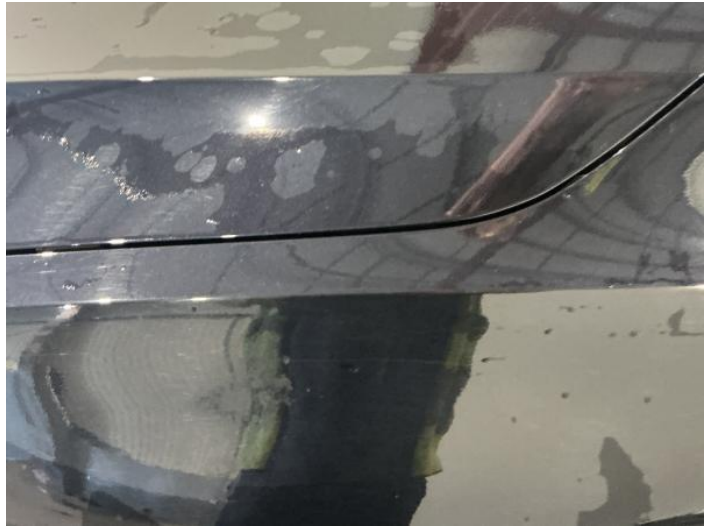
4: Wing nsf
Chipped
1 To 5

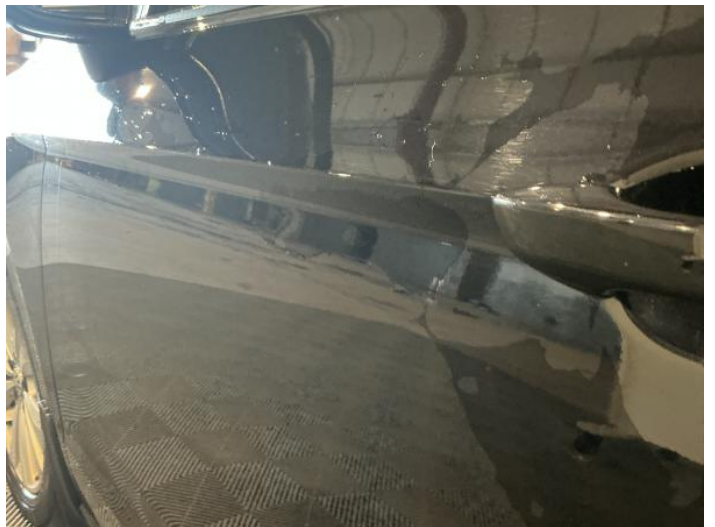
6: Door nsf
Chipped
1 To 5

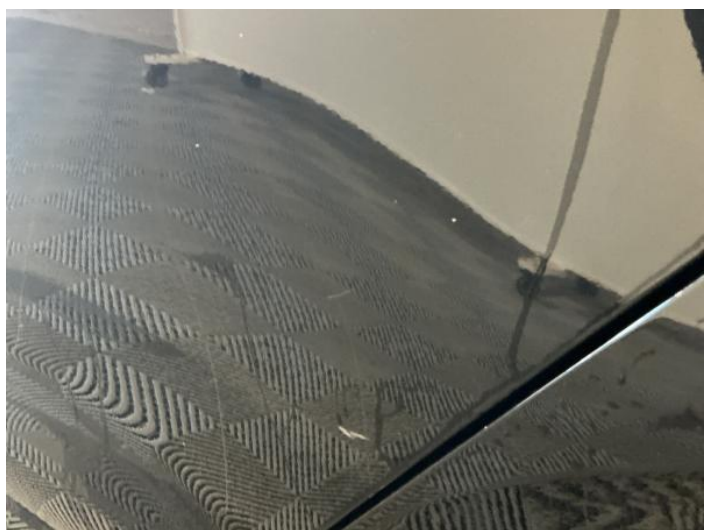
8: Door nsr
Scratched
UpTo 25mm Thru Paint

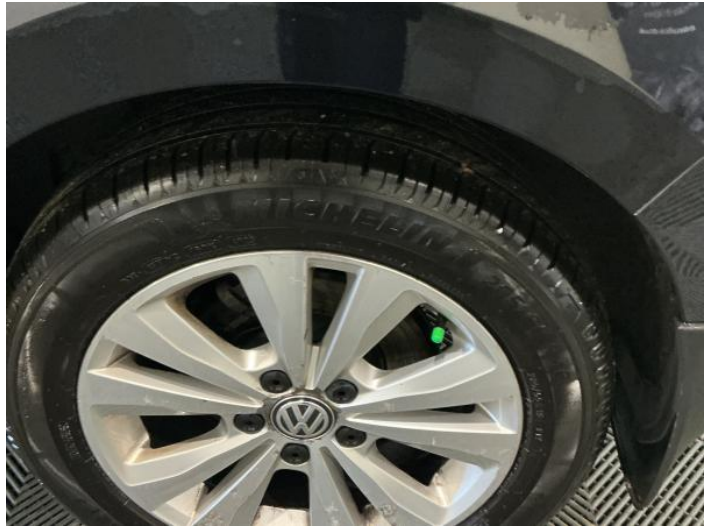
10: Wheel nsr
Scratched
Over 50mm

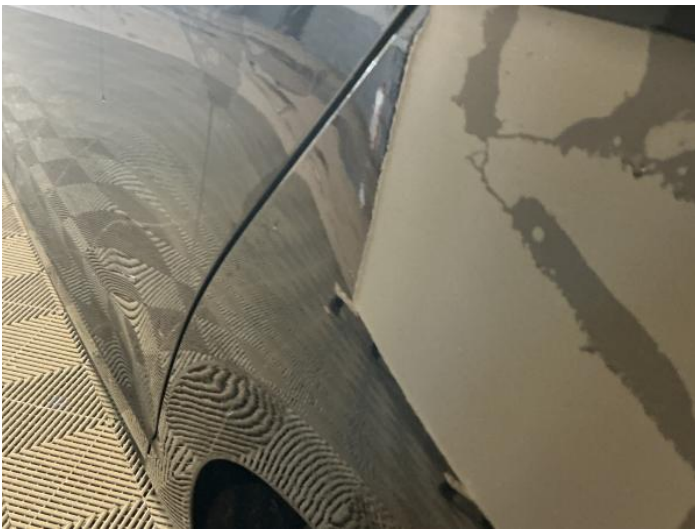
11: Qtr Panel nsr
Dented
Between 10mm + 30mm

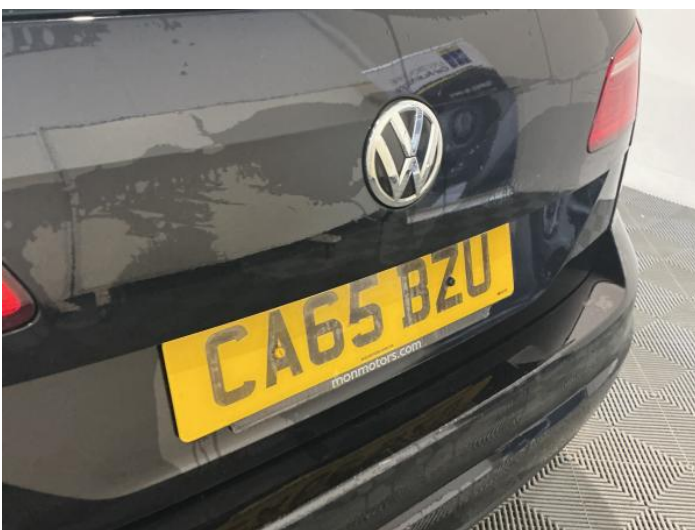
13: Bumper Rear
Scratched
Over 100mm Thru Paint

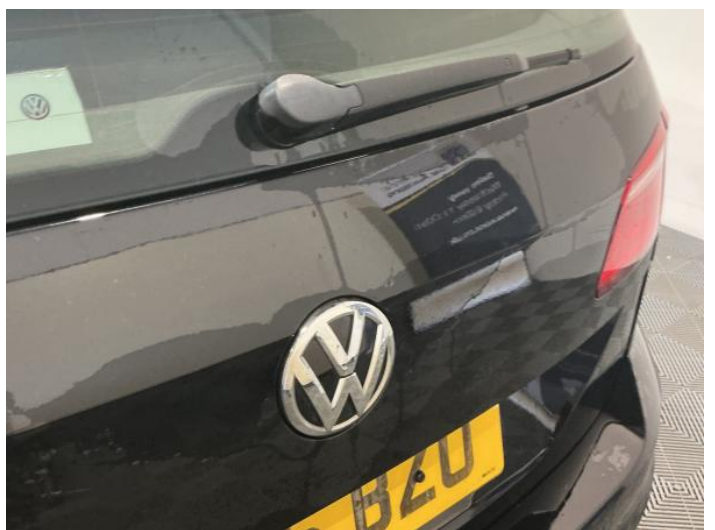
14: Boot Lid
Dented
Over 2 UpTo 10mm

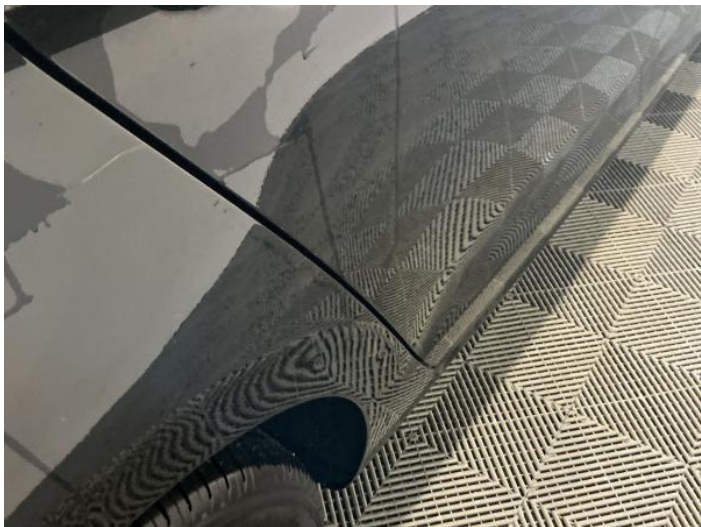
15: Qtr Panel osr
Dented
With Paint Damage

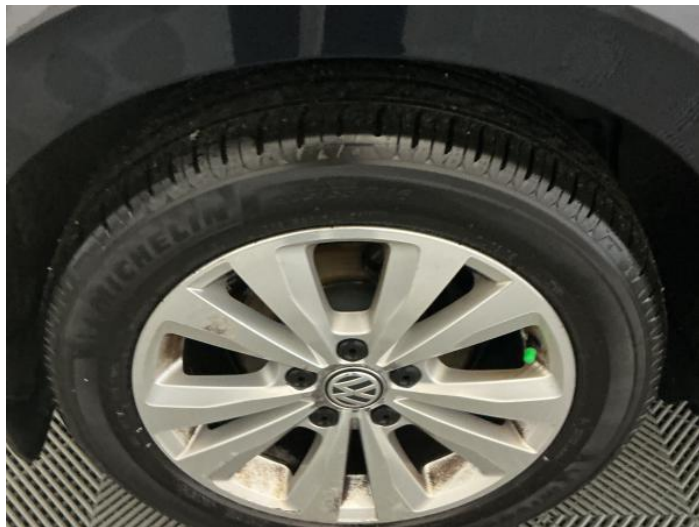
16: Wheel osr
Scratched
Over 50mm

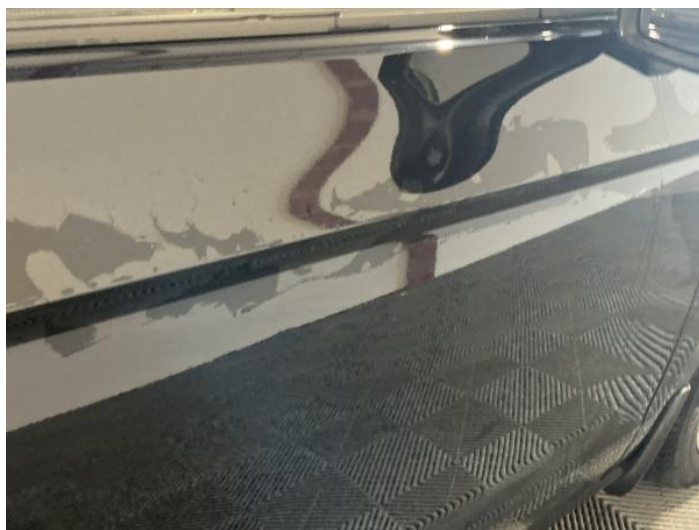
18: Door osf
Chipped
1 To 5

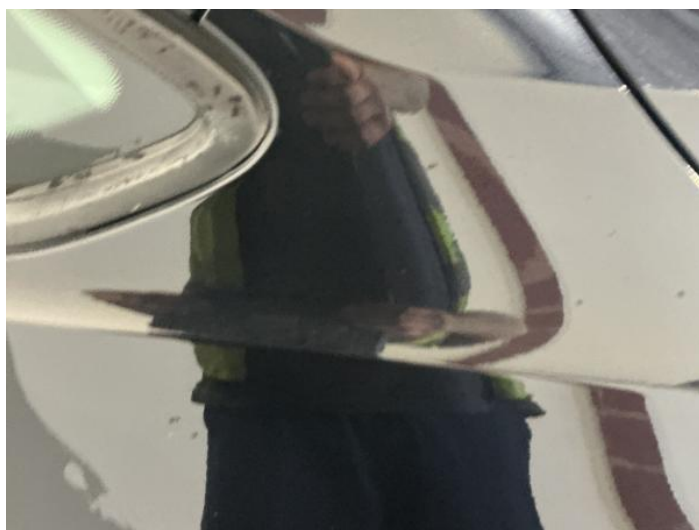
20: Wing osf
Chipped
1 To 5

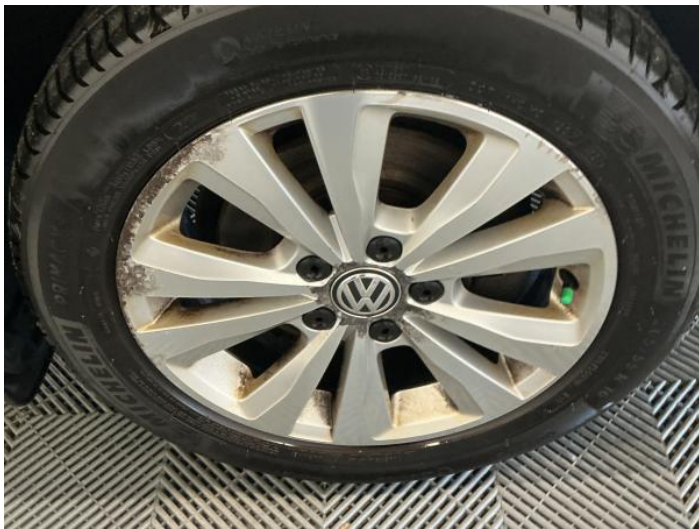
21: Wheel of
Scratched
Over 50mm
