VEHICLE INSPECTION REPORT

GY17YGO

Land Rover Discovery Sport 2.0 TD4 180 HSE 5dr Auto

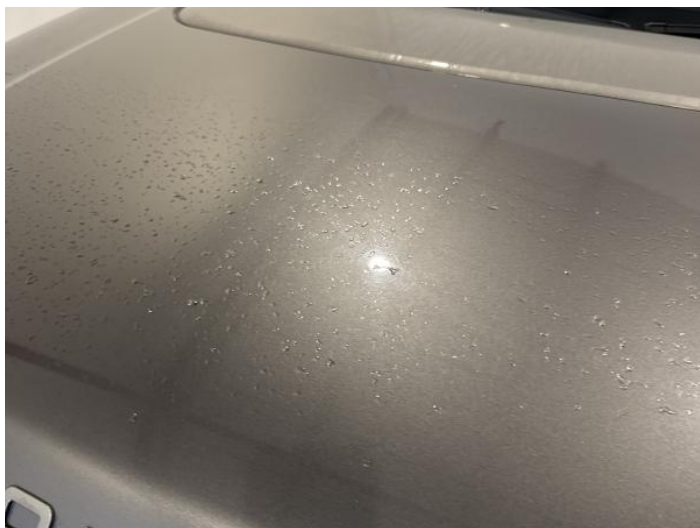
1: Bonnet  
Chipped  
1 To 5

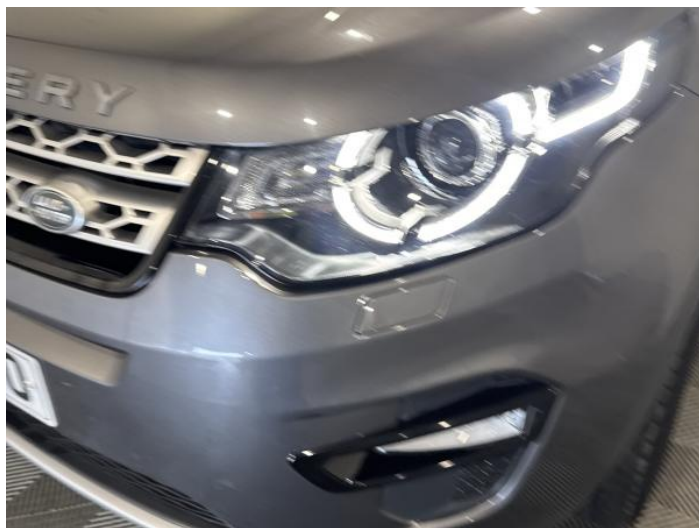
2: Bumper Front  
Chipped  
Multiple Chips

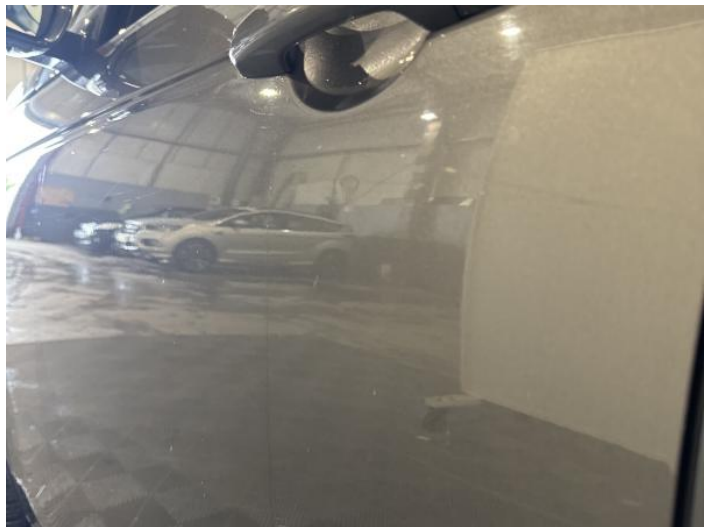
5: Wing nsf  
Scratched  
Over 25mm Not Thru Paint

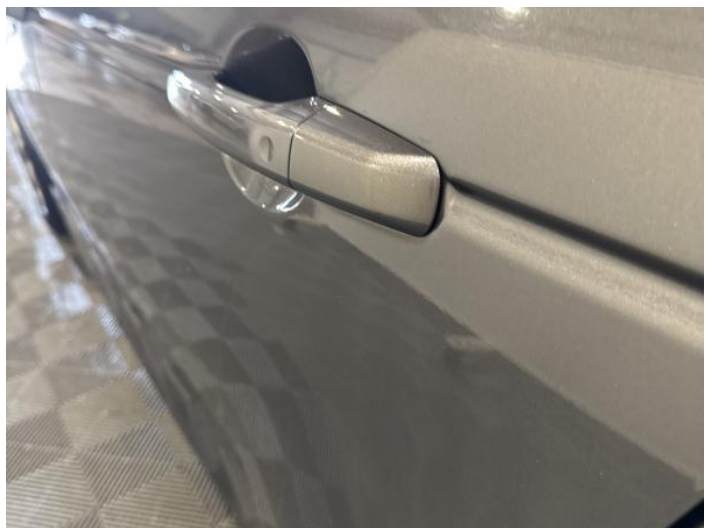
7: Door nsf  
Scratched  
Over 25mm Not Thru Paint

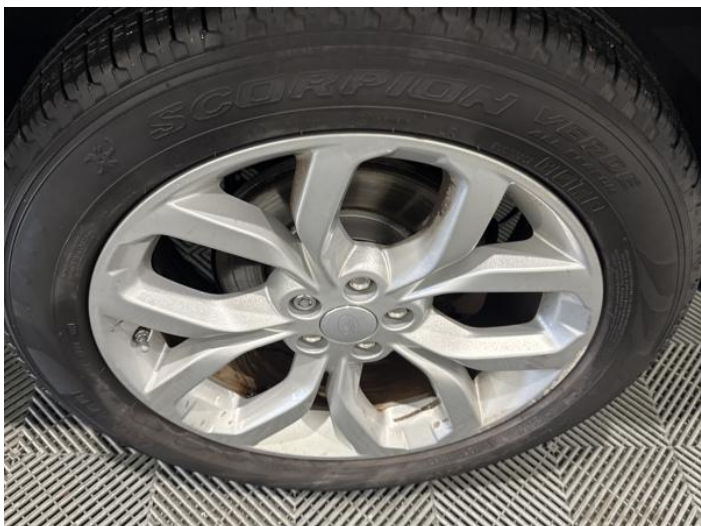
9: Wheel nsr  
Scratched  
Over 50mm

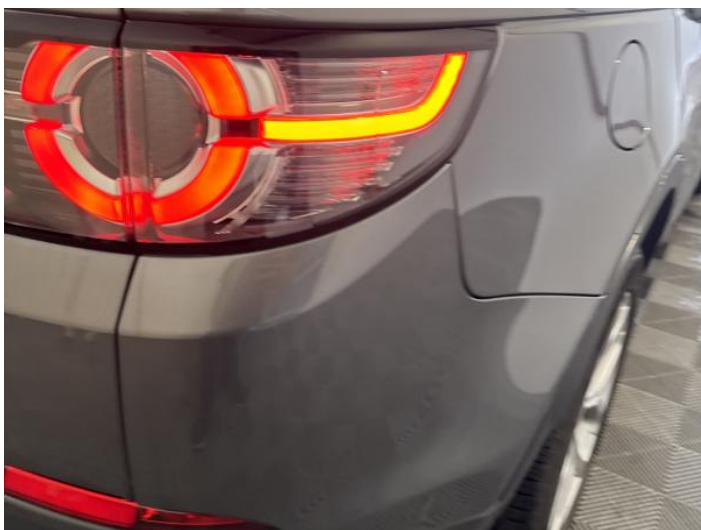
11: Bumper Rear  
Chipped  
Multiple Chips

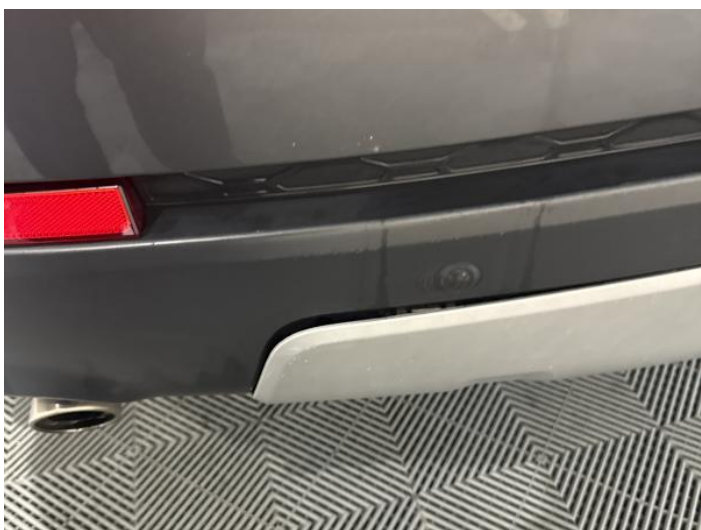
13: Bumper Rear Moulding  
Broken  
Replace

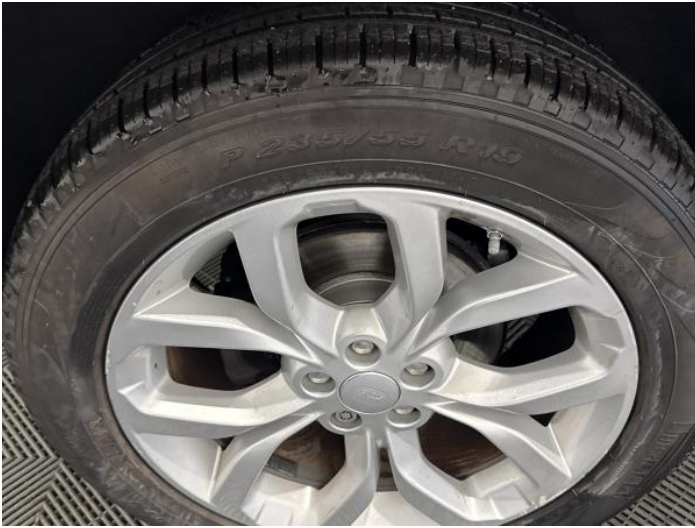
15: Wheel osr  
Scratched  
Over 50mm

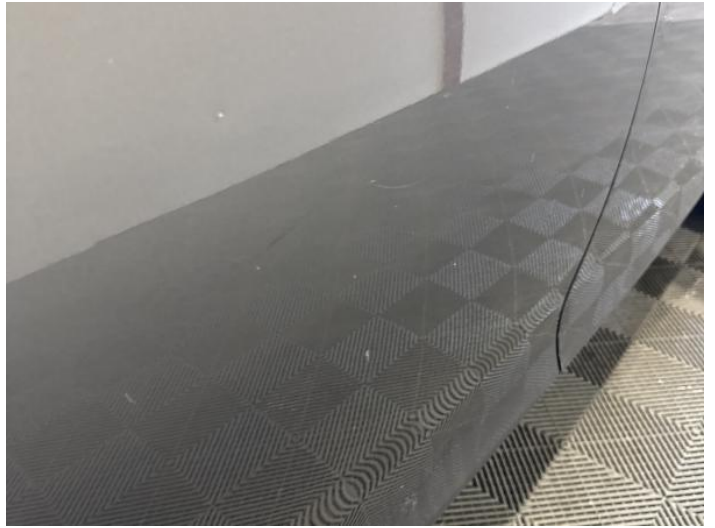
16: Door osr  
Dented  
Over 2 UpTo 10mm

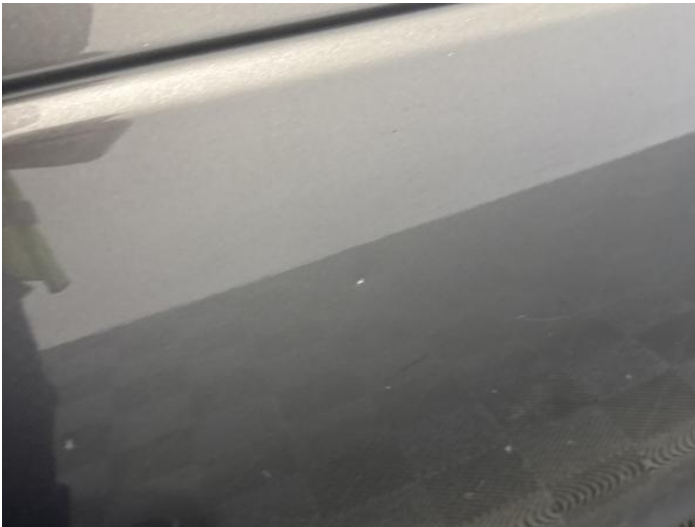
17: Door osr  
Chipped  
1 To 5

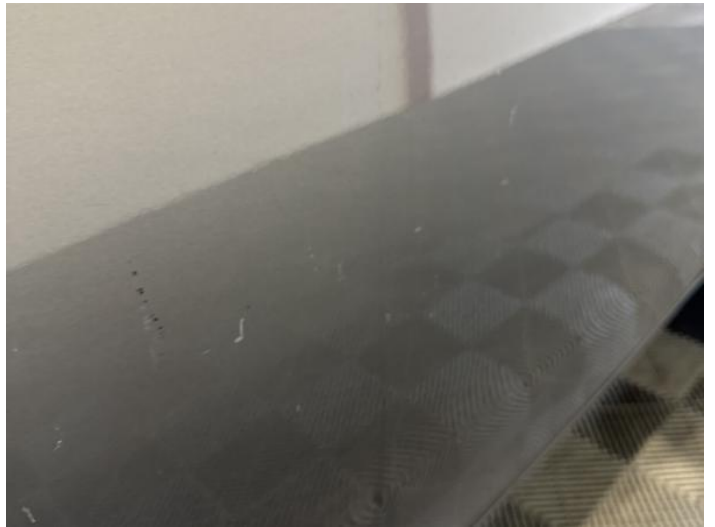
18: Door osf  
Chipped  
Multiple Chips

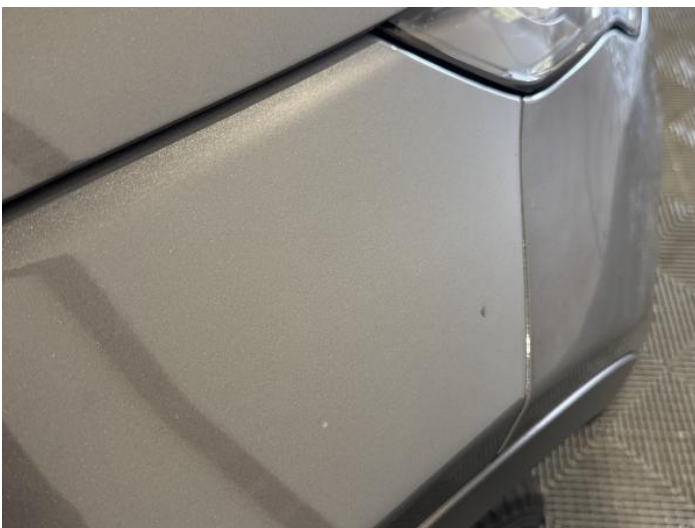
19: Wing osf  
Chipped  
1 To 5

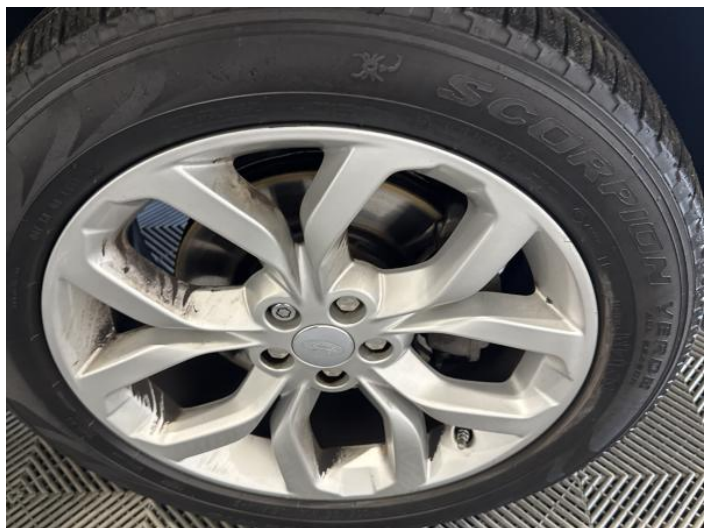
20: Wheel osf  
Scratched  
Over 50mm
