# VEHICLE INSPECTION REPORT

**GX14LEU**

## Volkswagen Golf 1.4 TSI SE 5dr

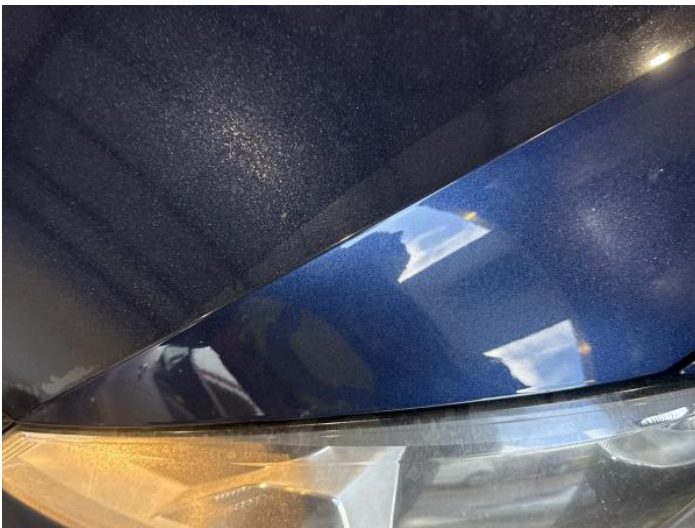
1: Bonnet  
Chipped  
1 To 5

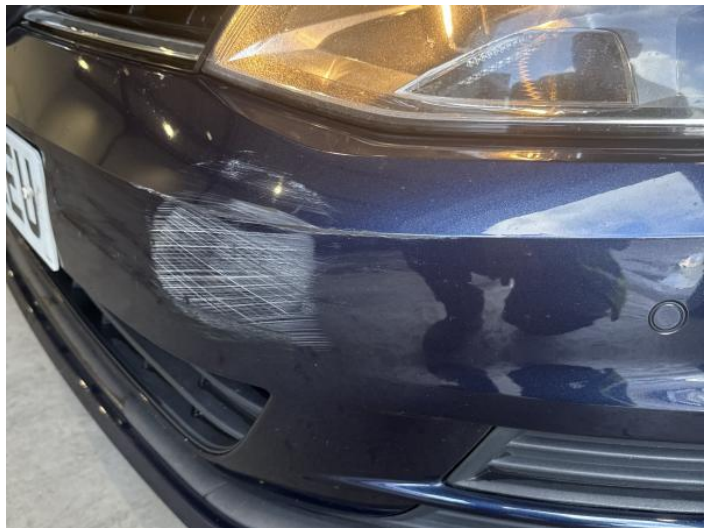
2: Bumper Front  
Scratched  
Over 100mm Thru Paint

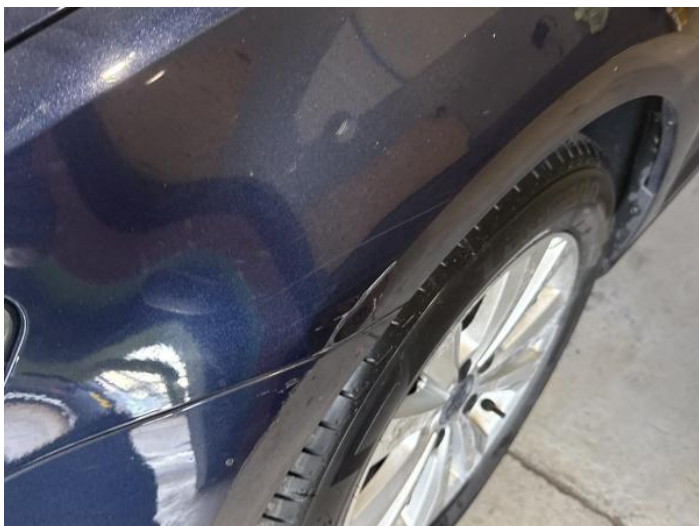
3: Wing nsf  
Dented  
With Paint Damage

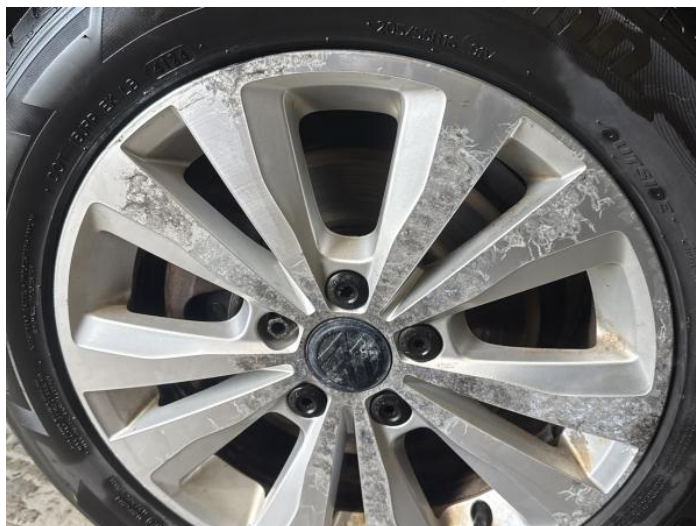
4: Wheel nsf  
Scratched  
Over 50mm

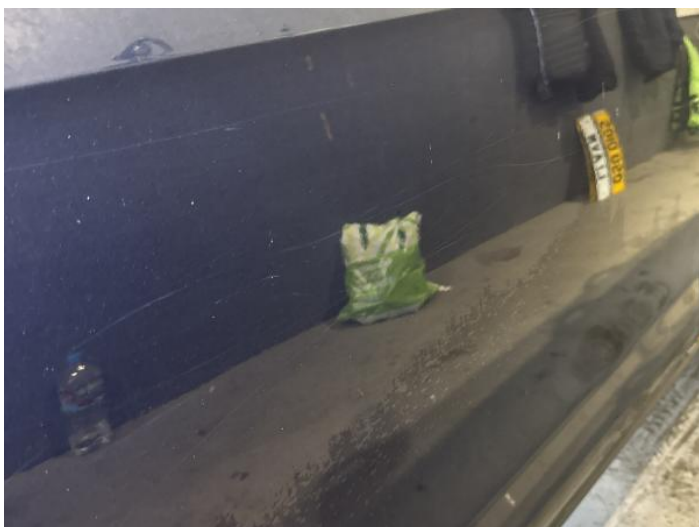
5: Door nsf  
Scratched  
Over 25mm Thru Paint

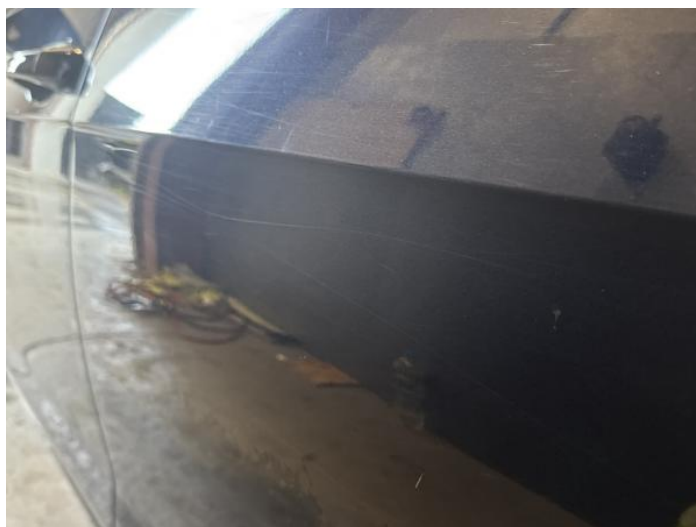
6: Door nsr  
Scratched  
Over 25mm Thru Paint

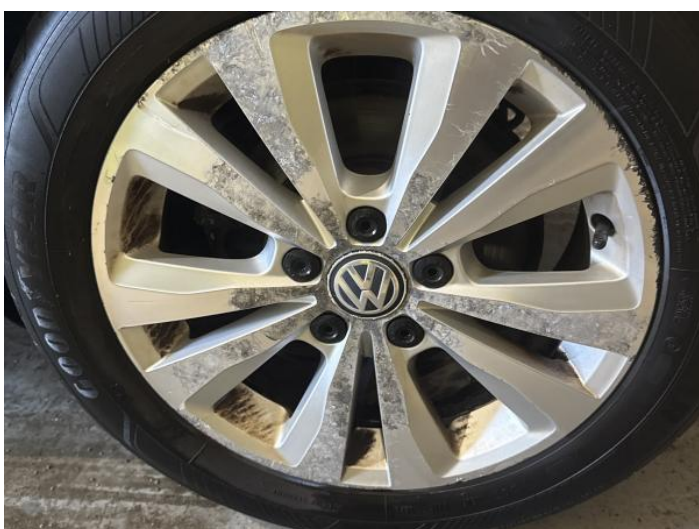
7: Wheel nsr  
Scratched  
Over 50mm

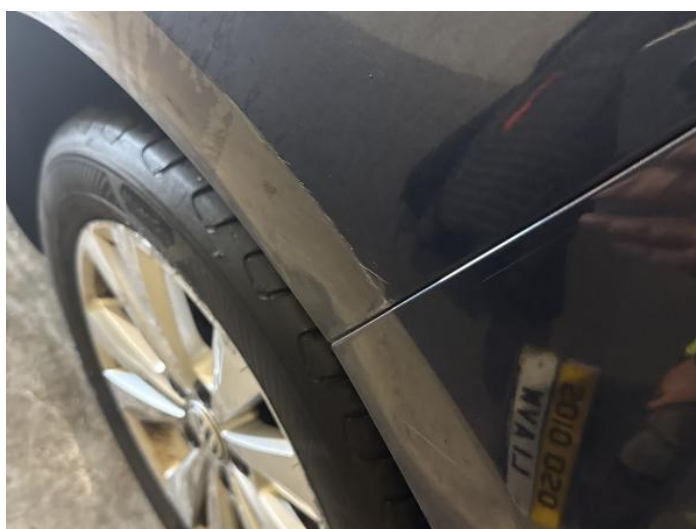
8: Qtr Panel nsr  
Dented  
With Paint Damage

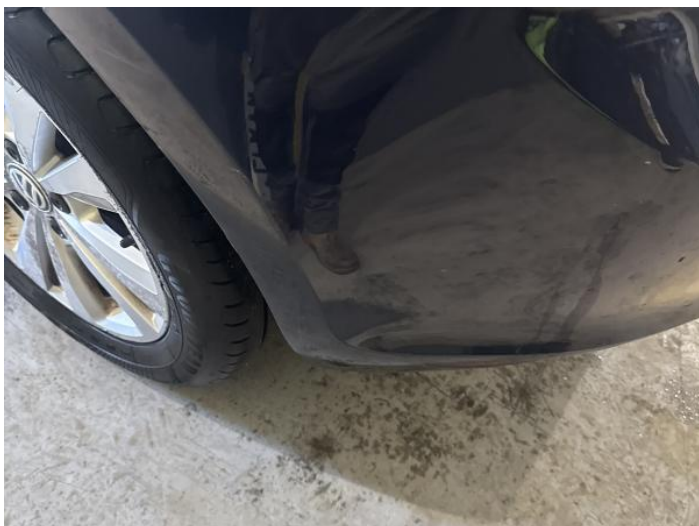
9: Bumper Rear  
Scratched  
Over 100mm Thru Paint

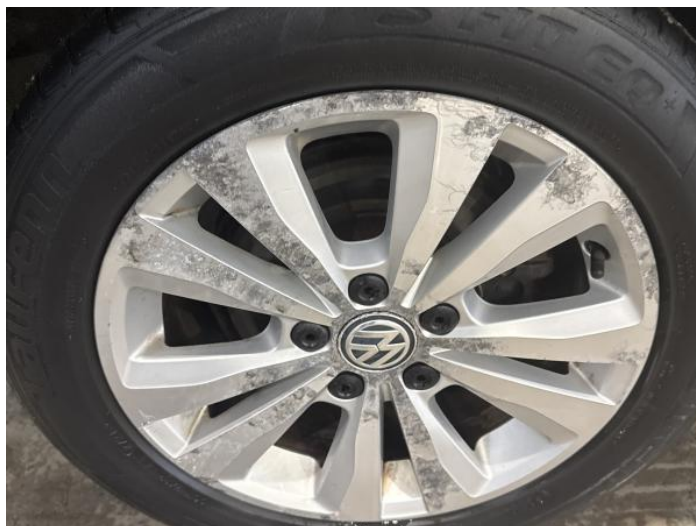
10: Wheel osr  
Scratched  
Over 50mm

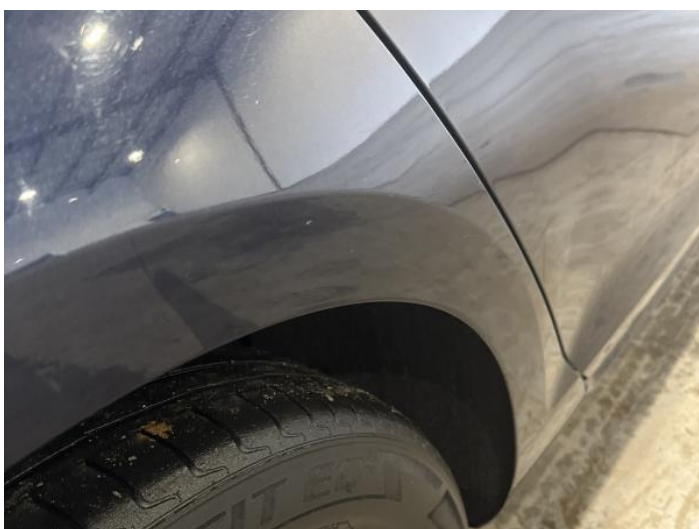
11: Qtr Panel osr  
Scratched  
Over 25mm Thru Paint

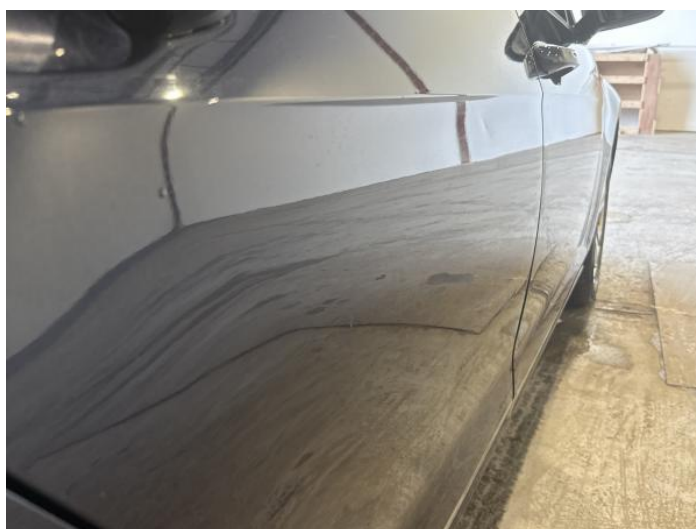
12: Door osr  
Dented  
Over 30mm

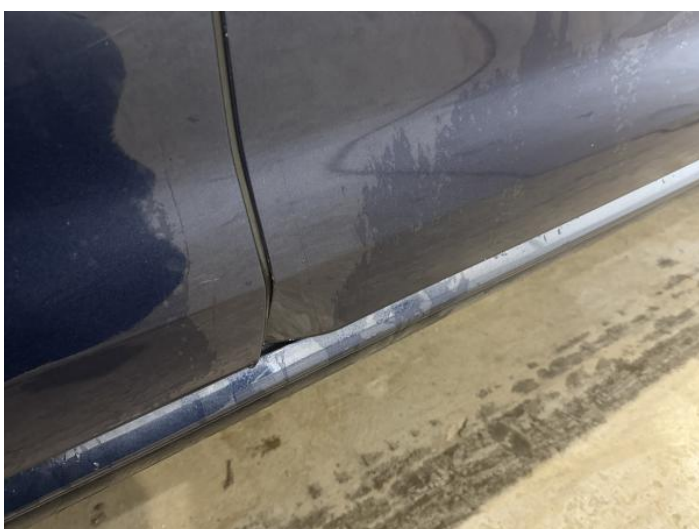
13: Door osf  
Dented  
Over 30mm

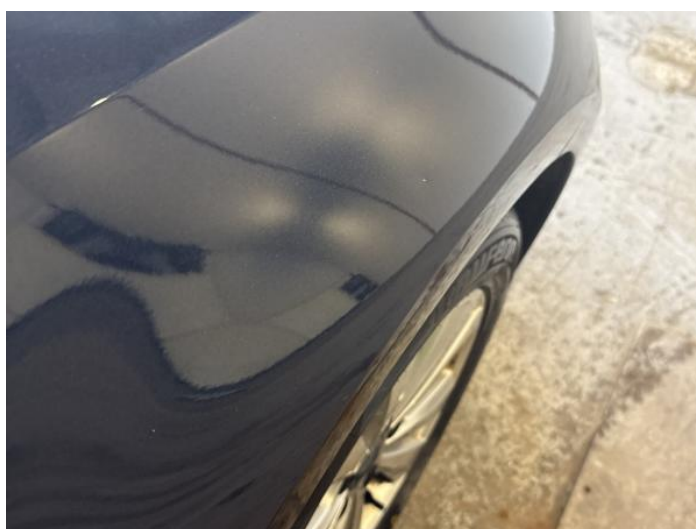
14: Wing osf  
Dented  
Between 10mm + 30mm

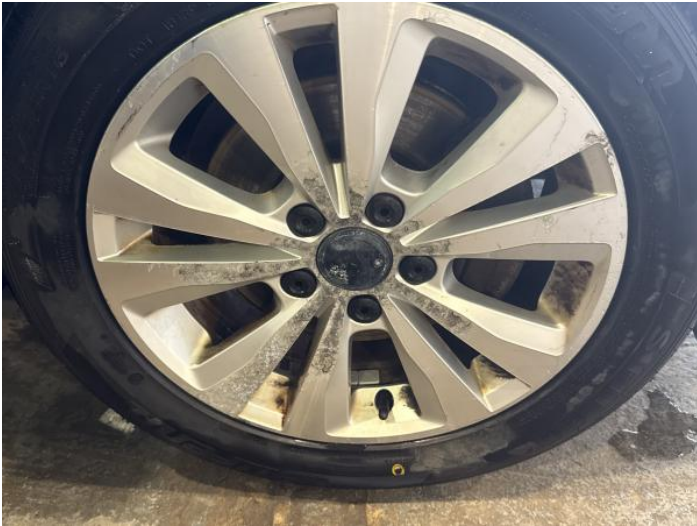
15: Wheel osf  
Scratched  
Over 50mm

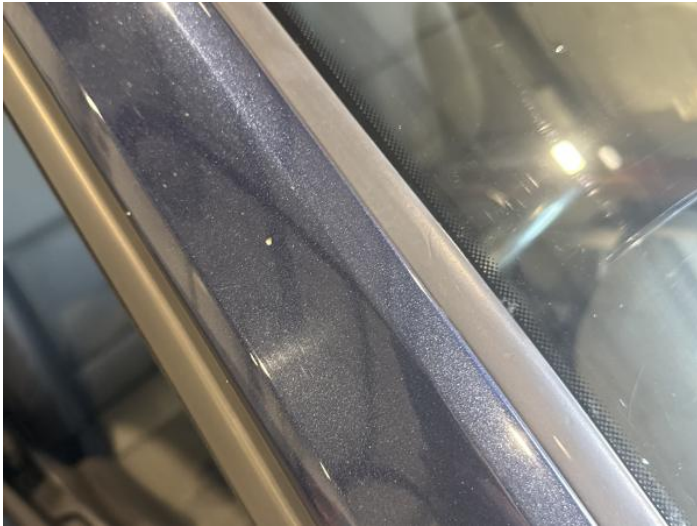
16: A Post os  
Chipped  
1 To 5

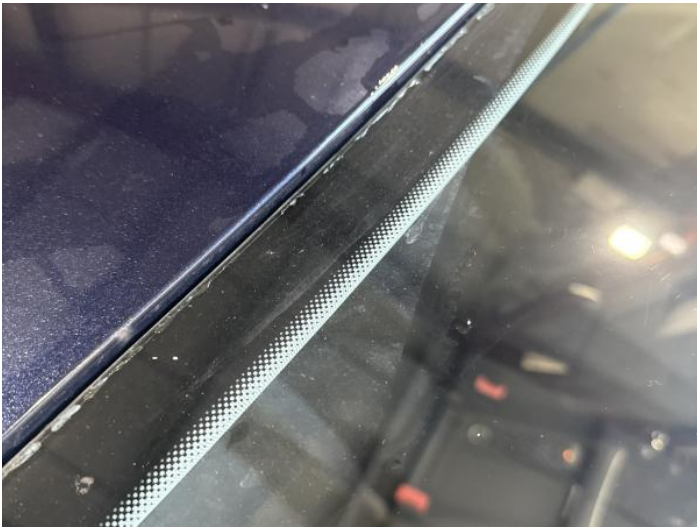
17: Roof  
Chipped  
Edge Chip
