VEHICLE INSPECTION REPORT

KN68ZST

Citroen C4 Spacetourer 1.5 BlueHDi 130 Flair 5dr

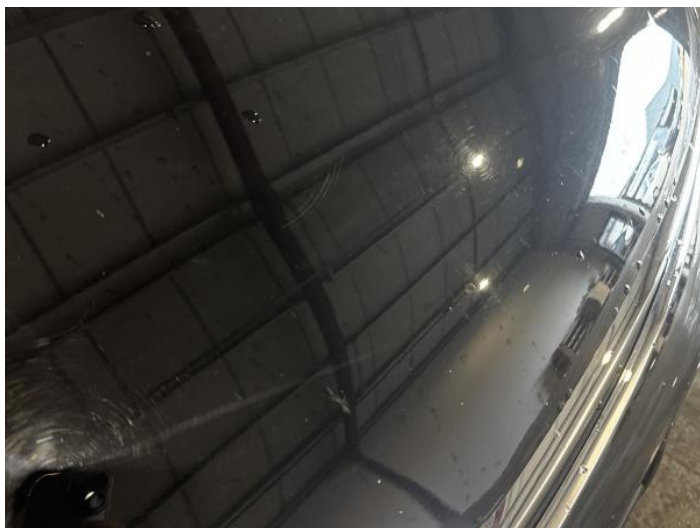
1: Bonnet
Scratched
Over 25mm Thru Paint

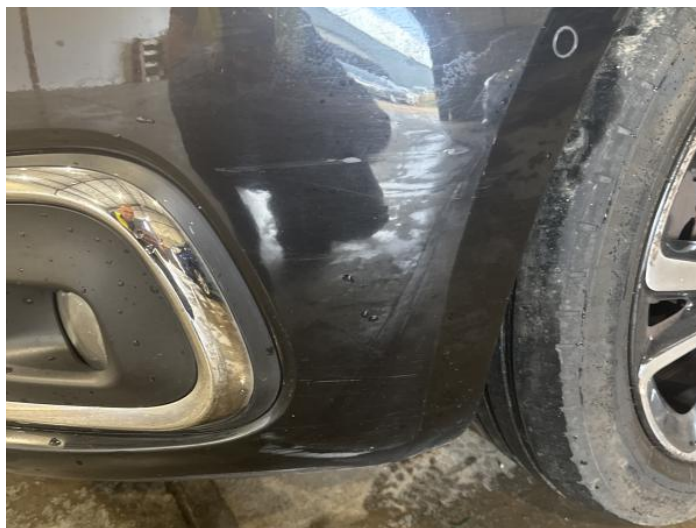
2: Bumper Front
Scratched
Over 100mm Thru Paint

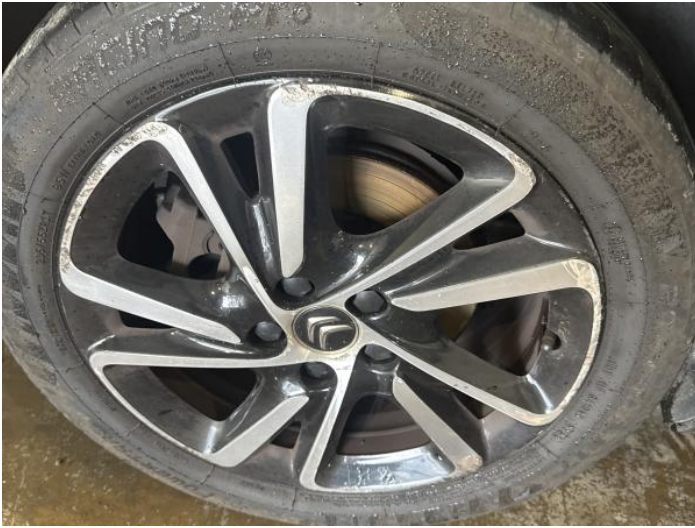
3: Wheel nsf
Scratched
Over 50mm

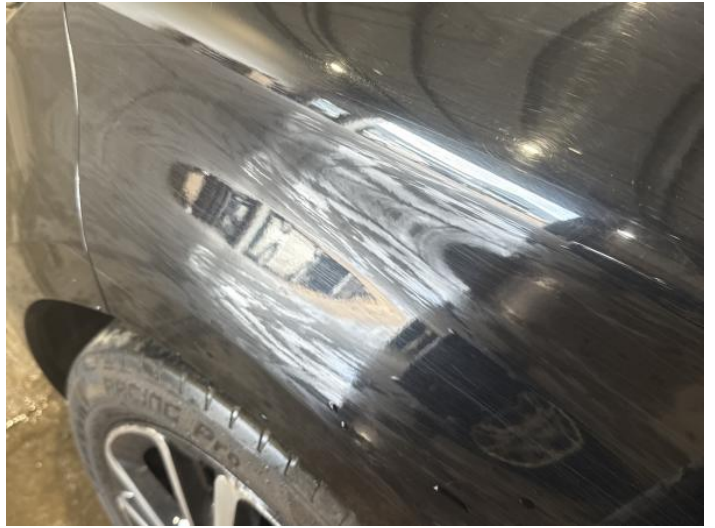
4: Wing nsf
Scratched
Over 25mm Thru Paint

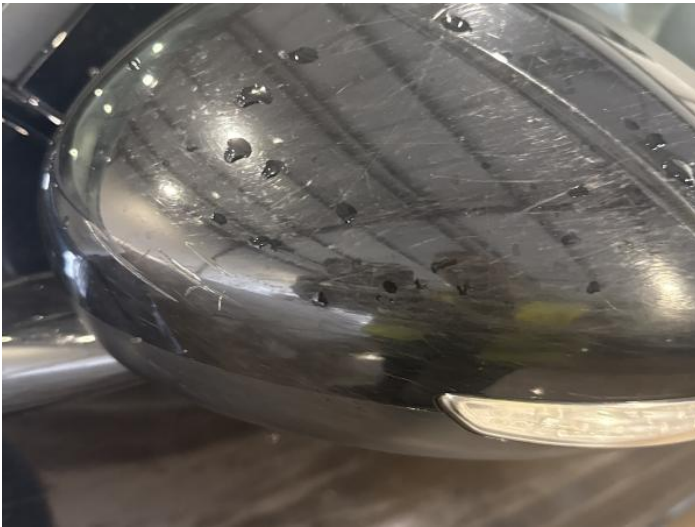
5: Door Mirror Assy nsf
Scratched (Painted)
Over 25mm Thru Paint

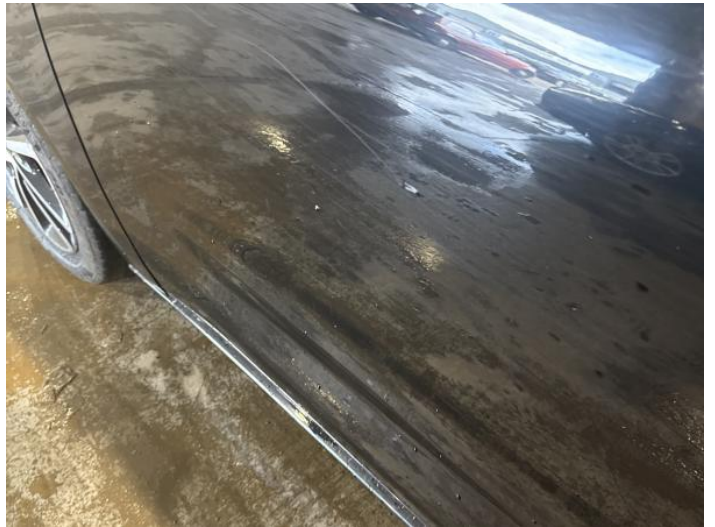
6: Door nsf
Scratched
Over 25mm Thru Paint

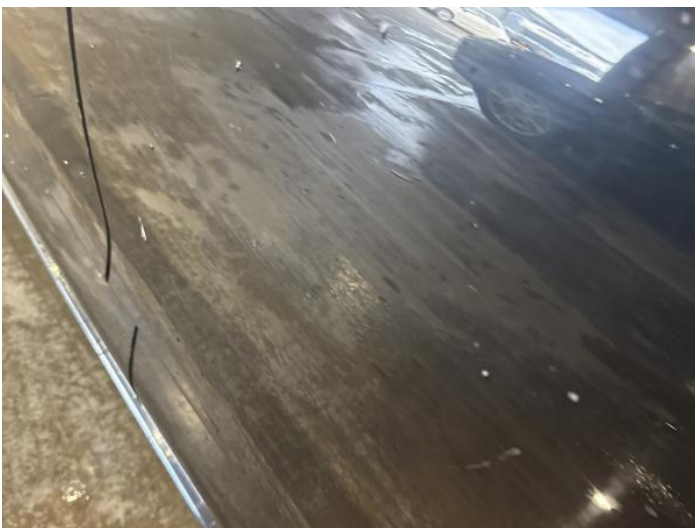
7: Door nsr
Dented
Between 10mm + 30mm

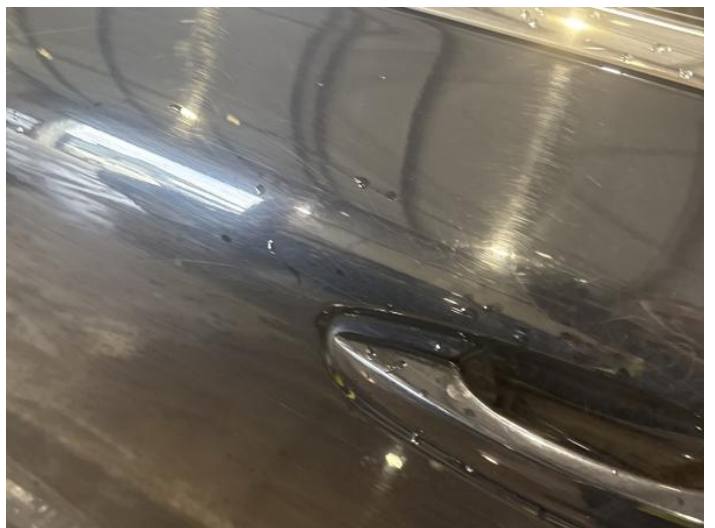
8: Door nsr
Scratched
Over 25mm Thru Paint

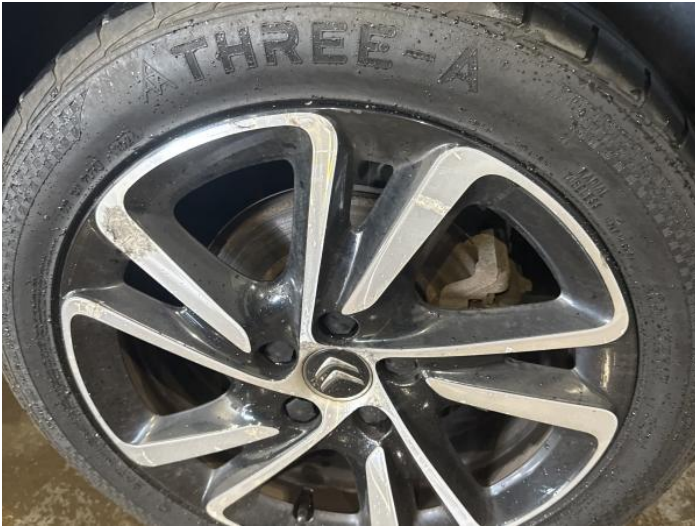
9: Wheel nsr
Scratched
Over 50mm

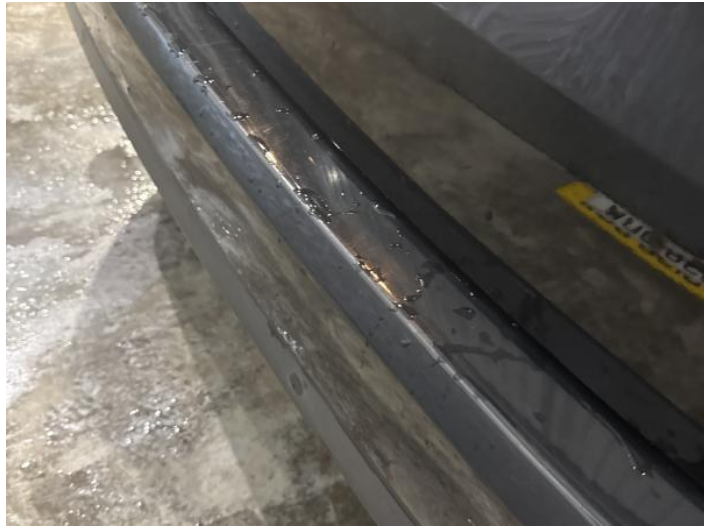
10: Bumper Rear
Scratched
25 to 100mm Thru Paint

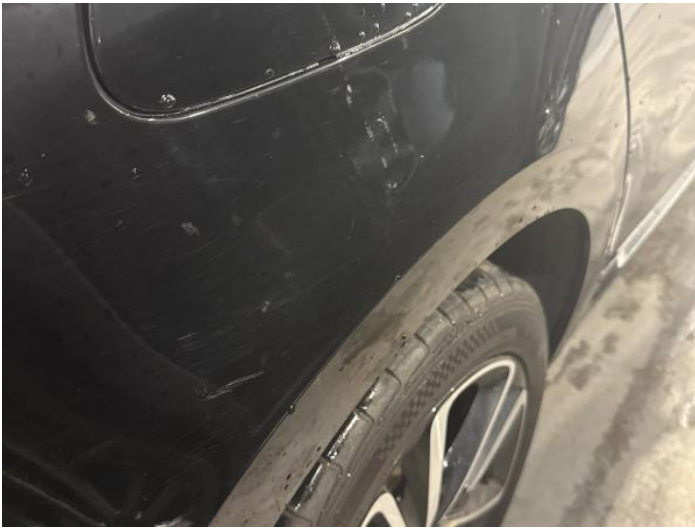
11: Qtr Panel osr
Dented
With Paint Damage

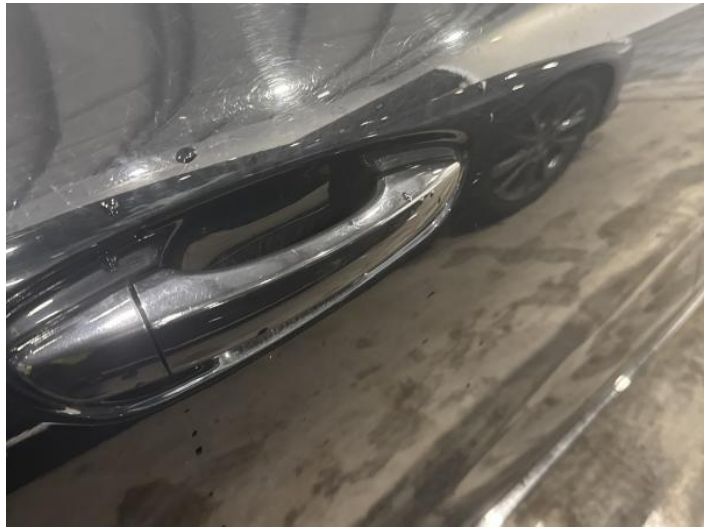
12: Door osr
Scratched
Over 25mm Thru Paint

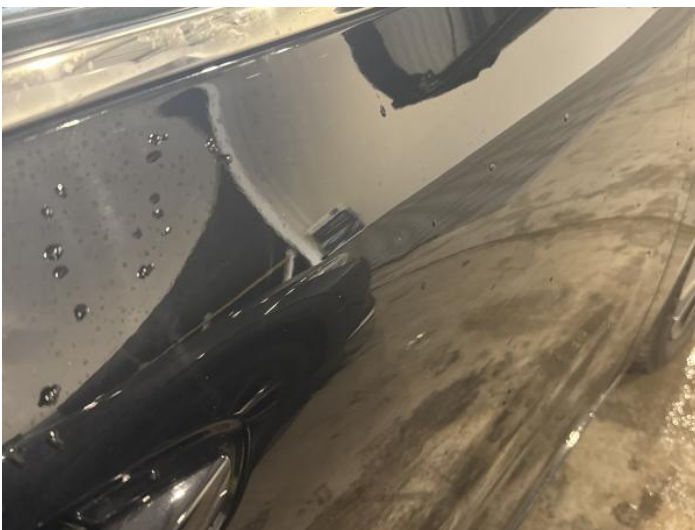
13: Door osf
Dented
Between 10mm + 30mm

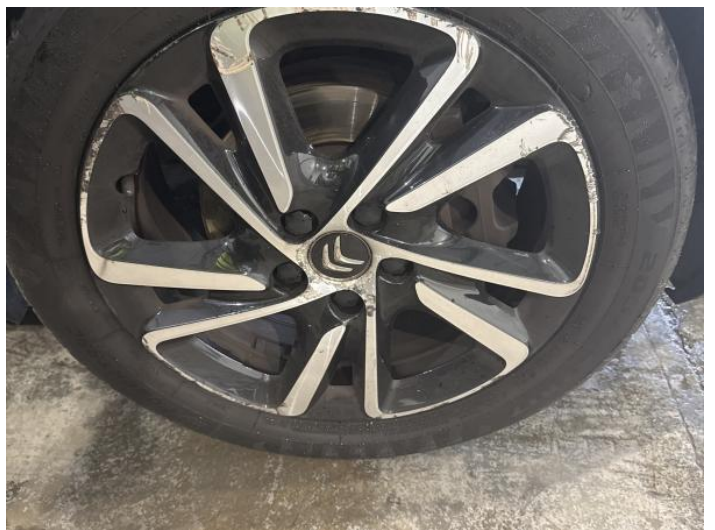
14: Wheel nsf
Scratched
Over 50mm

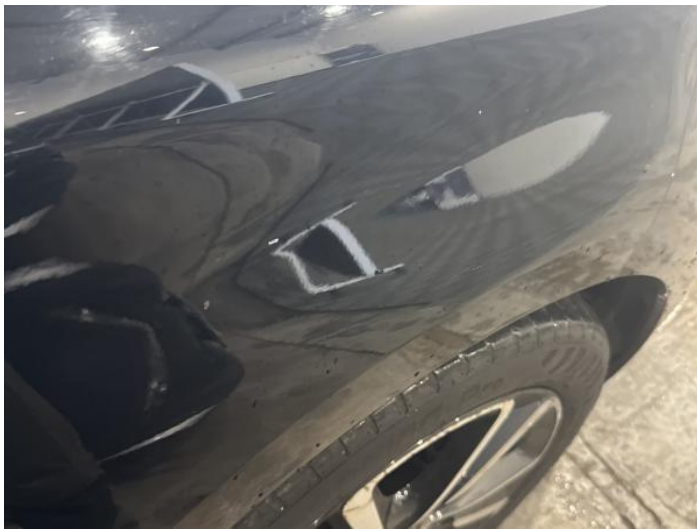
15: Wing osf
Scratched
UpTo 25mm Thru Paint

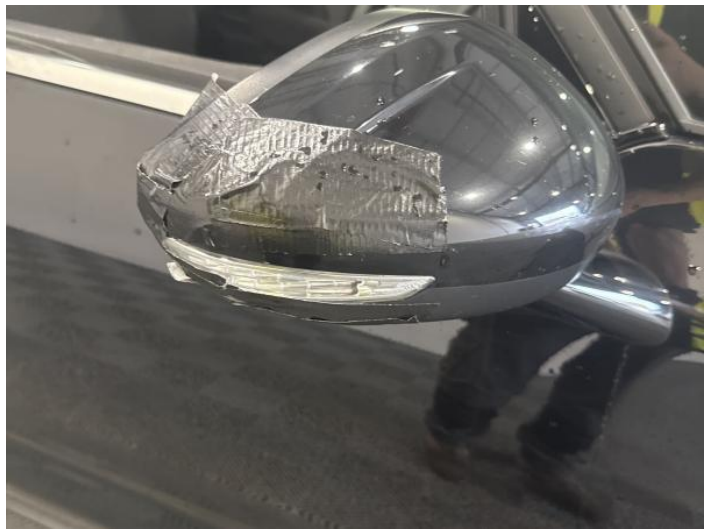
16: Door Mirror Assy osf
Broken
Replace
