VEHICLE INSPECTION REPORT

GX73WVU

Volkswagen T-Roc 1.5 TSI Style 5dr DSG

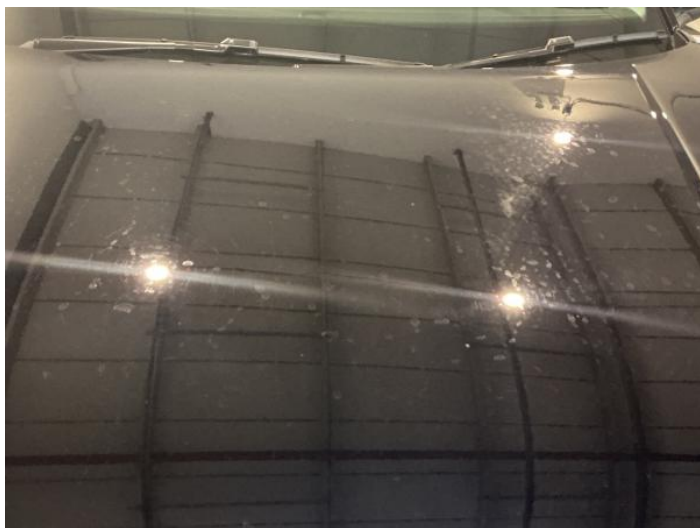
1: Bonnet
Chipped
1 To 5

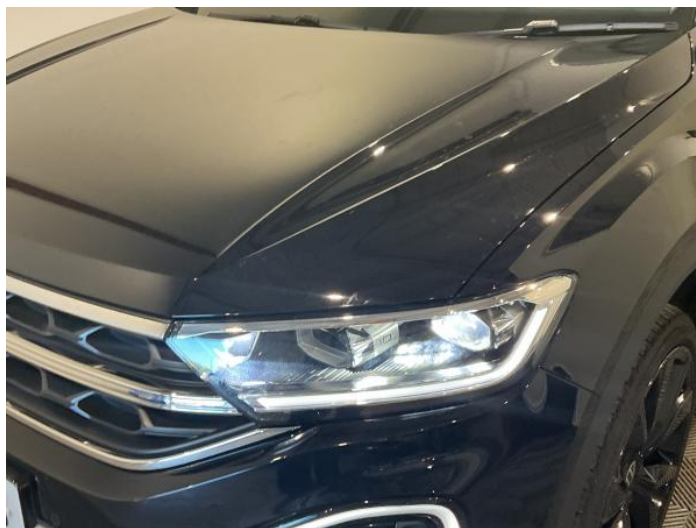
2: Bumper Front
Chipped
Multiple Chips

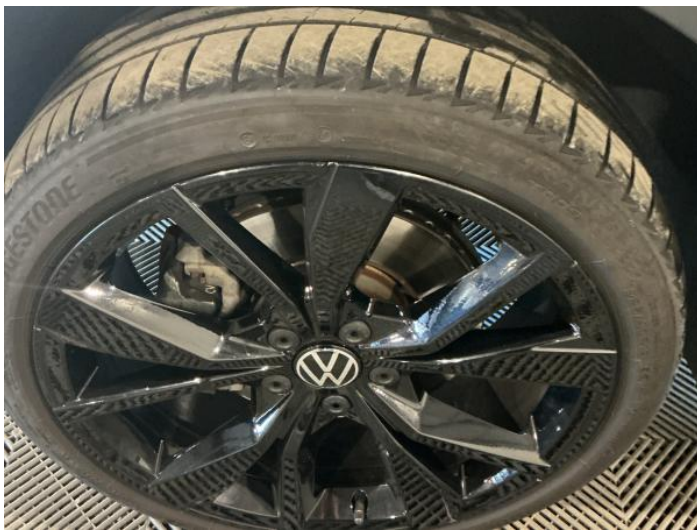
5: Wheel nsr
Scratched
Up To 50mm

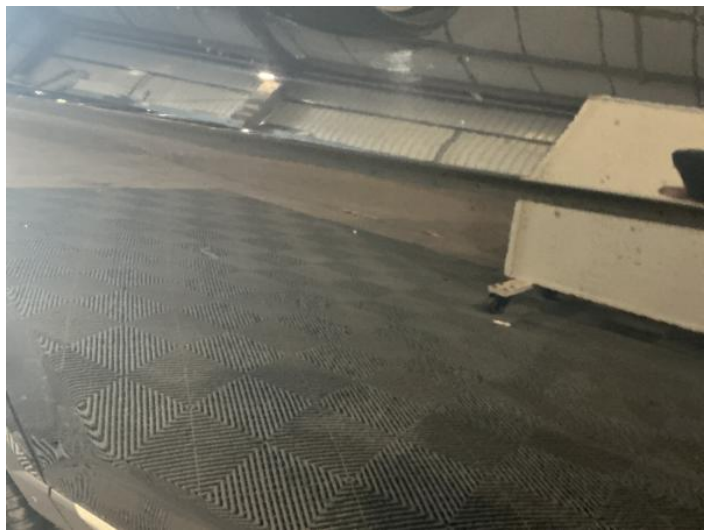
6: Door nsf
Chipped
1 To 5

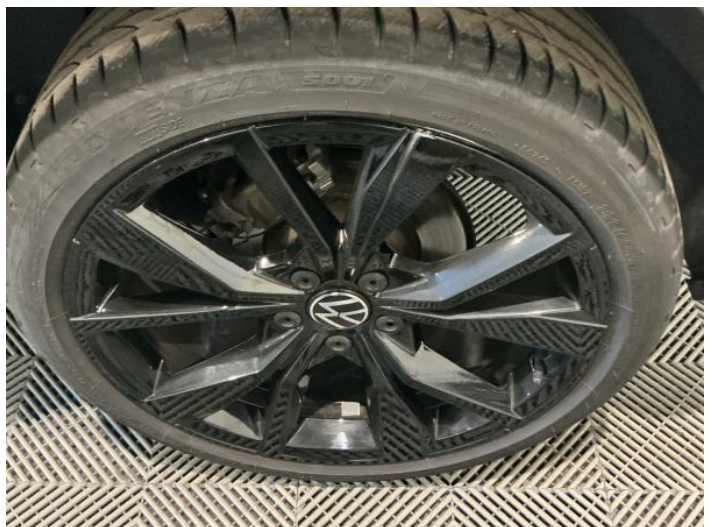
8: Wheel nsr
Scratched
Up To 50mm

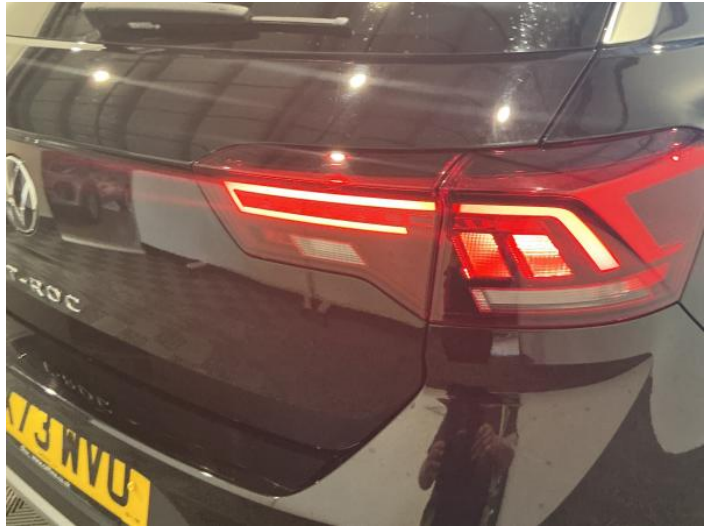
9: Qtr Panel nsr
Scratched
Over 25mm Not Thru Paint
