VEHICLE INSPECTION REPORT

VX64XLK

Volkswagen Tiguan 2.0 TDi BlueMotion Tech Match 5dr DSG

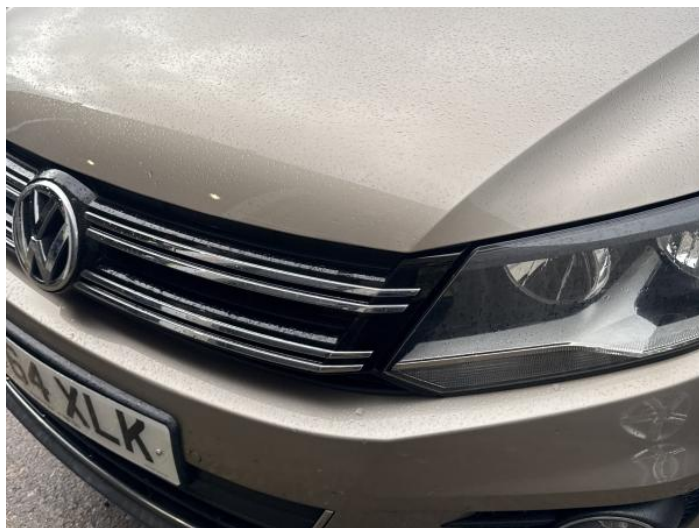
2: Bumper Front
Chipped
Multiple Chips

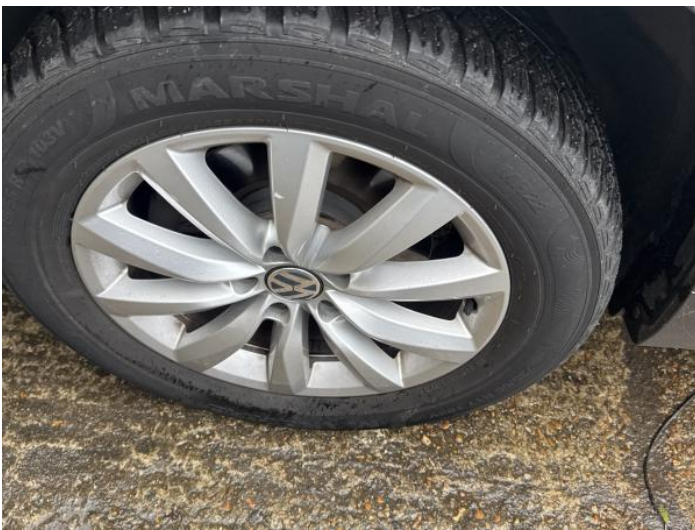
5: Wheel nsf
Scratched
Up To 50mm

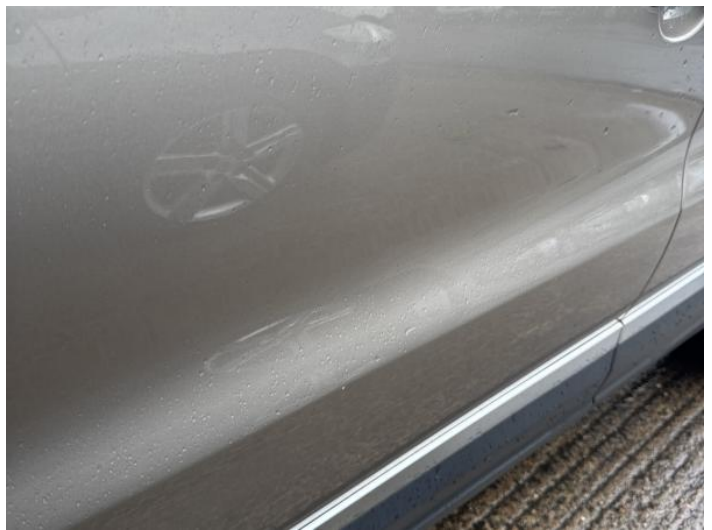
6: Door nsf
Chipped
1 To 5

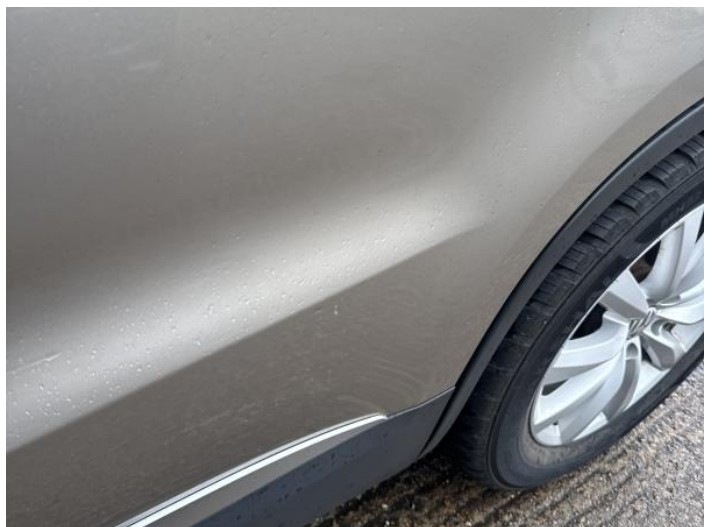
8: Door nsr
Chipped
1 To 5

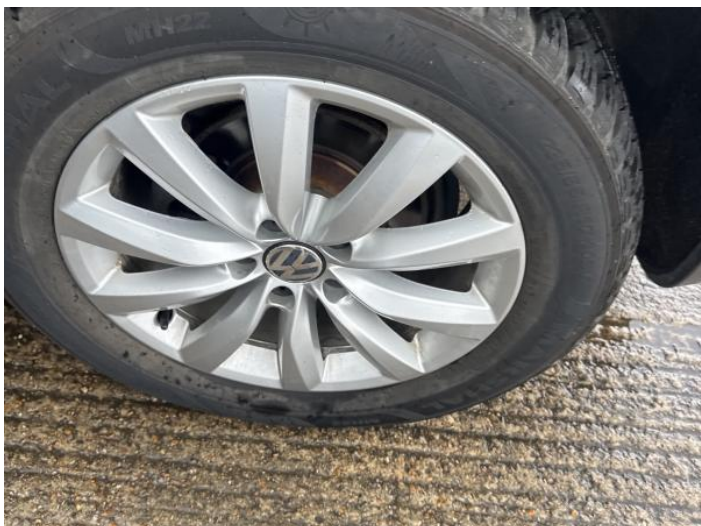
9: Wheel nsr
Scratched
Up To 50mm

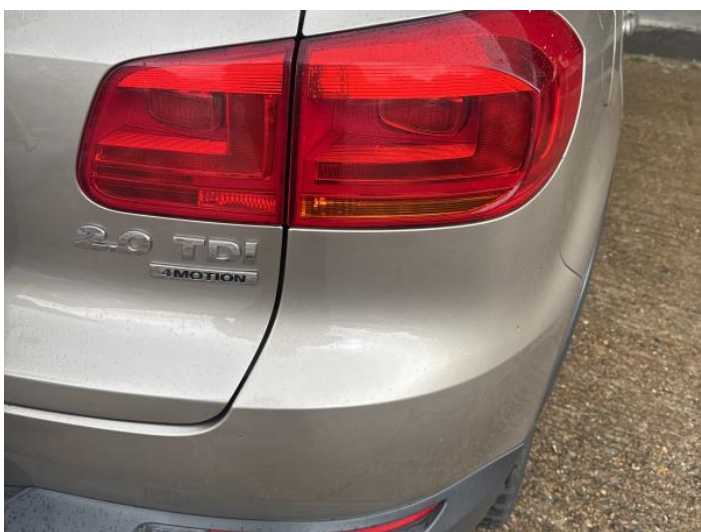
11: Bumper Rear
Chipped
Multiple Chips

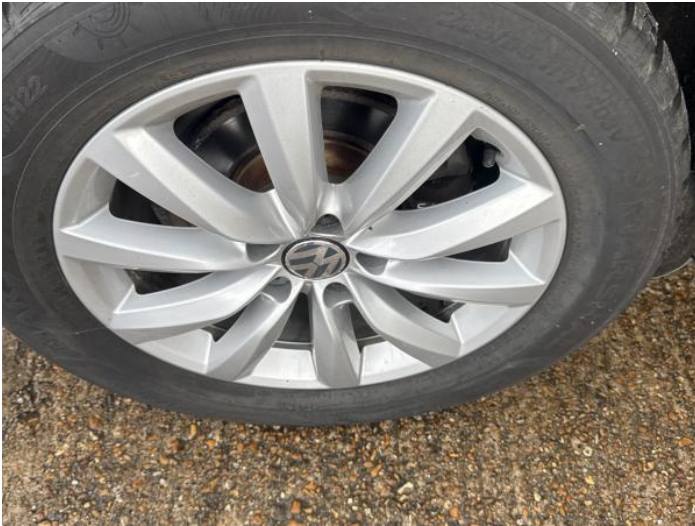
15: Wheel osr
Scratched
Up To 50mm

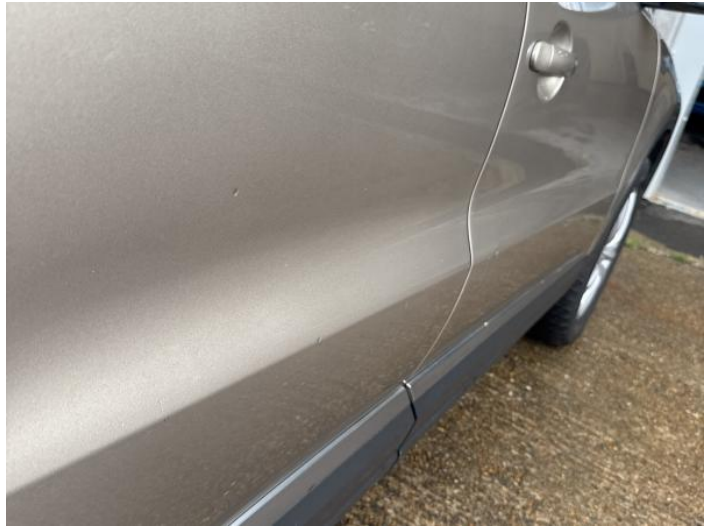
16: Door osr
Chipped
1 To 5

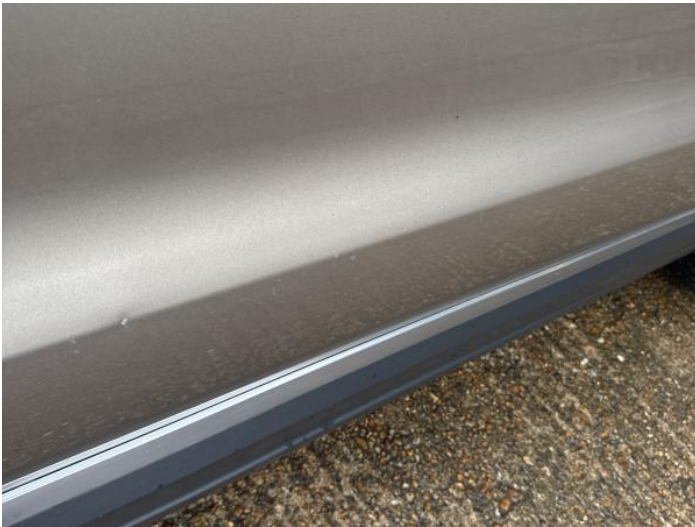
17: Door osf
Dented
With Paint Damage

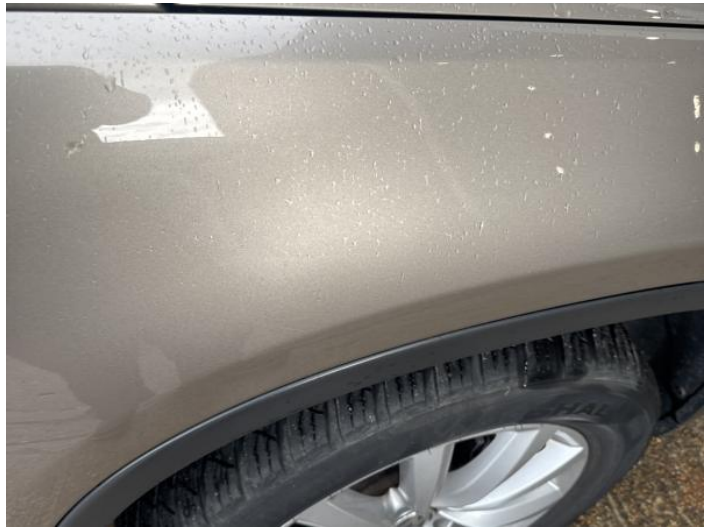
18: Wing osf
Chipped
1 To 5

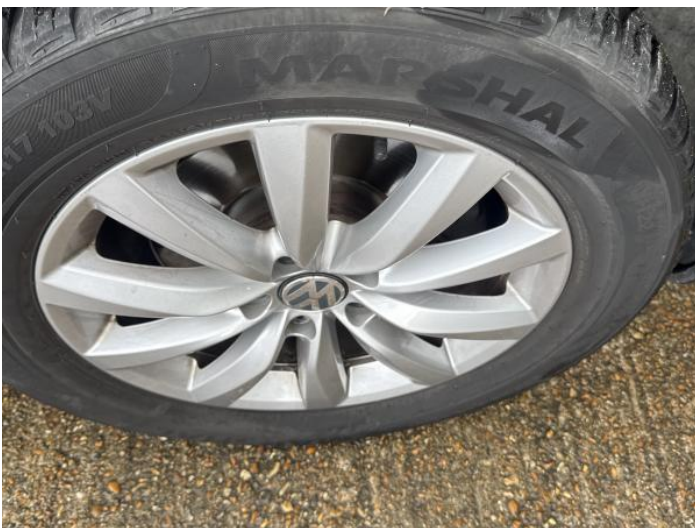
19: Wheel osf
Scratched
Over 50mm
