# VEHICLE INSPECTION REPORT

**HX64ZNP**

## Volvo XC60 D5 [215] R DESIGN Lux Nav 5dr AWD Geartronic

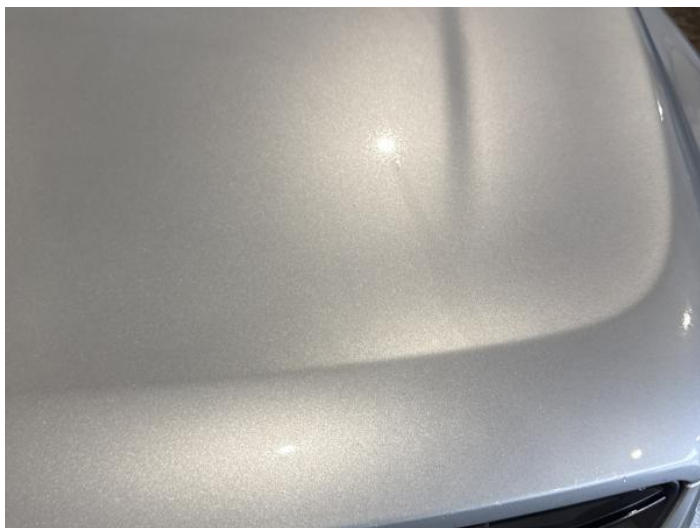
1: Bonnet  
Chipped  
1 To 5

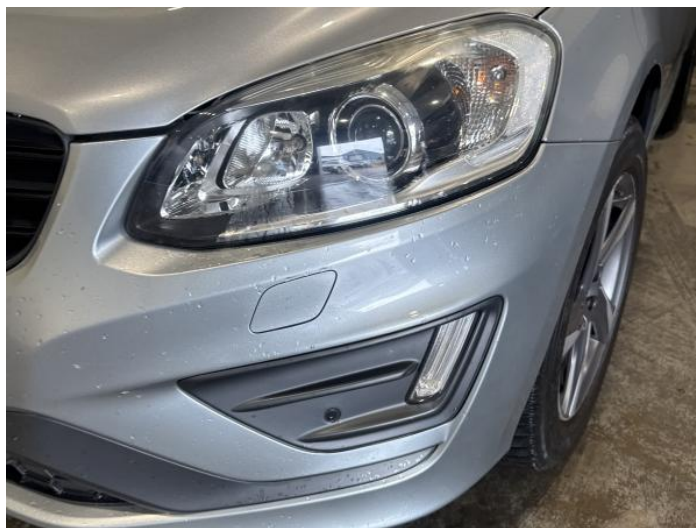
2: Bumper Front  
Chipped  
Multiple Chips

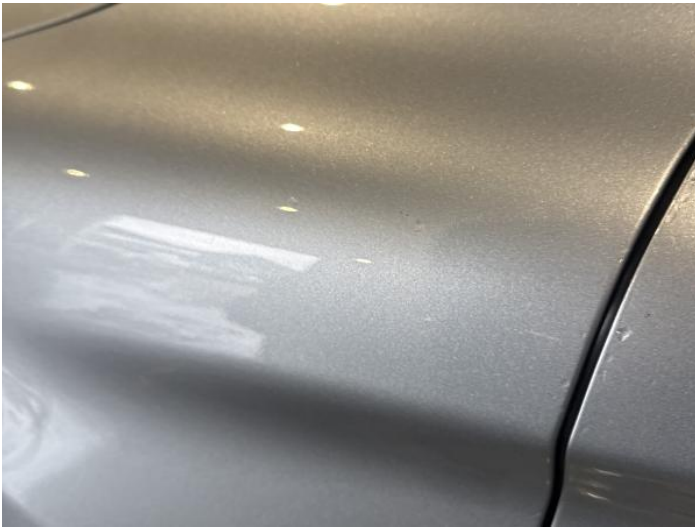
5: Wing nsf  
Chipped  
1 To 5

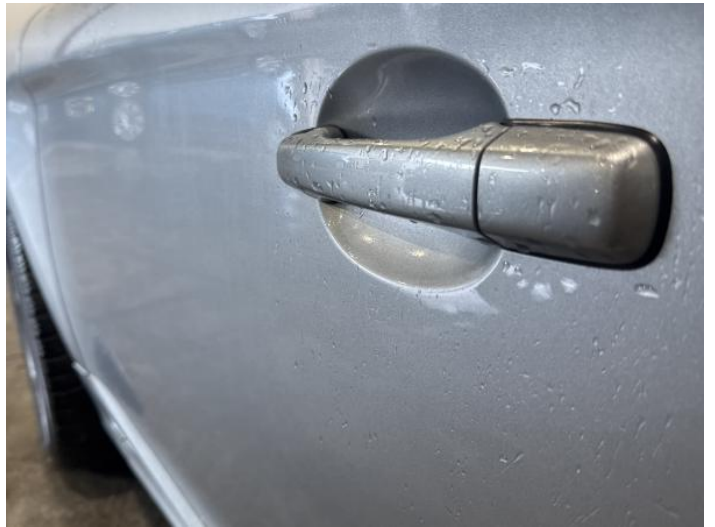
6: Door nsr  
Chipped  
1 To 5

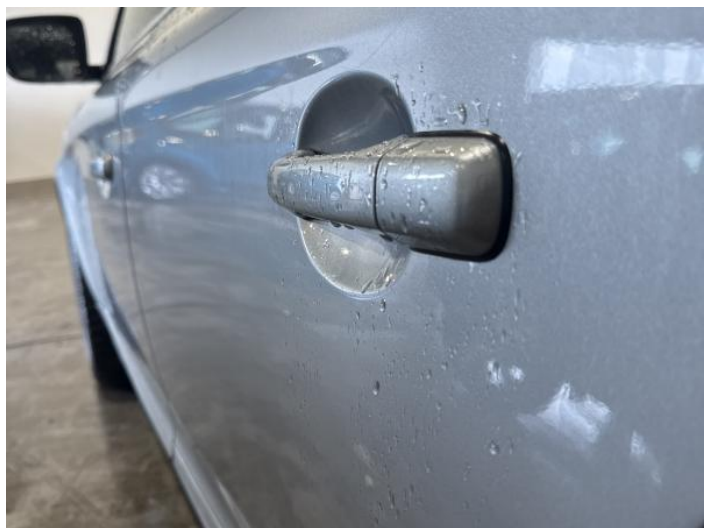
7: Door nsf  
Scratched  
Over 25mm Not Thru Paint

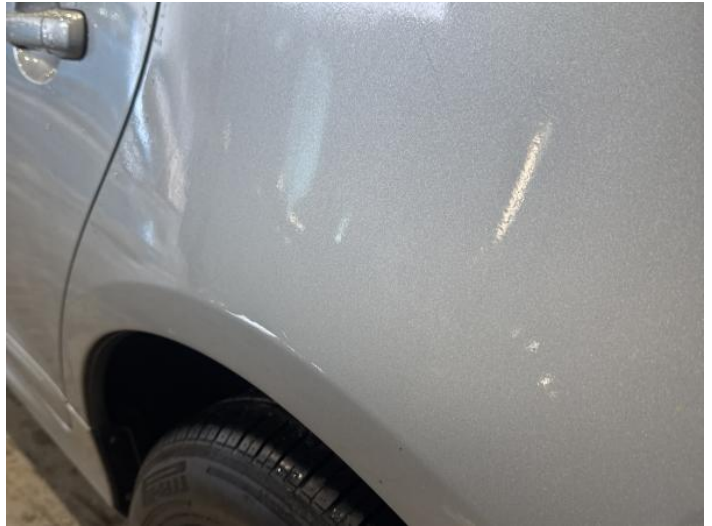
10: Qtr Panel nsr  
Chipped  
1 To 5

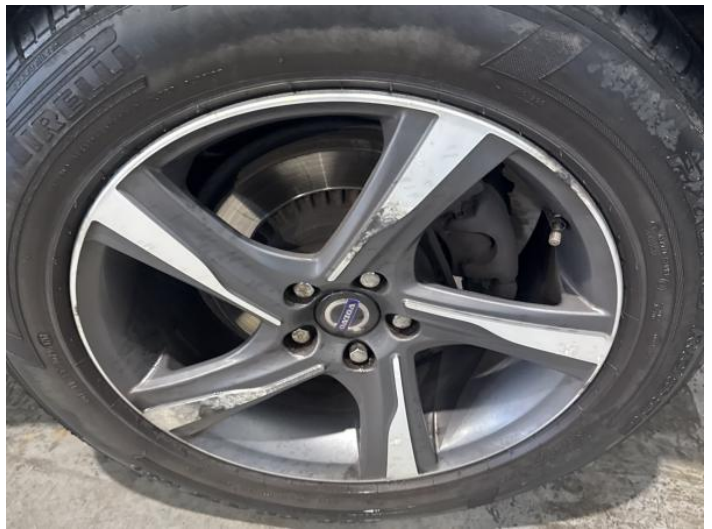
12: Wheel nsr  
Scratched  
Over 50mm

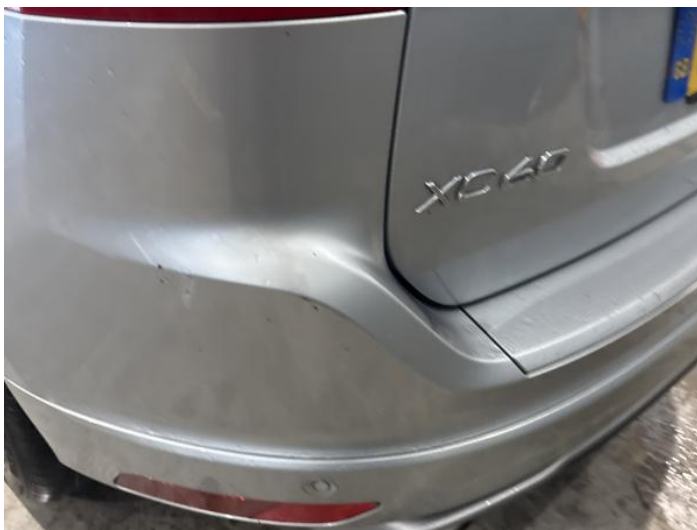
13: Bumper Rear  
Poor Previous Repair  
Poor Paint

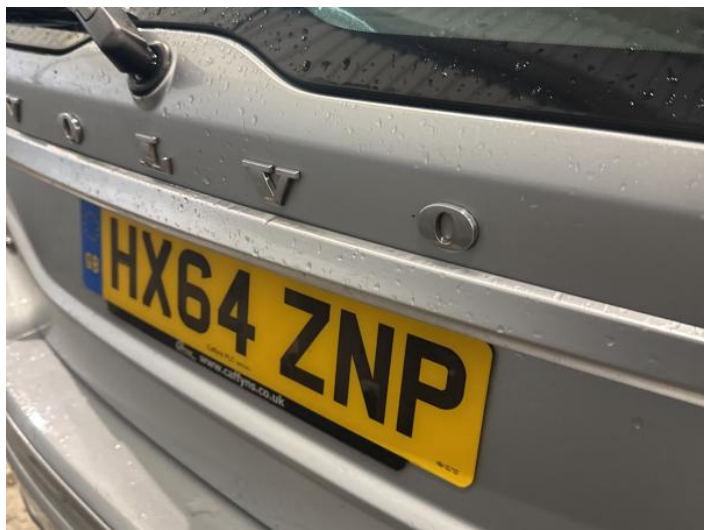
14: Boot Lid  
Dented  
Over 2 UpTo 10mm

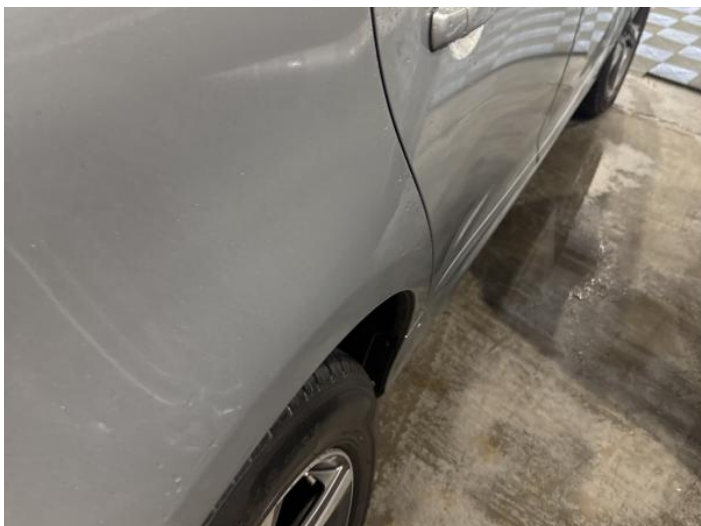
15: Qtr Panel osr  
Dented  
2 Or Less UpTo 10mm

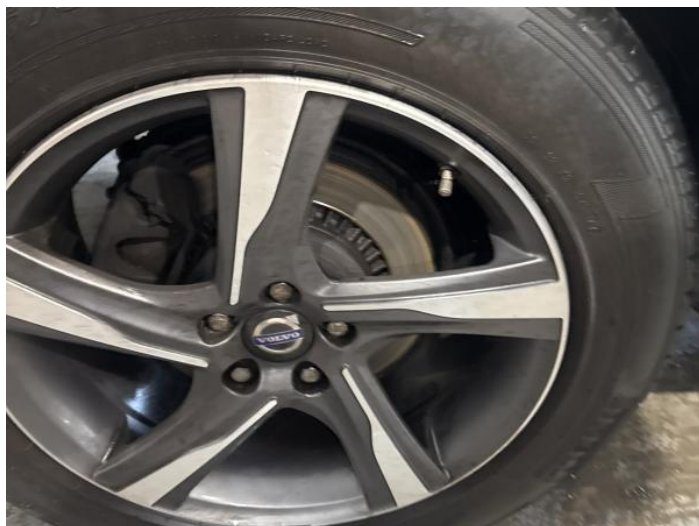
16: Wheel osr  
Scratched  
Up To 50mm

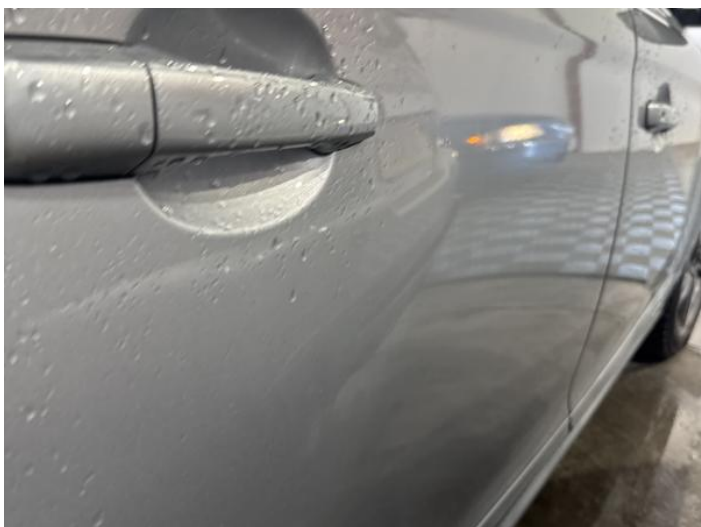
17: Door osr  
Chipped  
1 To 5

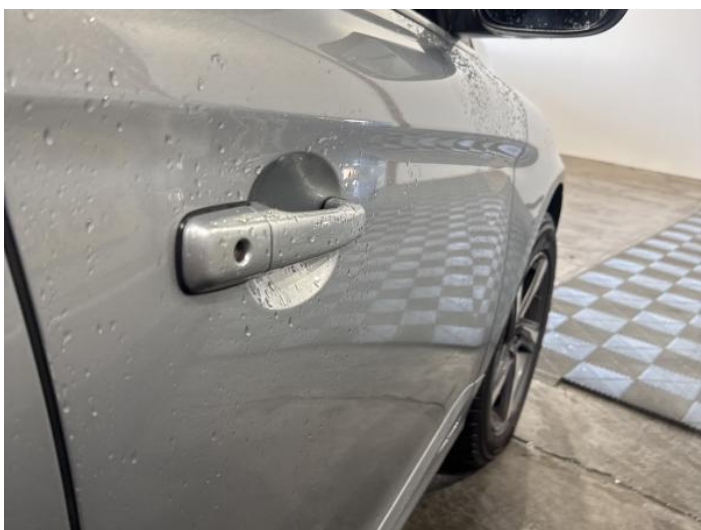
19: Door osf  
Chipped  
1 To 5

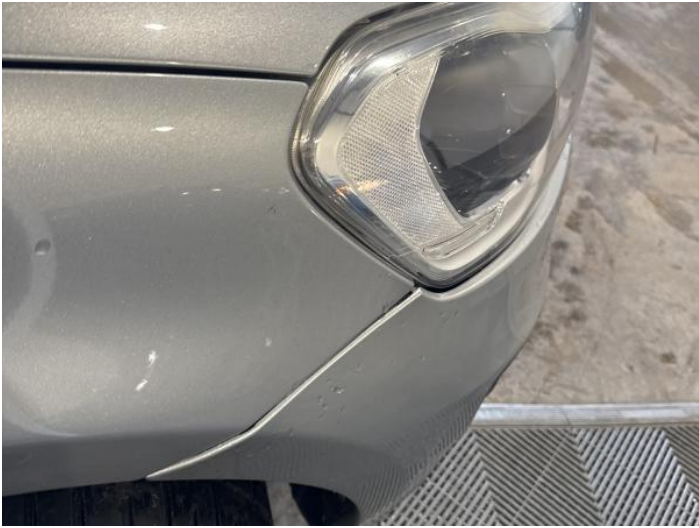
21: Wing osf  
Chipped  
1 To 5

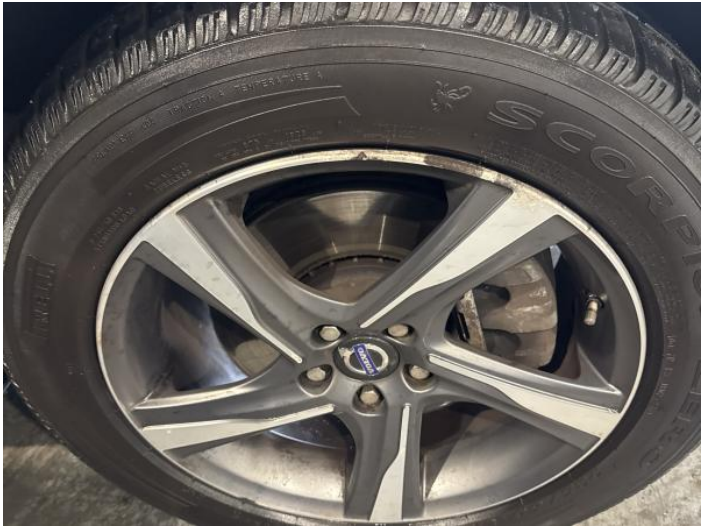
22: Wheel osf  
Scratched  
Over 50mm

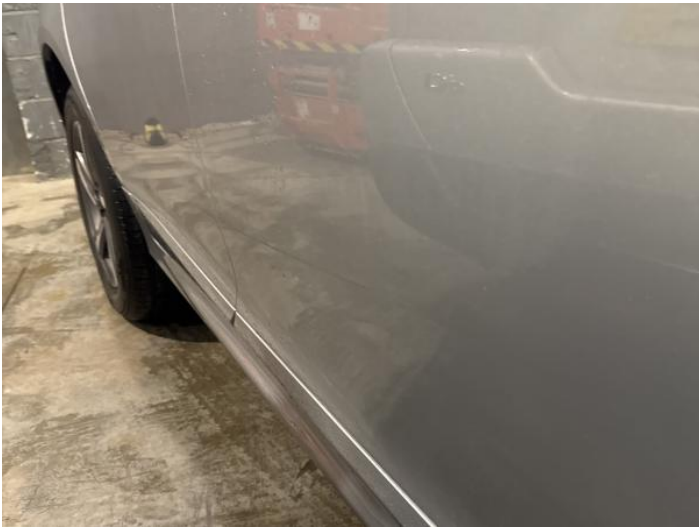
23: Door osf  
Dented  
Between 10mm + 30mm
