# VEHICLE INSPECTION REPORT

**EY11GME**

## Audi TT 2.0 TDI Quattro Black Edition 2dr

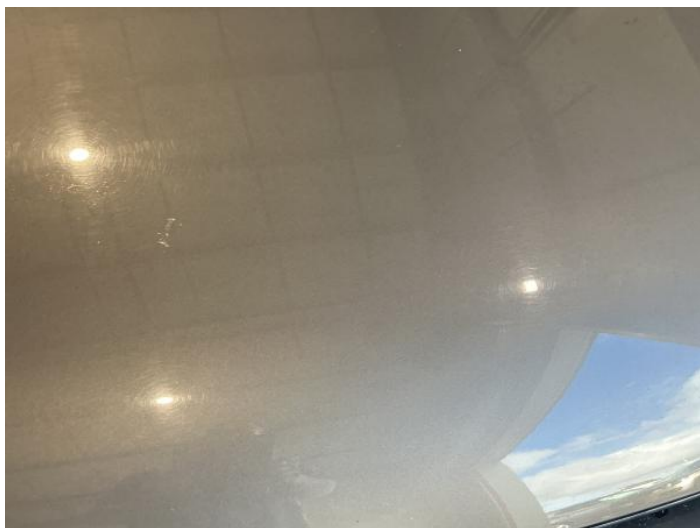
1: Bonnet  
Chipped  
Multiple Chips

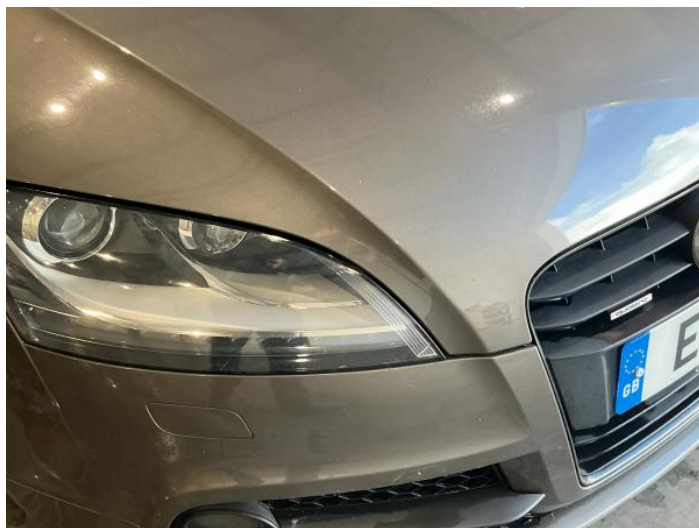
2: Bumper Front  
Chipped  
Multiple Chips

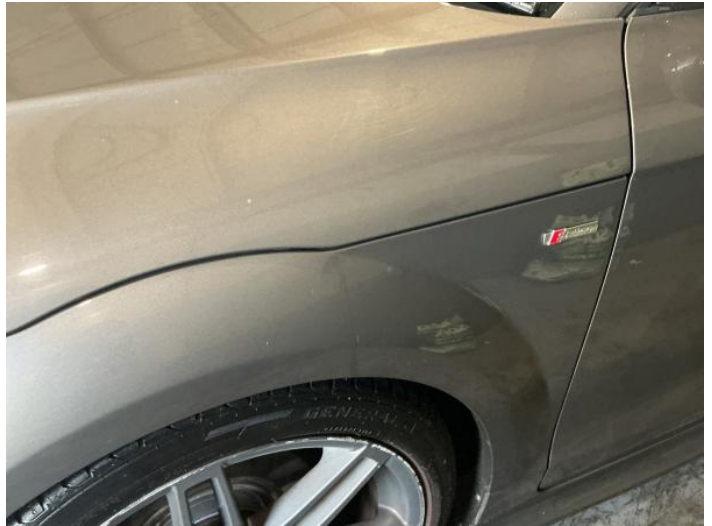
4: Wing nsf  
Chipped  
1 To 5

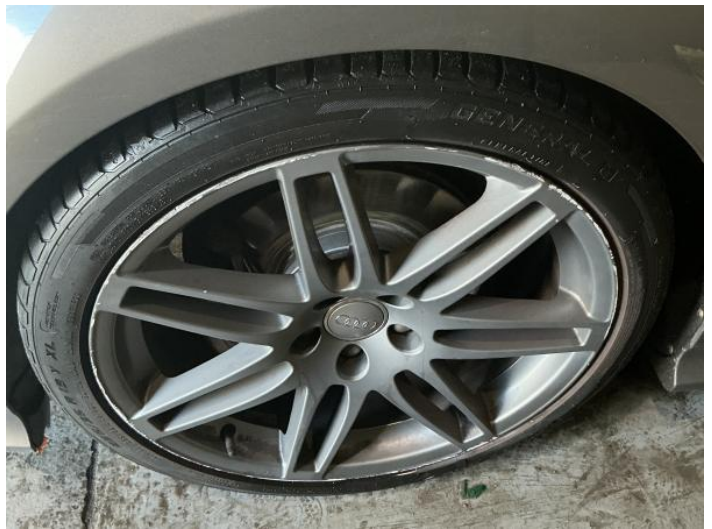
6: Wheel nsf  
Scratched  
Over 50mm

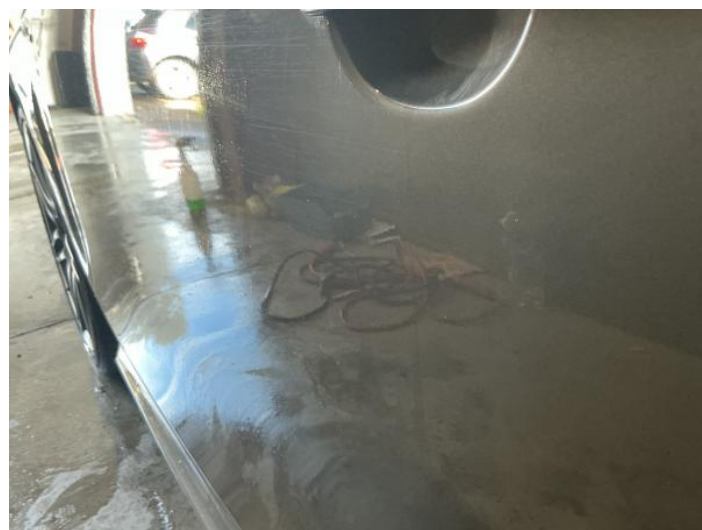
7: Door nsr  
Chipped  
1 To 5

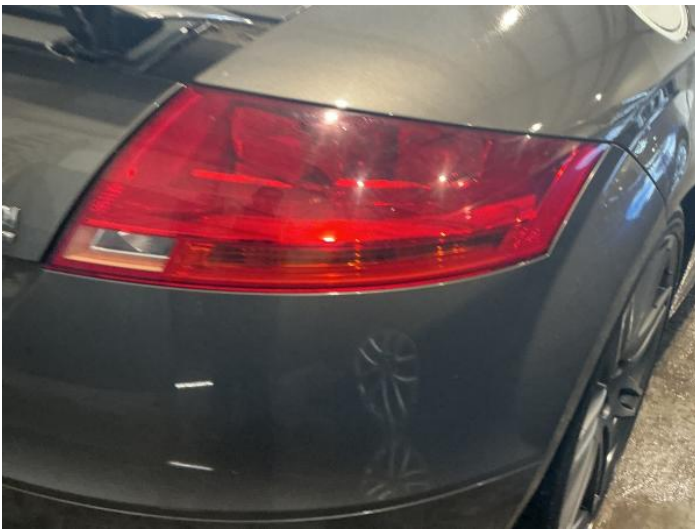
11: Bumper Rear  
Chipped  
Multiple Chips

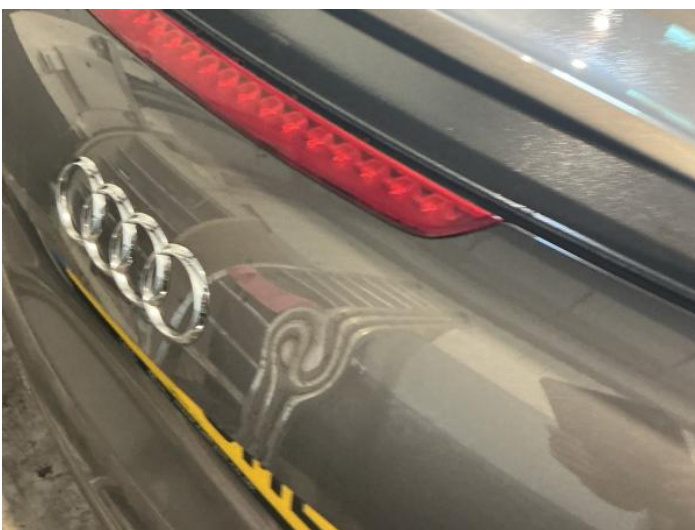
13: Boot Lid  
Dented  
Between 10mm + 30mm

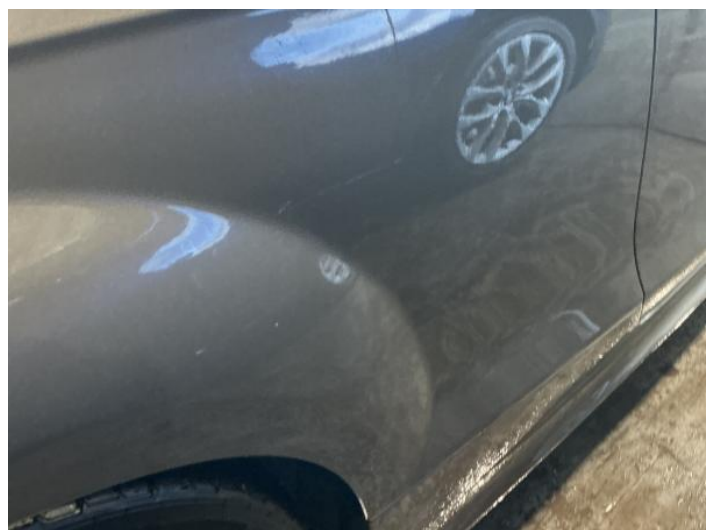
14: Qtr Panel osr  
Chipped  
1 To 5

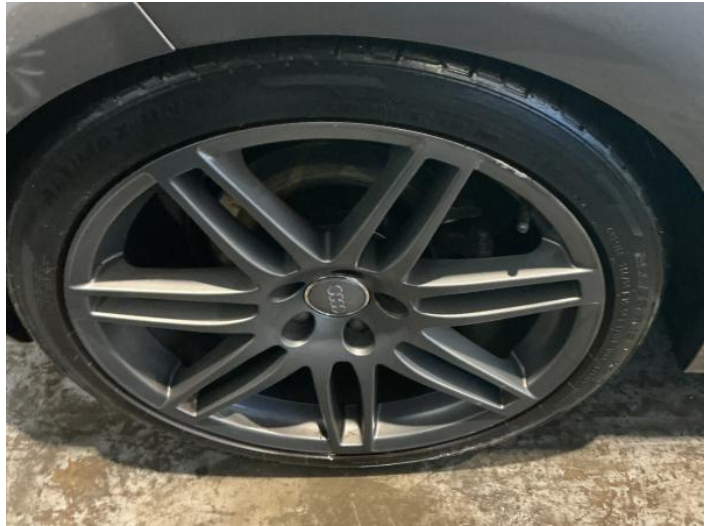
15: Qtr Panel osr  
Scratched  
Over 25mm Not Thru Paint

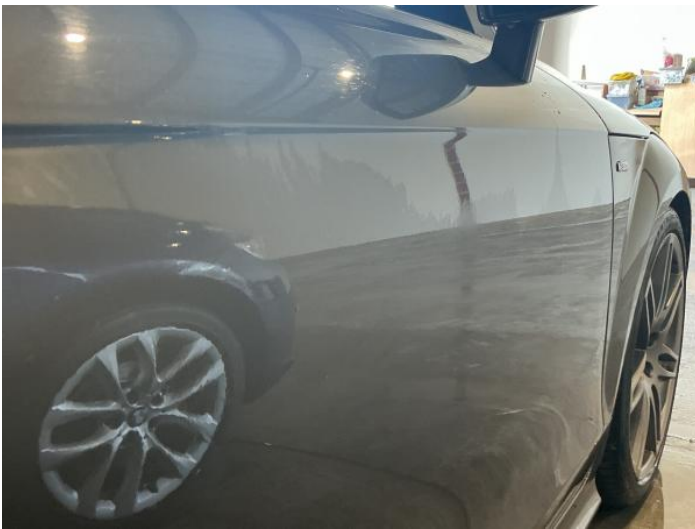
17: Door osf  
Chipped  
1 To 5

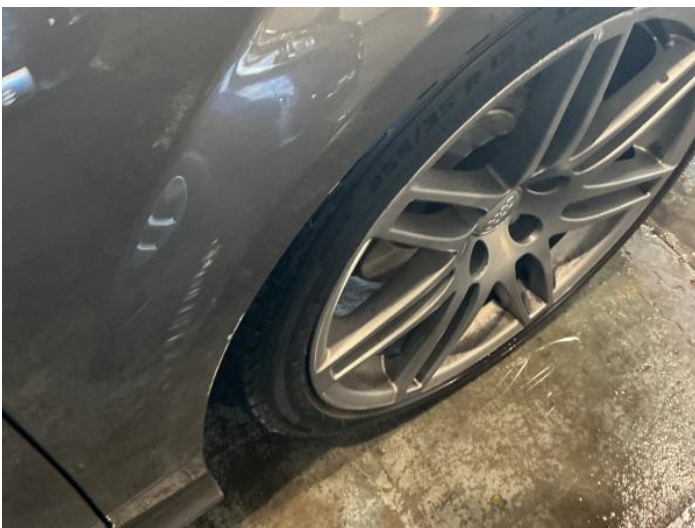
19: Wing osf  
Dented  
With Paint Damage

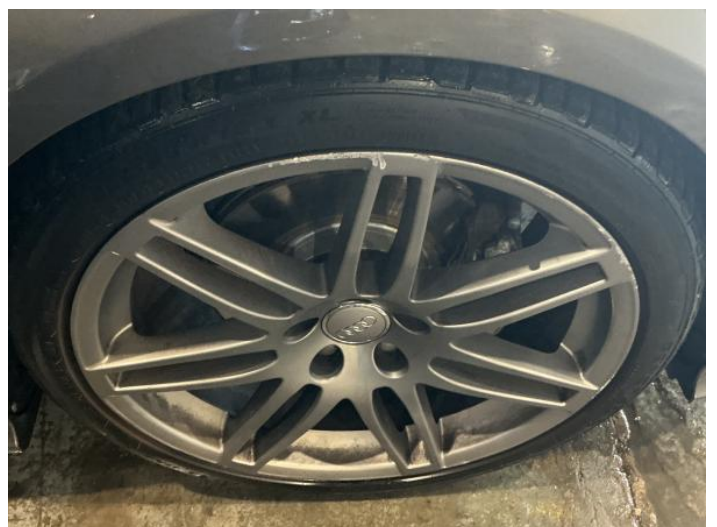
20: Wheel osf  
Scratched  
Over 50mm
