# VEHICLE INSPECTION REPORT

**LV64YFP**

## Nissan Juke 1.6 Acenta Premium 5dr Xtronic

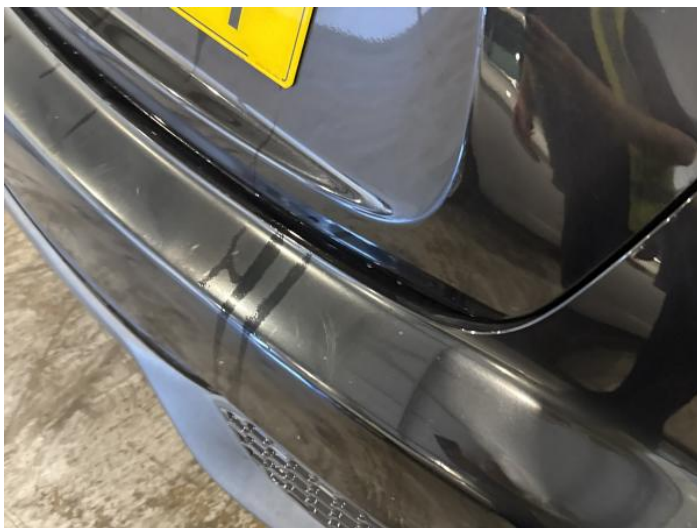
1: Bumper Rear  
Poor Previous Repair  
Poor Paint

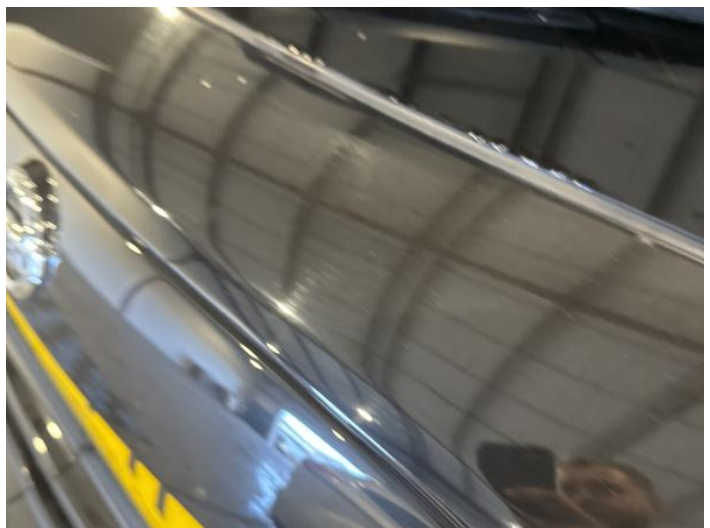
2: Boot Lid  
Chipped  
1 To 5

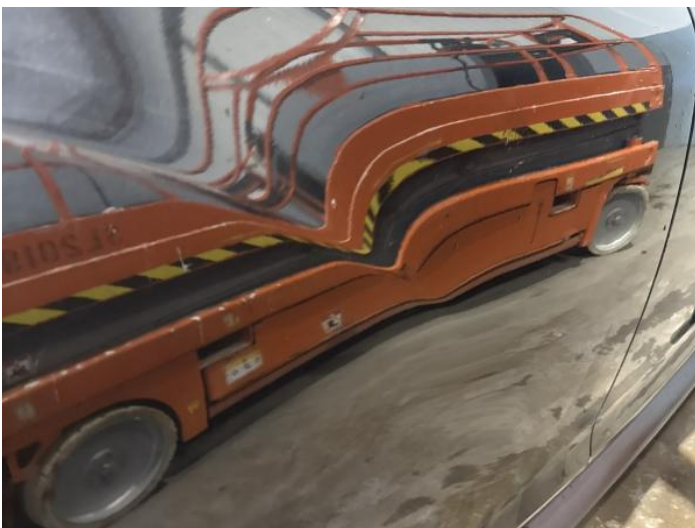
7: Door osr  
Dented  
Over 2 UpTo 10mm

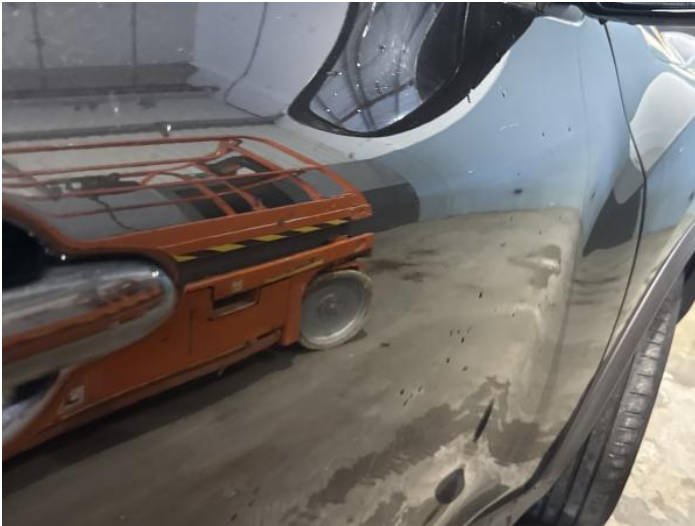
9: Door osf  
Chipped  
1 To 5

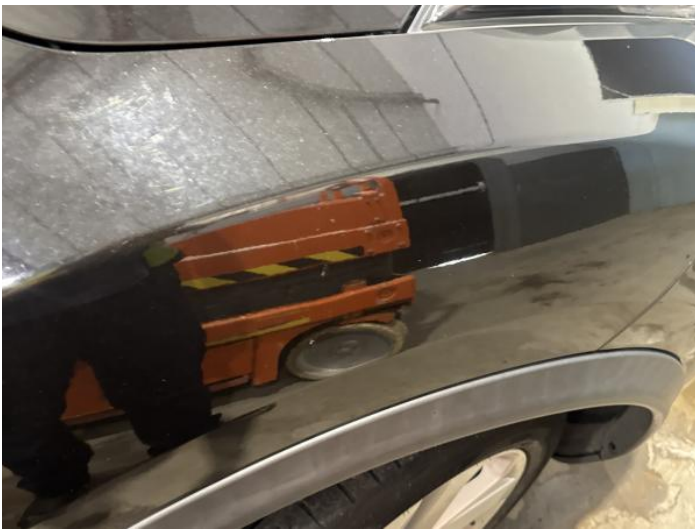
11: Wing osf  
Chipped  
1 To 5

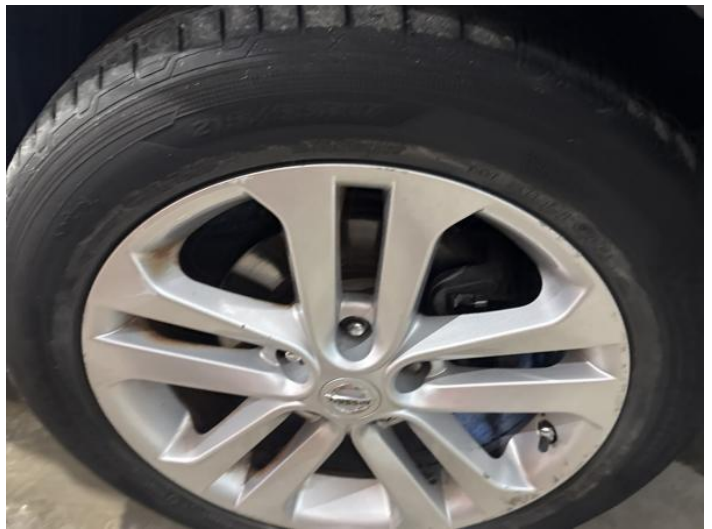
12: Wheel osf  
Scratched  
Over 50mm

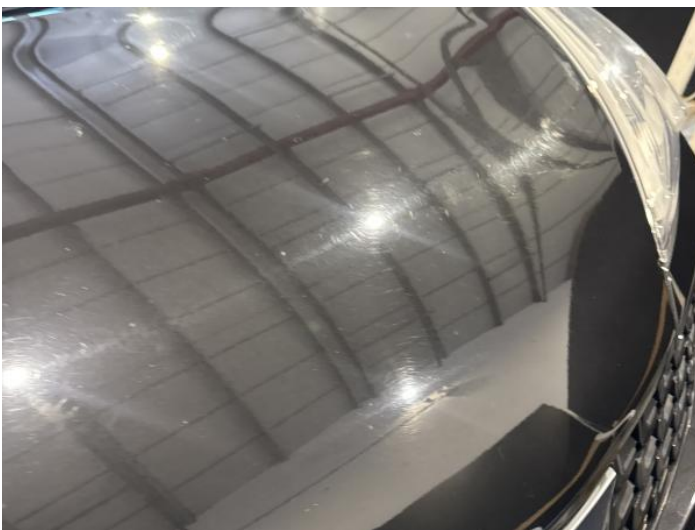
13: Bonnet  
Chipped  
1 To 5

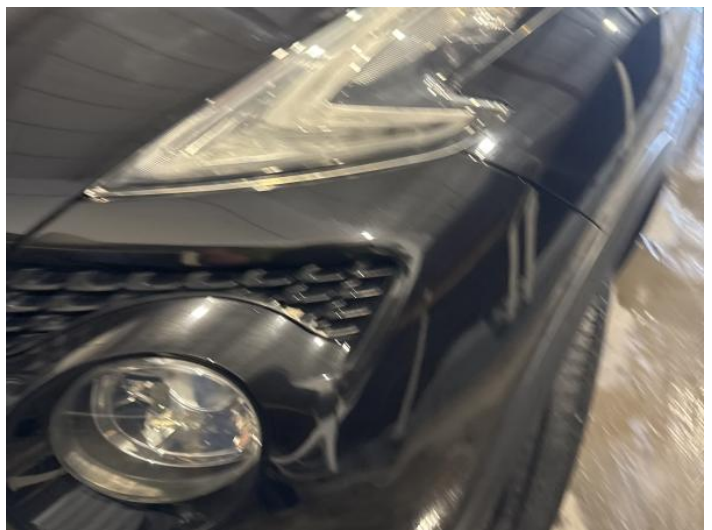
14: Bumper Front  
Chipped  
Multiple Chips

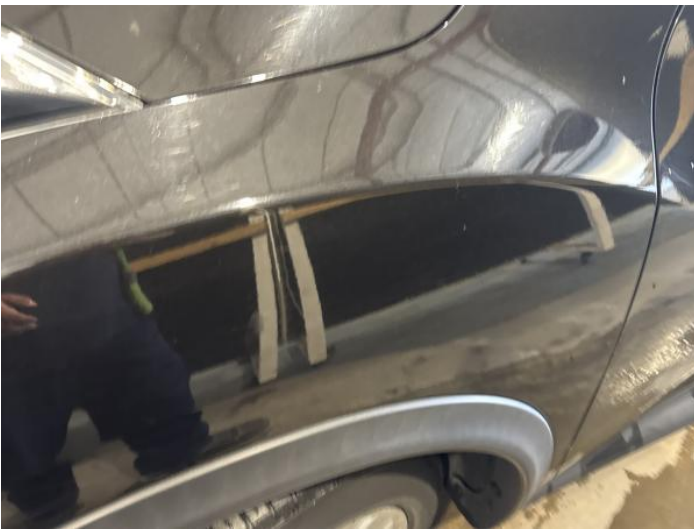
17: Wing nsf  
Chipped  
1 To 5

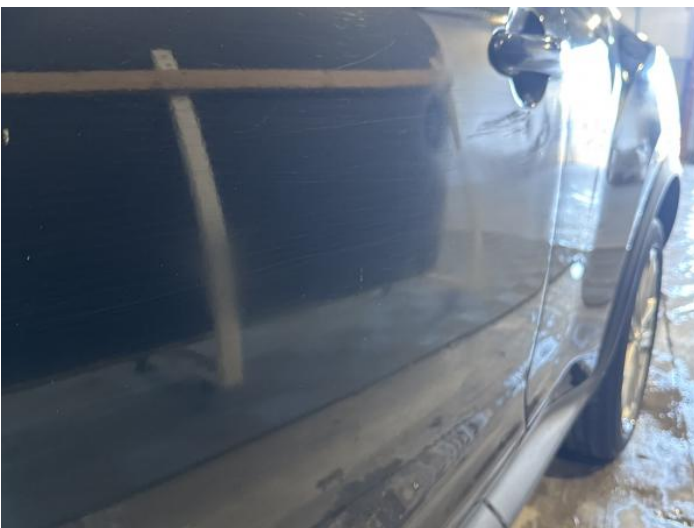
19: Door nsf  
Dented  
With Paint Damage

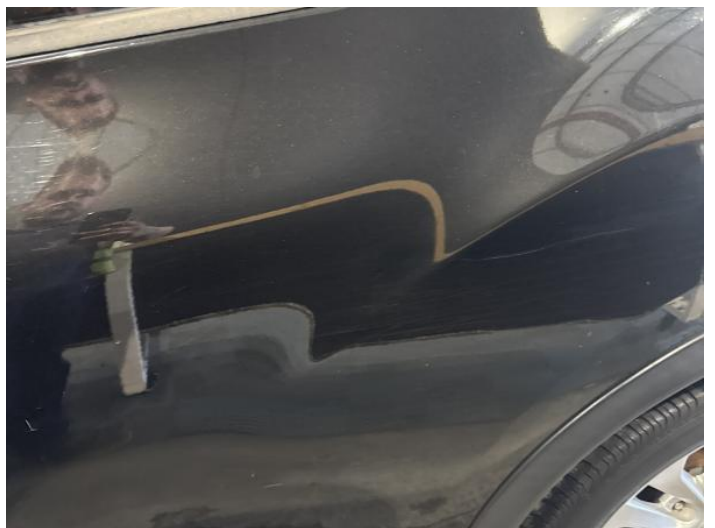
20: Door nsr  
Dented  
With Paint Damage

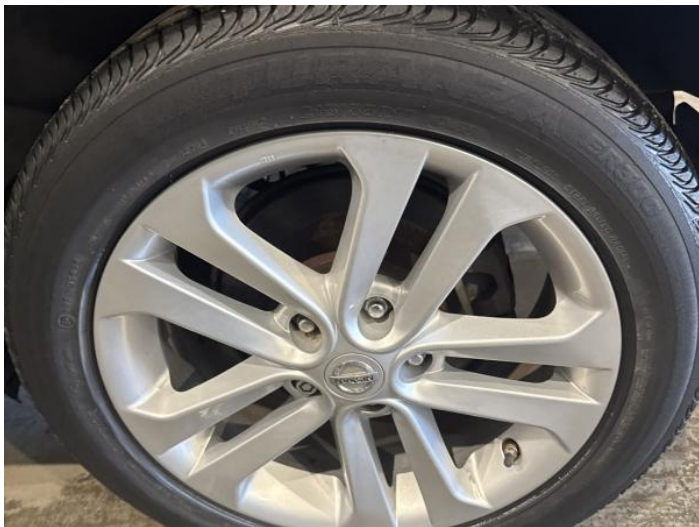
21: Wheel nsr  
Scratched  
Up To 50mm

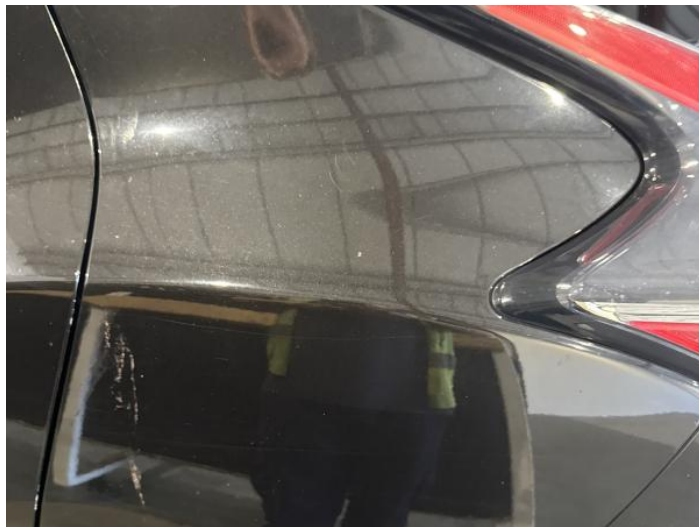
22: Qtr Panel nsr  
Chipped  
1 To 5

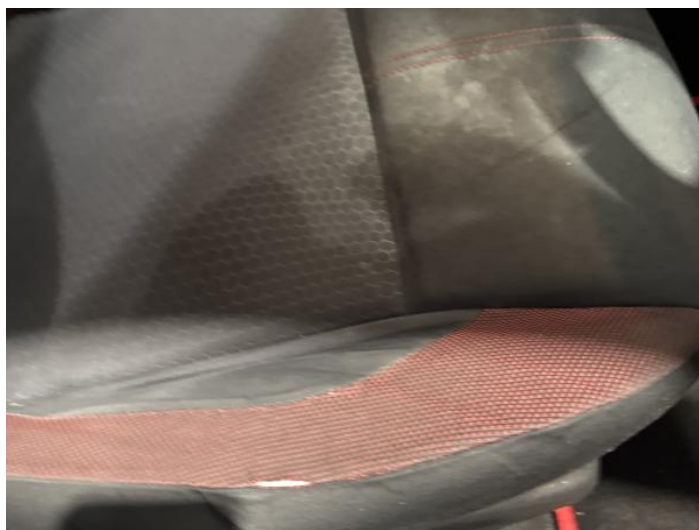
24: Seat Base Cover osf  
Torn  
UpTo 3mm
