# VEHICLE INSPECTION REPORT

**GN65UKT**

## Mazda 3 2.0 SE-L 5dr

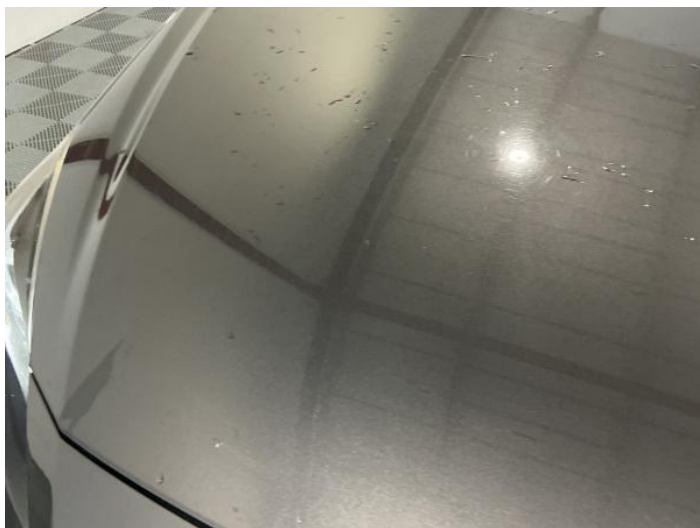
1: Bonnet  
Chipped  
1 To 5

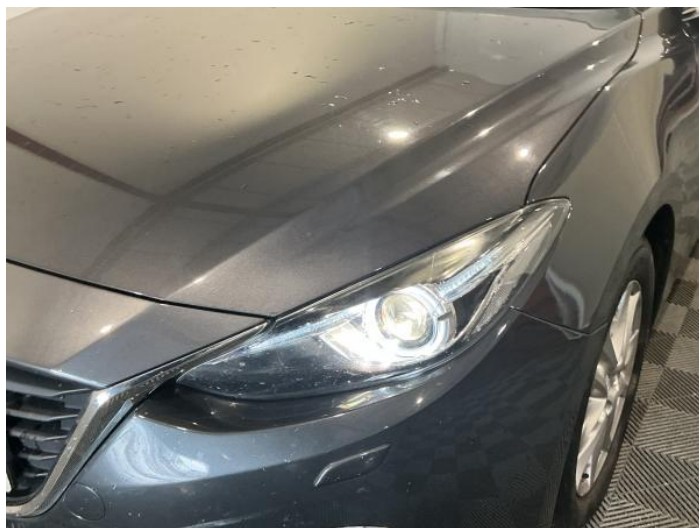
2: Bumper Front  
Chipped  
Multiple Chips

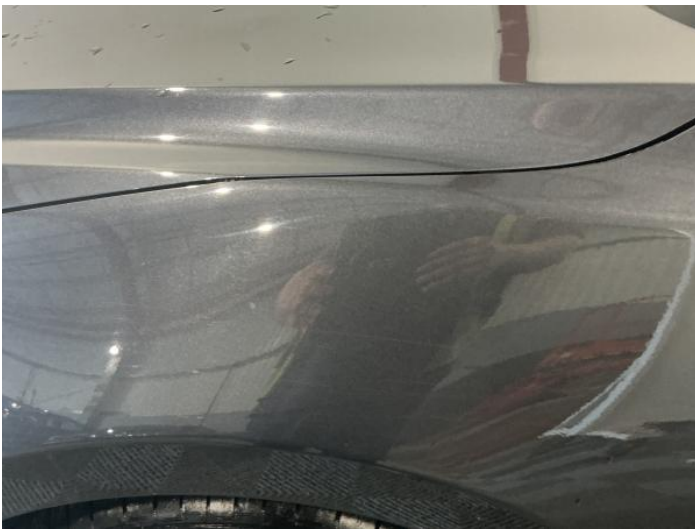
5: Wing nsf  
Chipped  
1 To 5

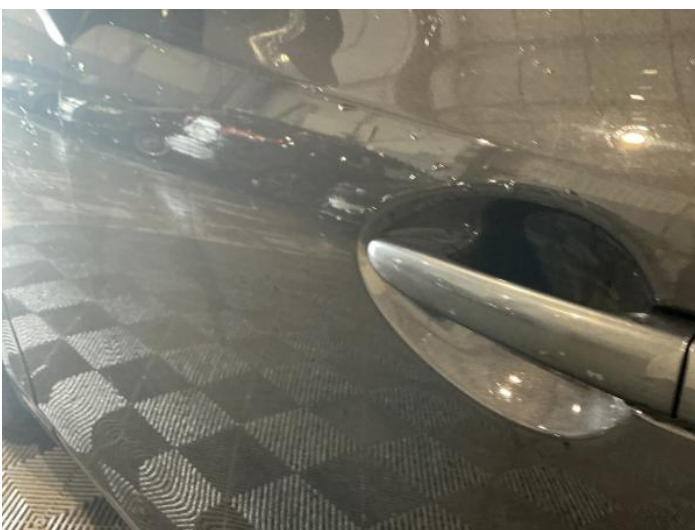
7: Door nsf  
Dented  
Over 2 UpTo 10mm

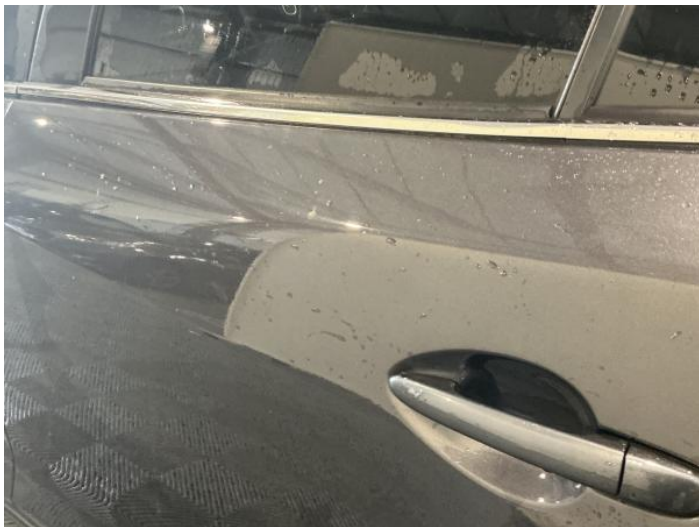
9: Door nsr  
Dented  
2 Or Less UpTo 10mm

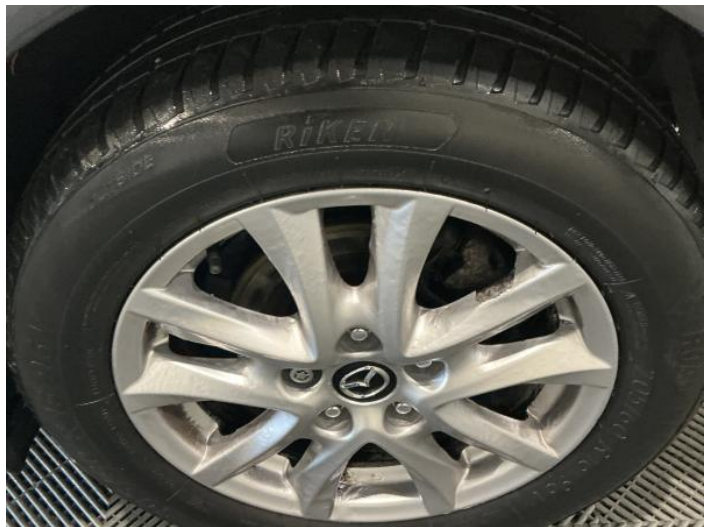
10: Wheel nsr  
Scratched  
Over 50mm

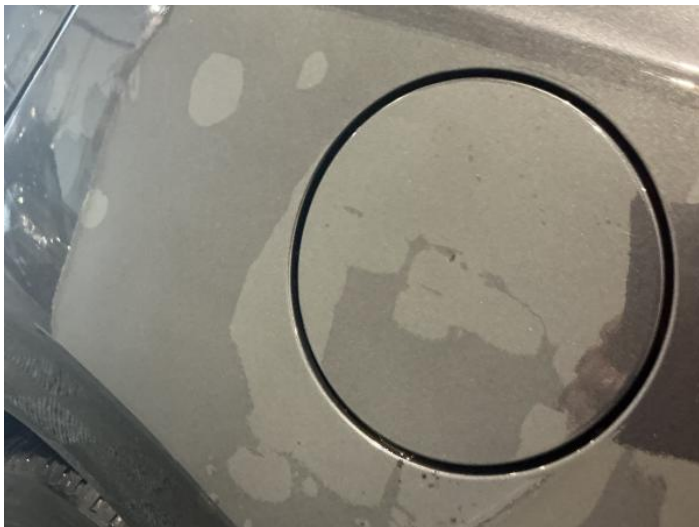
11: Qtr Panel nsr  
Chipped  
1 To 5

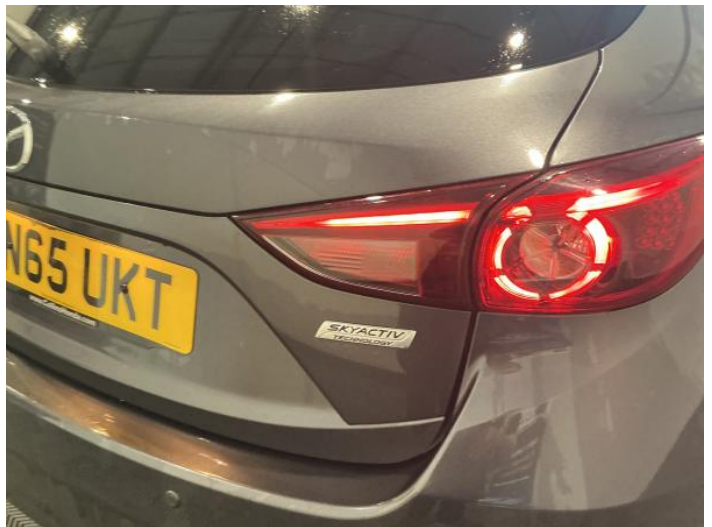
12: Bumper Rear  
Chipped  
Multiple Chips

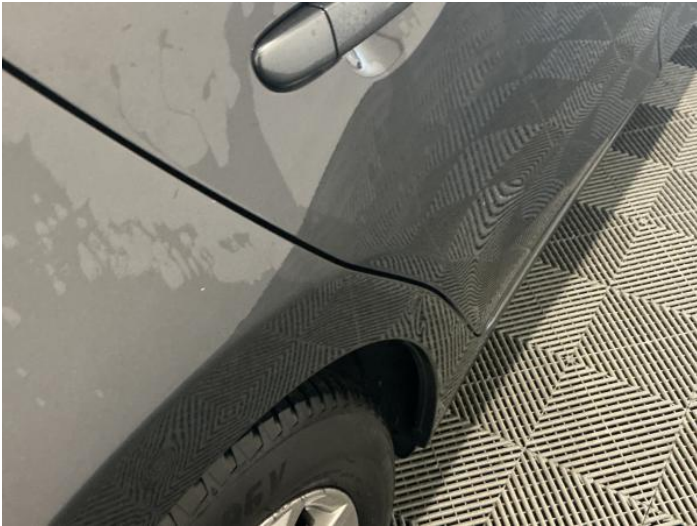
15: Qtr Panel osr  
Dented  
Between 10mm + 30mm

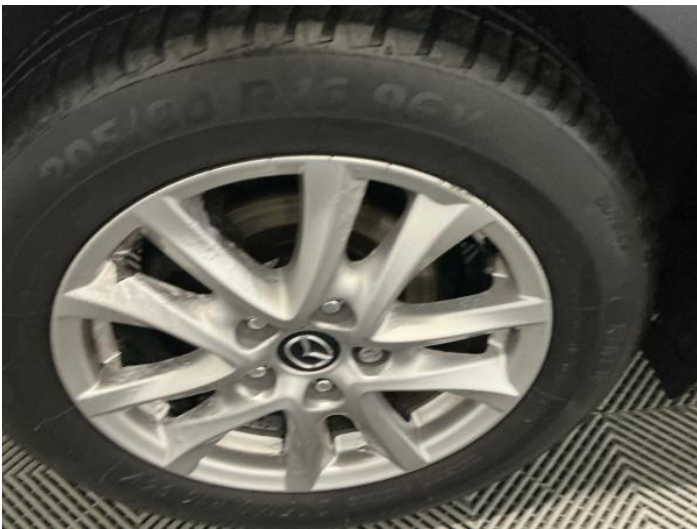
17: Wheel osr  
Scratched  
Over 50mm

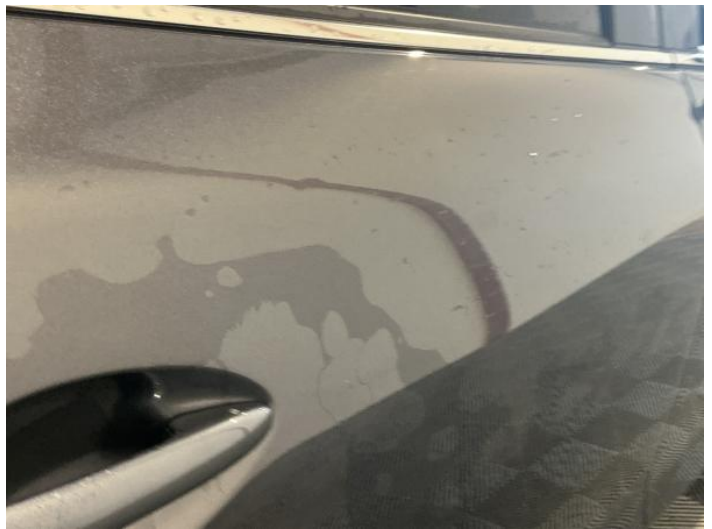
18: Door osr  
Dented  
Over 2 UpTo 10mm

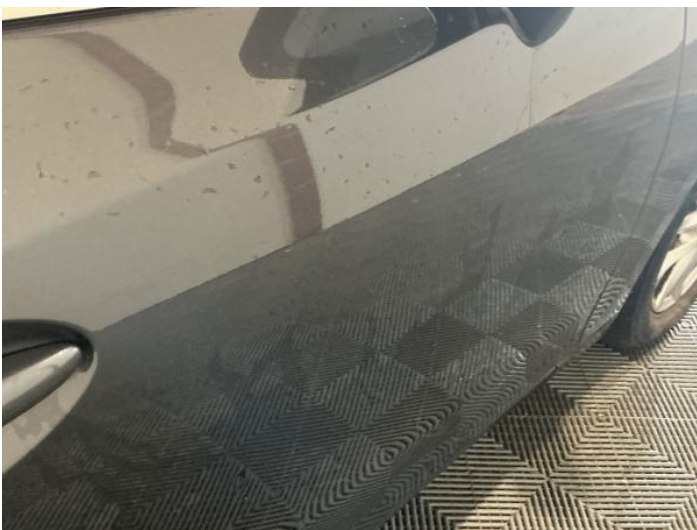
19: Door osf  
Dented  
Over 2 UpTo 10mm

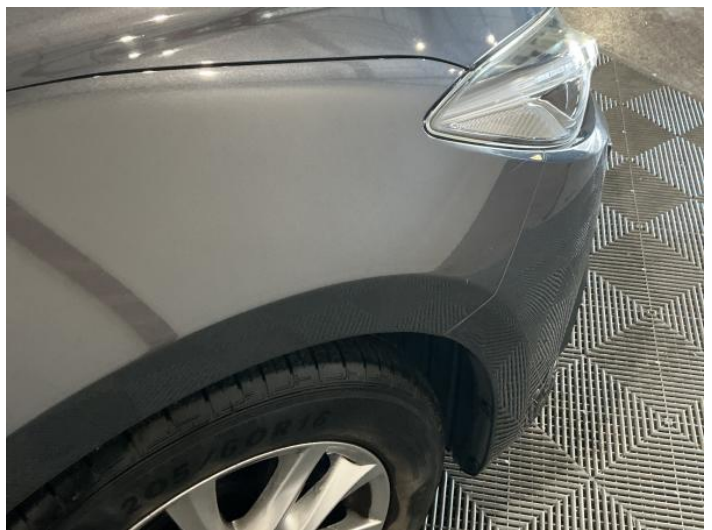
20: Wing osf  
Chipped  
1 To 5

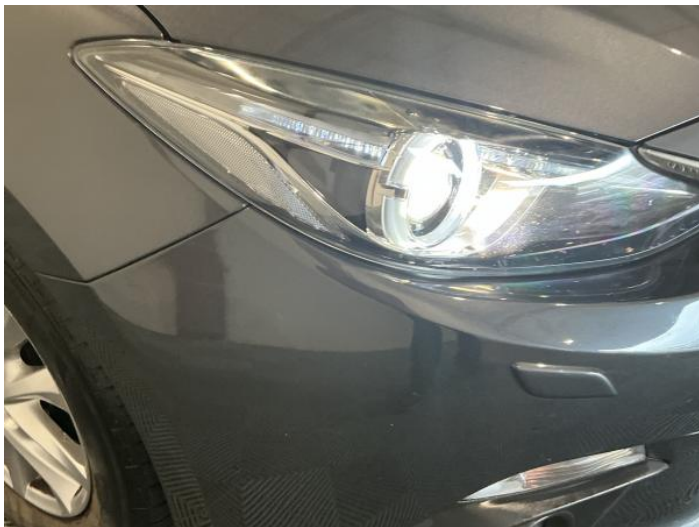
21: Bumper Front  
Scratched  
25 to 100mm Thru Paint
