VEHICLE INSPECTION REPORT

RK66EOF

Skoda Fabia 1.2 TSI 90 Monte Carlo 5dr

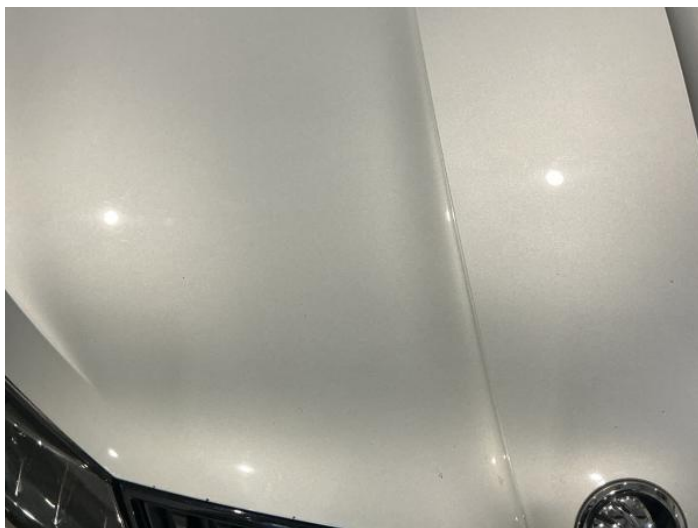
1: Bonnet
Chipped
Multiple Chips

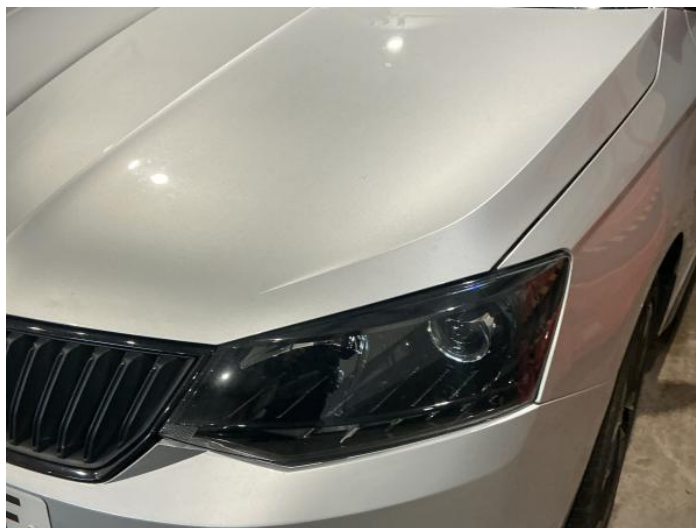
2: Bumper Front
Chipped
Multiple Chips

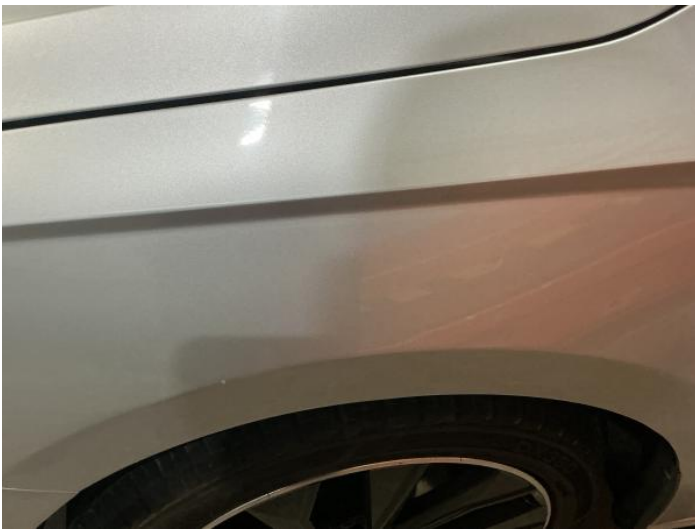
5: Wing nsf
Chipped
1 To 5

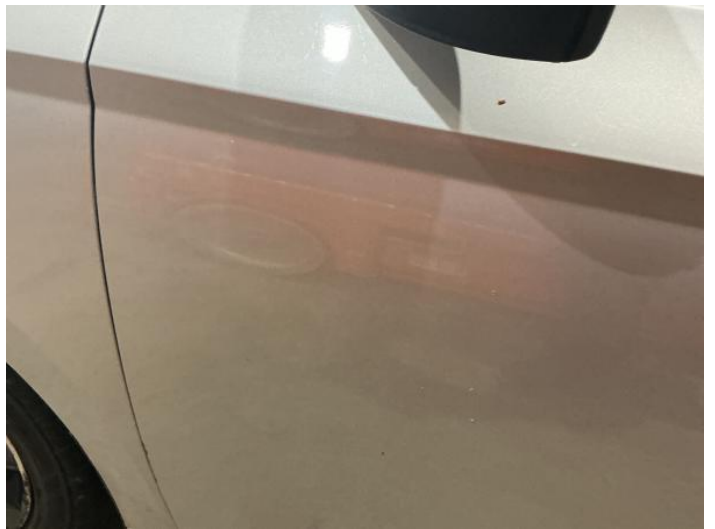
6: Door nsf
Chipped
1 To 5

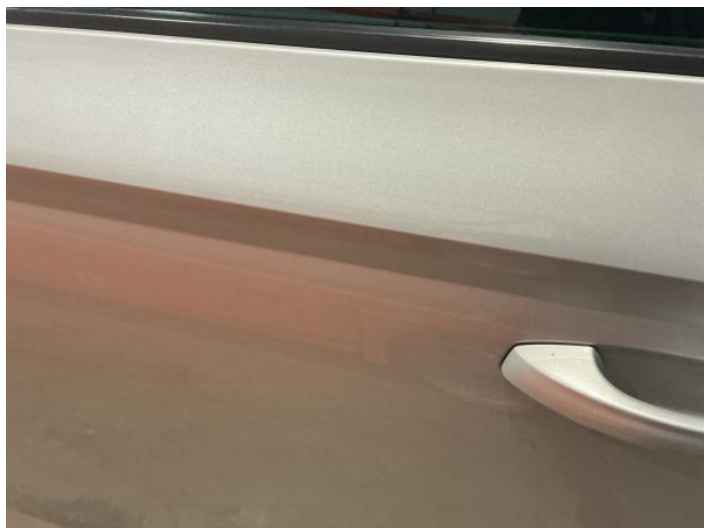
7: Door nsf
Scratched
Over 25mm Not Thru Paint

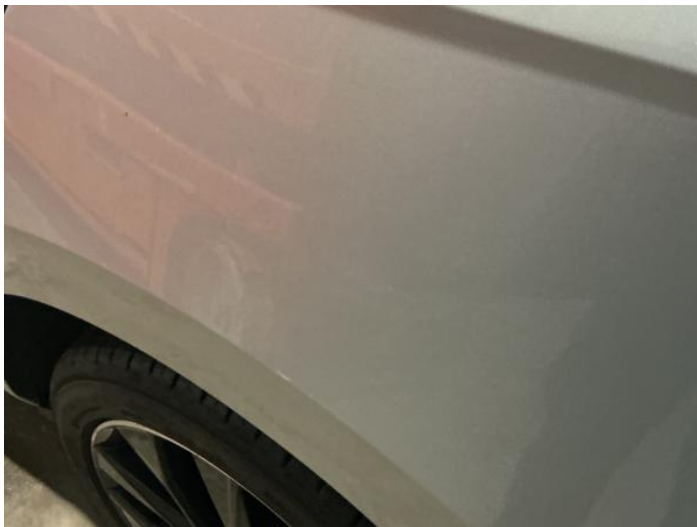
9: Qtr Panel nsr
Chipped
1 To 5

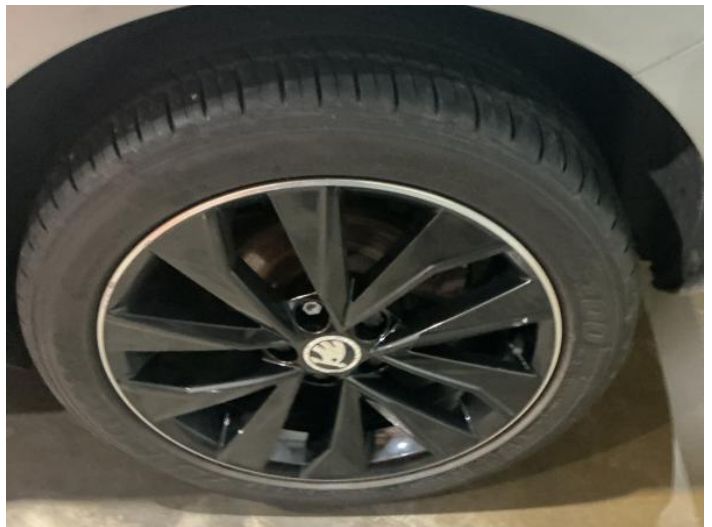
10: Wheel nsr
Scratched
Over 50mm

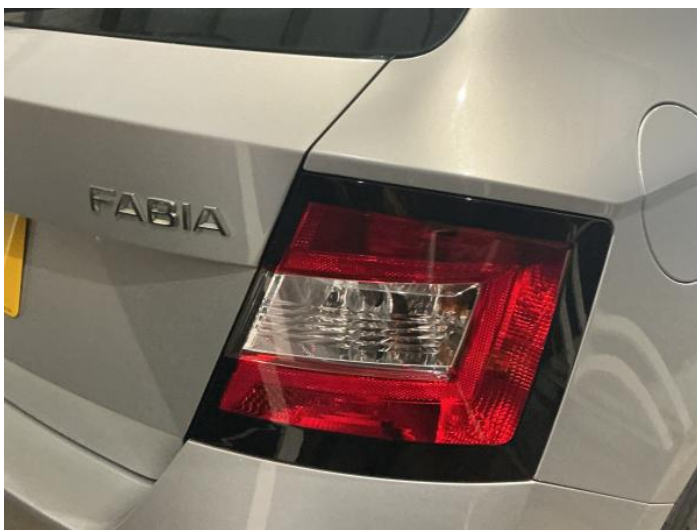
11: Bumper Rear
Scratched
25 to 100mm Thru Paint

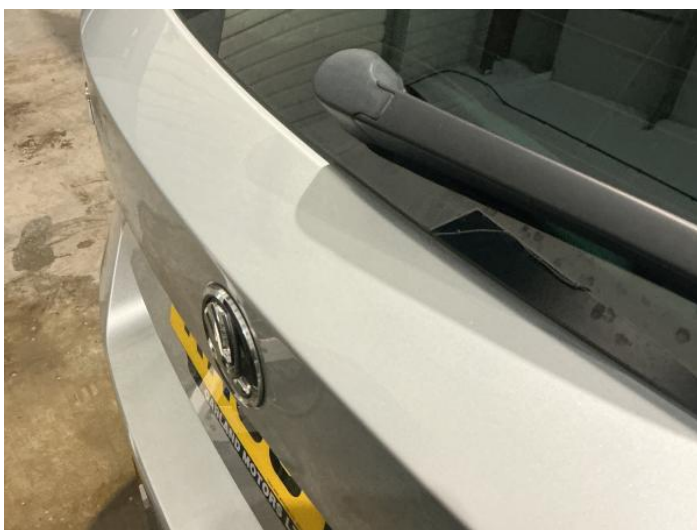
13: Boot Lid
Dented
Over 2 UpTo 10mm

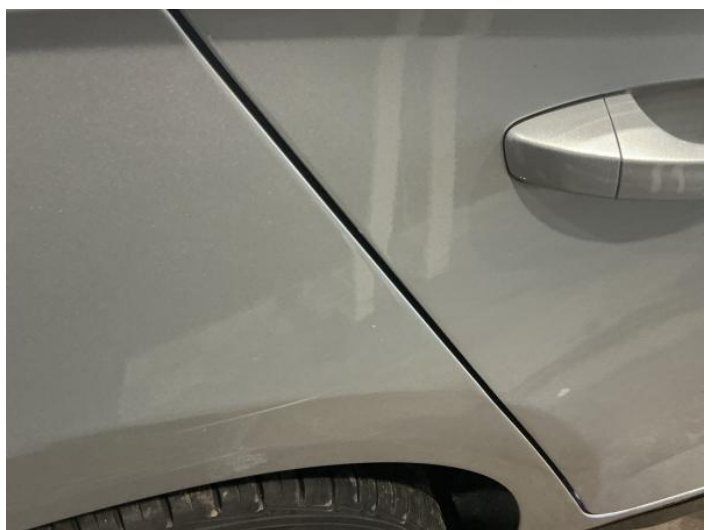
14: Qtr Panel osr
Scratched
Over 25mm Thru Paint

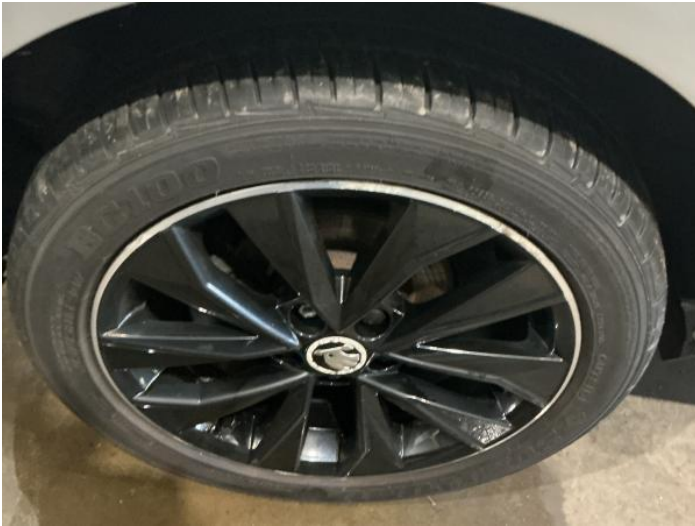
15: Wheel osr
Scratched
Over 50mm

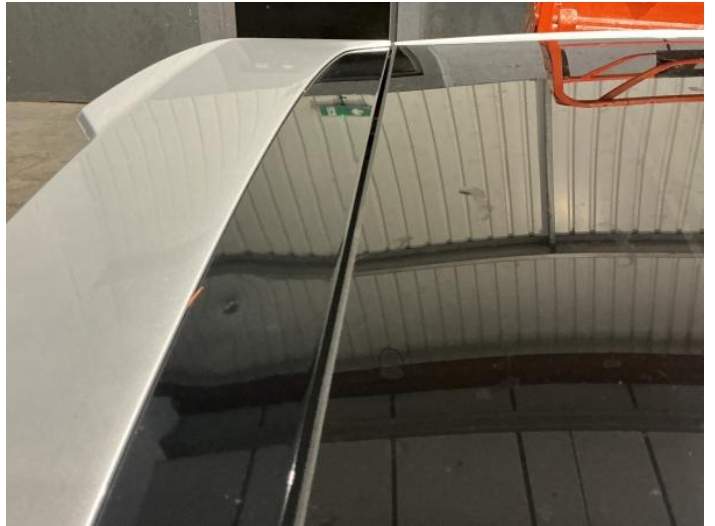
16: Roof
Dented
Between 10mm + 30mm

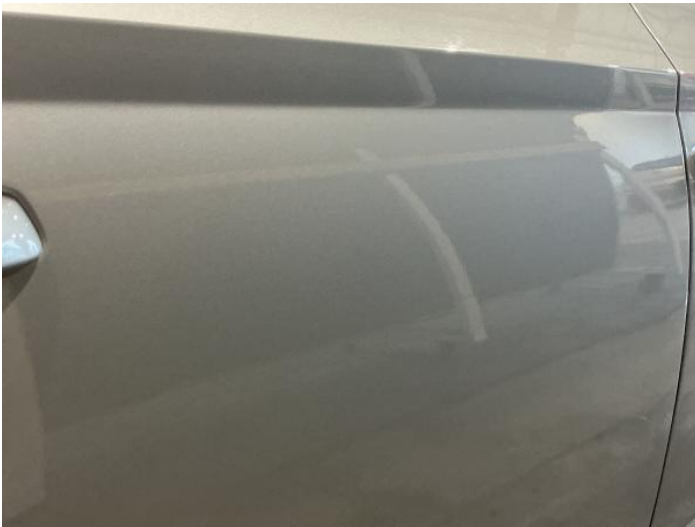
17: Door osr
Chipped
1 To 5

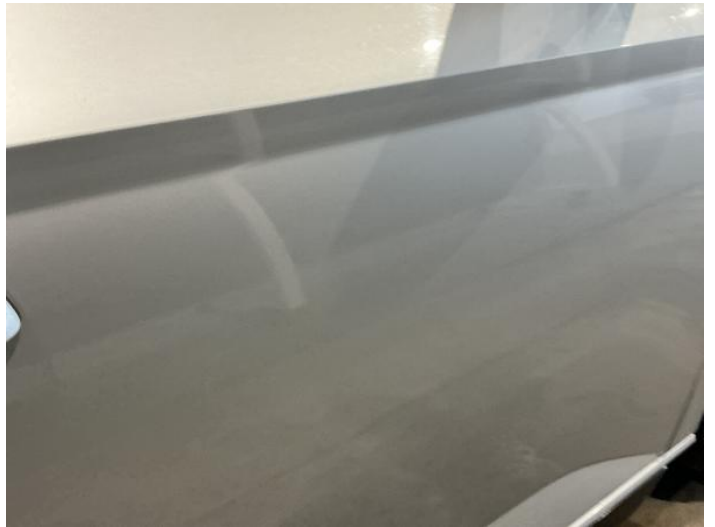
18: Door osf
Poor Previous Repair
Poor Paint

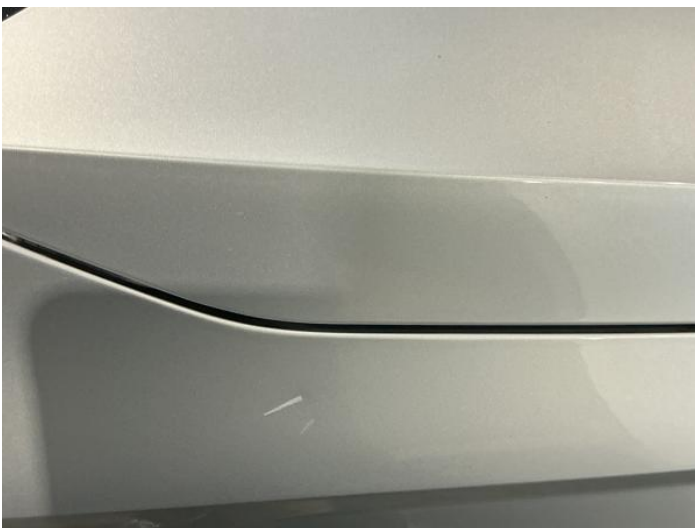
19: Wing osf
Dented
Between 10mm + 30mm

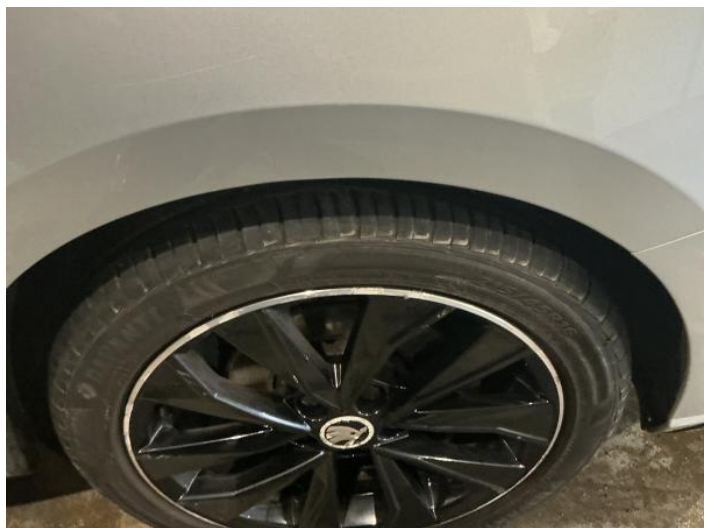
20: Wheel osf
Scratched
Over 50mm
