# VEHICLE INSPECTION REPORT

RE66CVM

## BMW 2 Series 218i Luxury 5dr [Nav] Step Auto

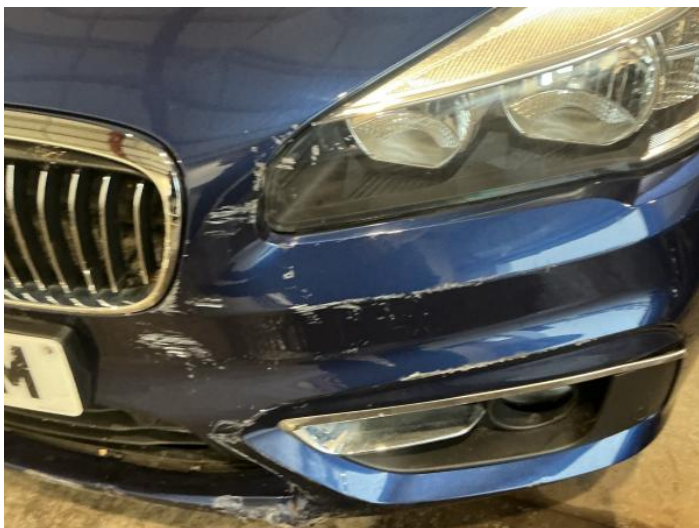
1: Bumper Front  
Cracked  
Over 25mm

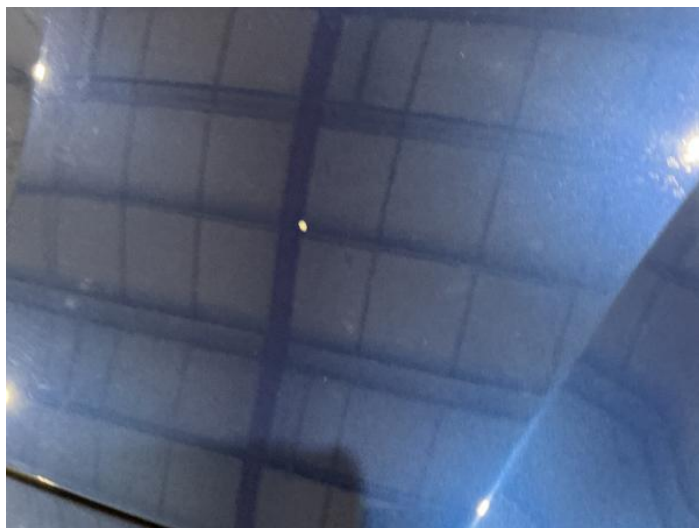
2: Bonnet  
Chipped  
1 To 5

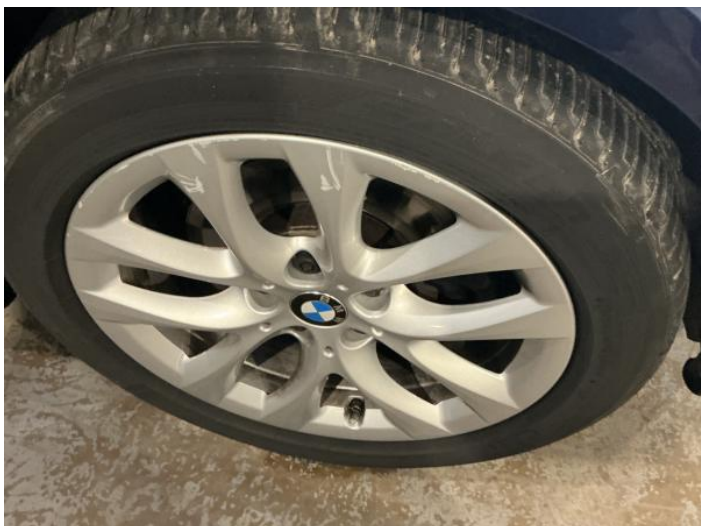
3: Wheel osf  
Scratched  
Over 50mm

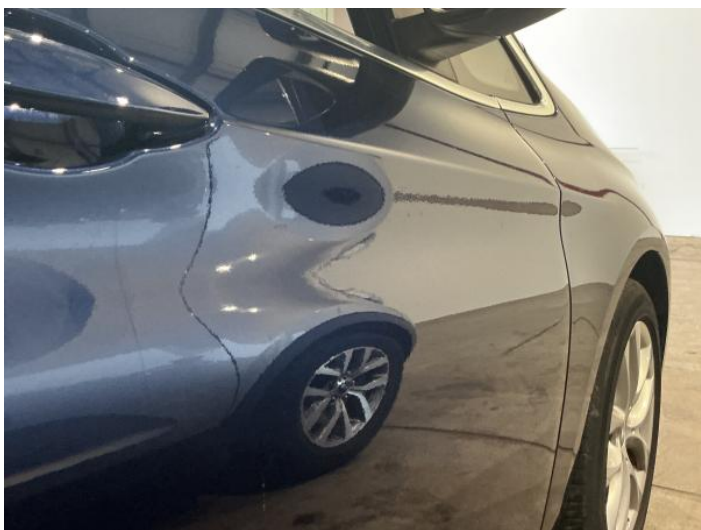
5: Door osf  
Chipped  
1 To 5

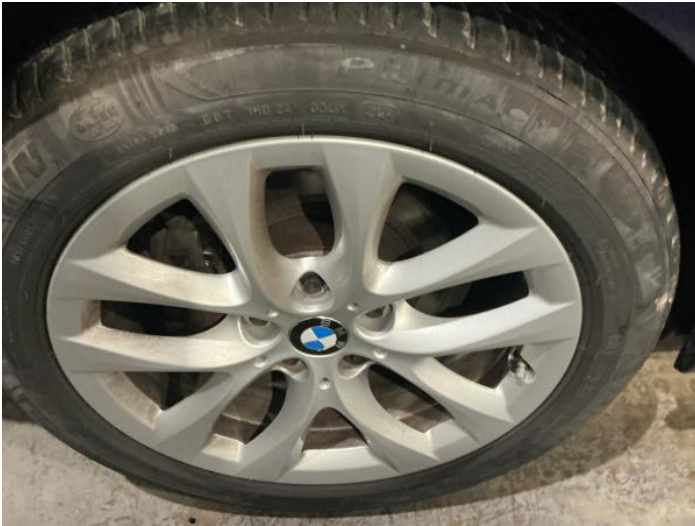
9: Wheel osr  
Scratched  
Up To 50mm

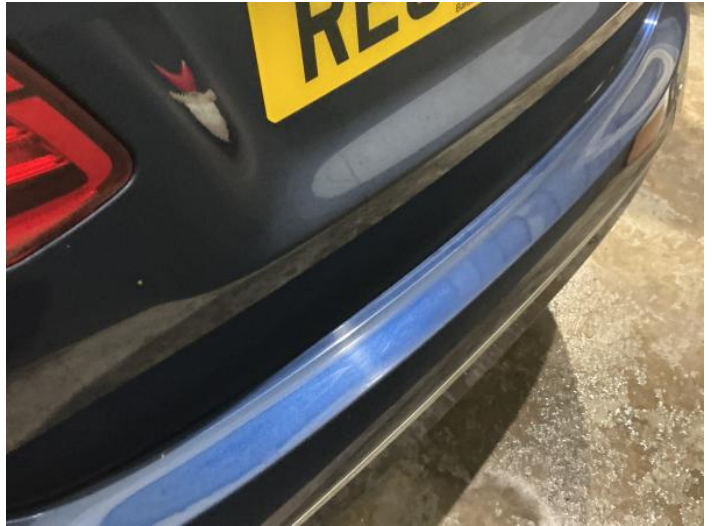
10: Bumper Rear  
Chipped  
Multiple Chips

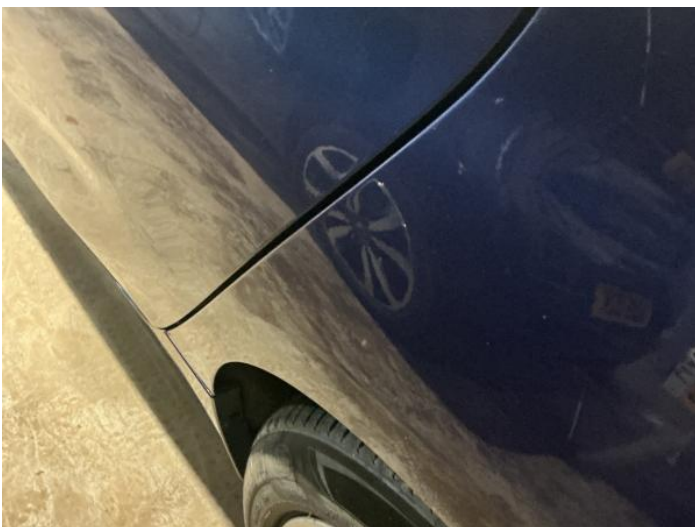
13: Qtr Panel nsr  
Dented  
Over 2 UpTo 10mm

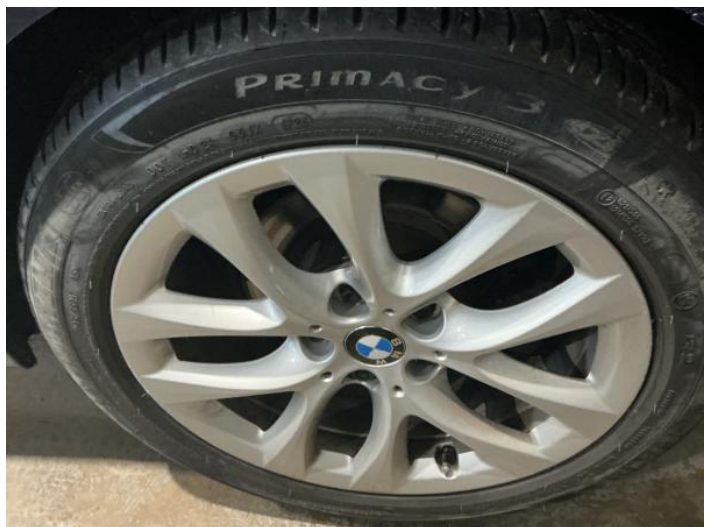
14: Wheel nsr  
Scratched  
Up To 50mm

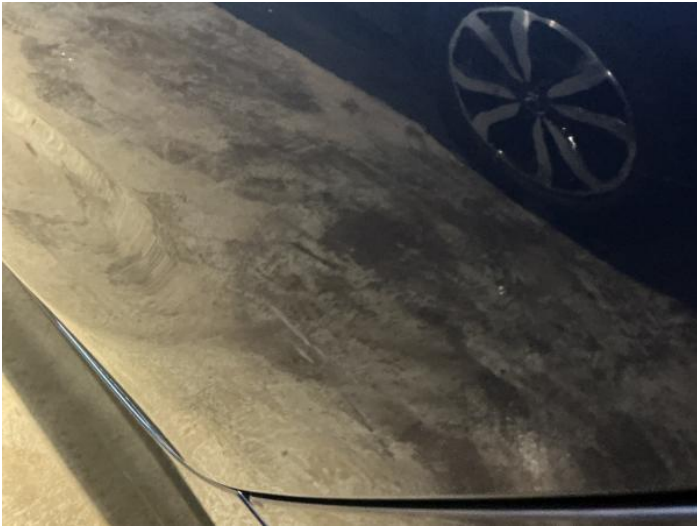
15: Door nsr  
 Scratched  
 Over 25mm Thru Paint

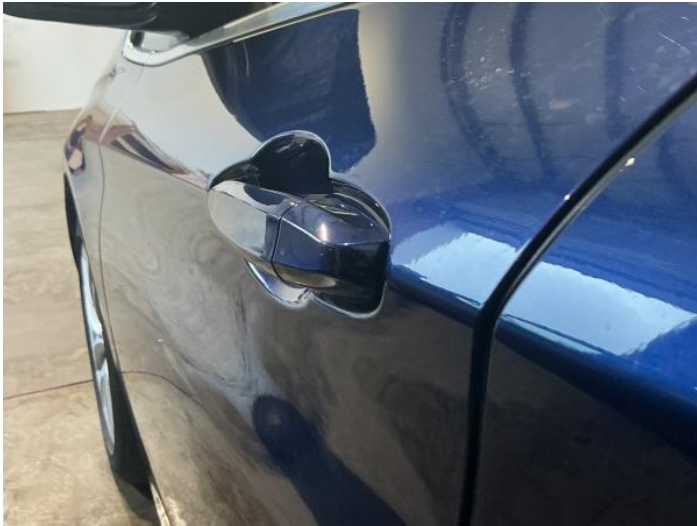
16: Door nsf  
 Dented  
 Over 2 UpTo 10mm

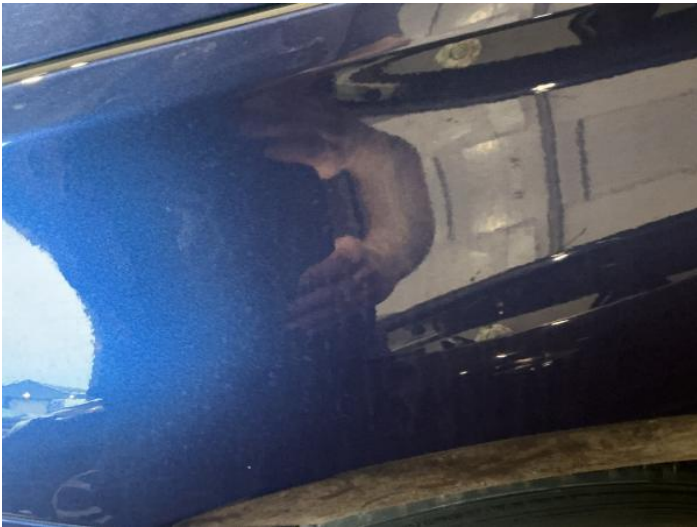
17: Wing nsf  
 Chipped  
 1 To 5

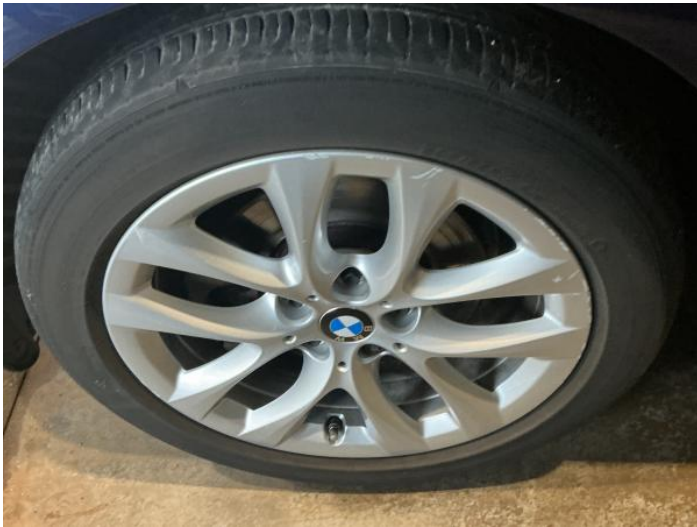
18: Wheel nsf  
 Scratched  
 Over 50mm
