VEHICLE INSPECTION REPORT

AU18WCT

Ford Kuga 1.5 EcoBoost ST-Line 5dr 2WD

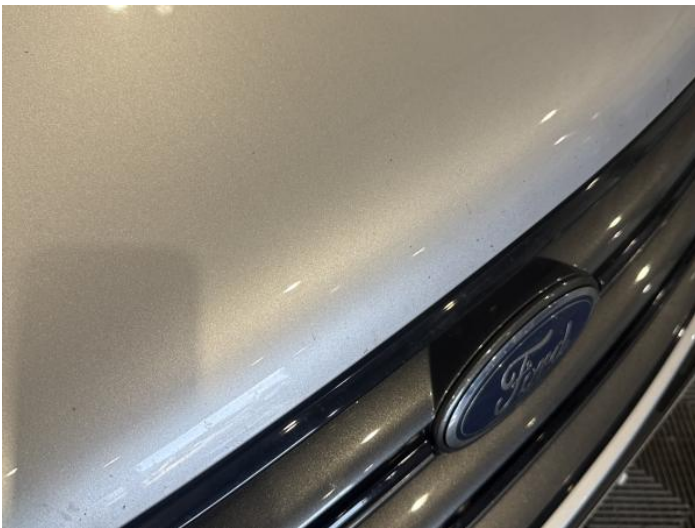
1: Bonnet
Chipped
Multiple Chips

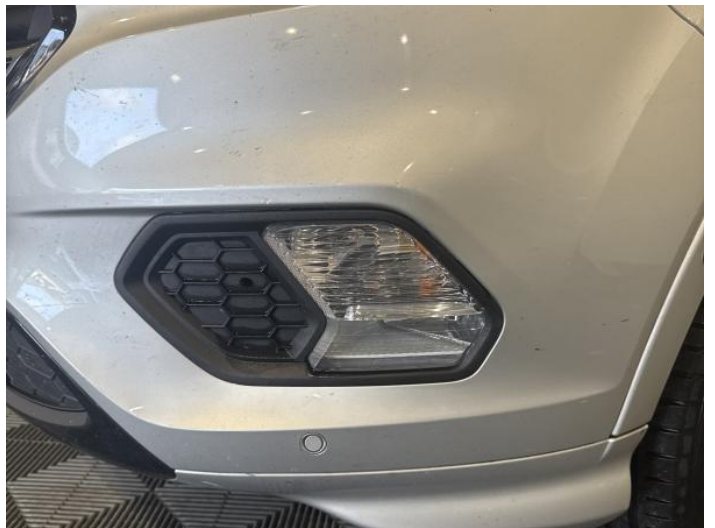
2: Bumper Front
Scratched
Over 100mm Thru Paint

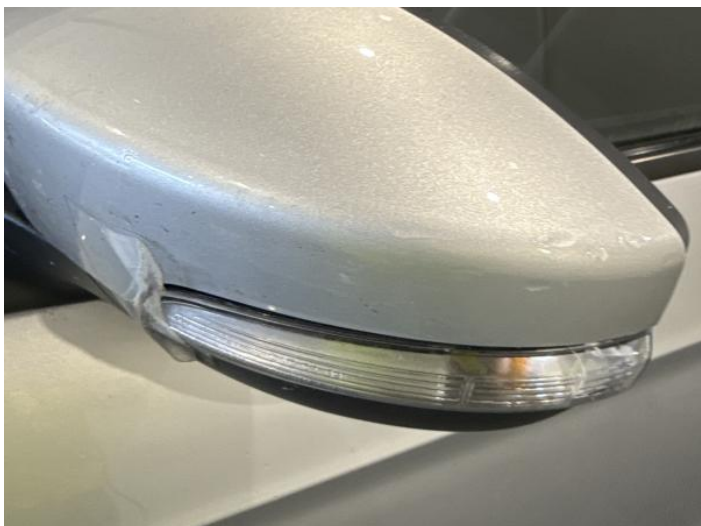
3: Flasher Side Repeater ns
Broken
Replace

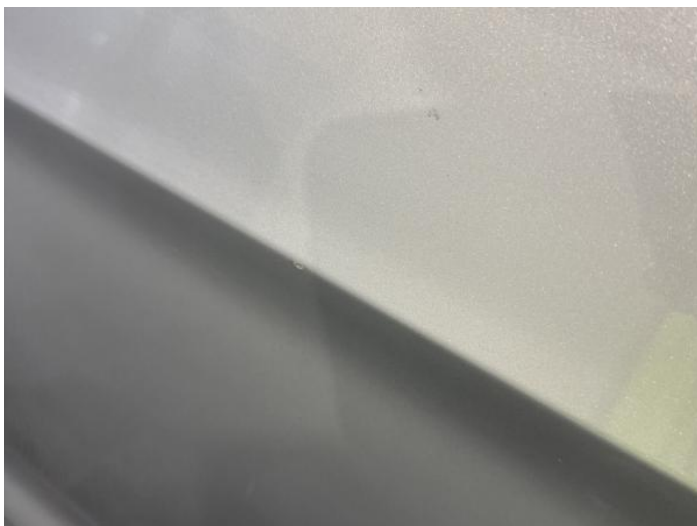
4: Door nsf
Chipped
1 To 5

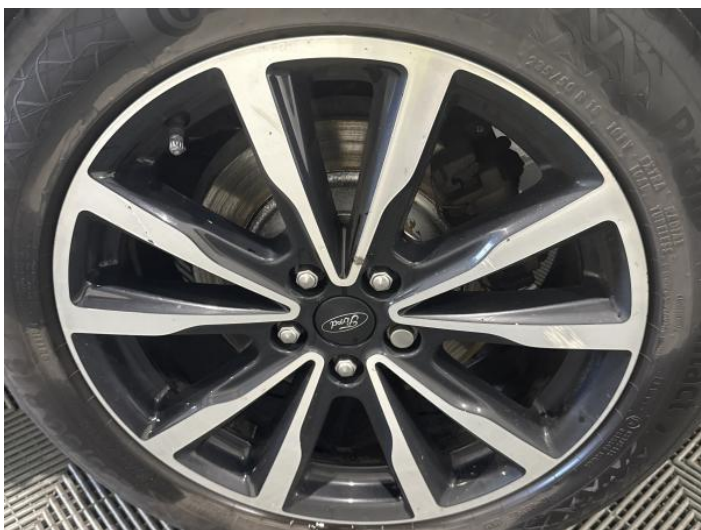
5: Wheel nsr
Scratched
Over 50mm

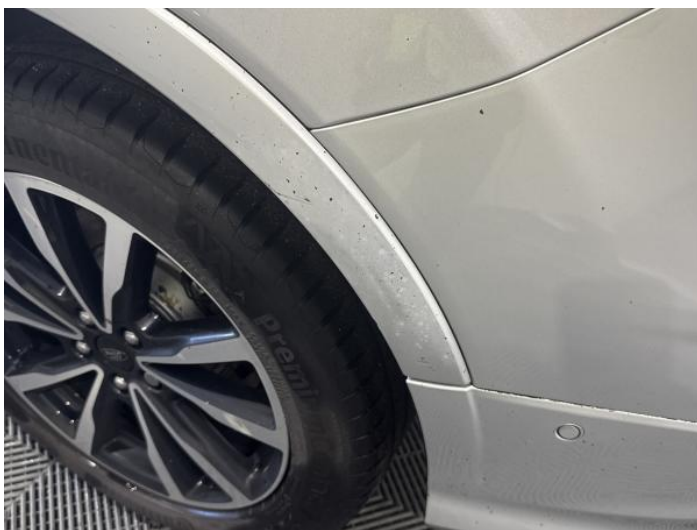
6: Qtr Panel Arch Extension ns
Scratched (Painted)
Over 25mm Thru Paint

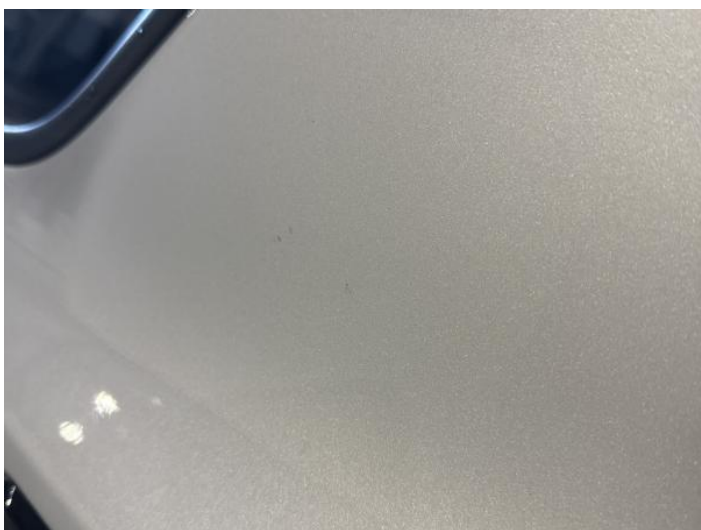
7: Qtr Panel nsr
Chipped
1 To 5

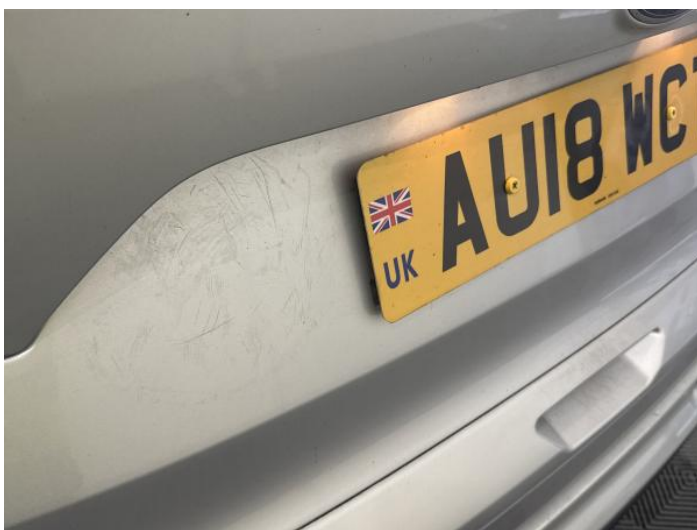
8: Tailgate
Scratched
Over 25mm Thru Paint

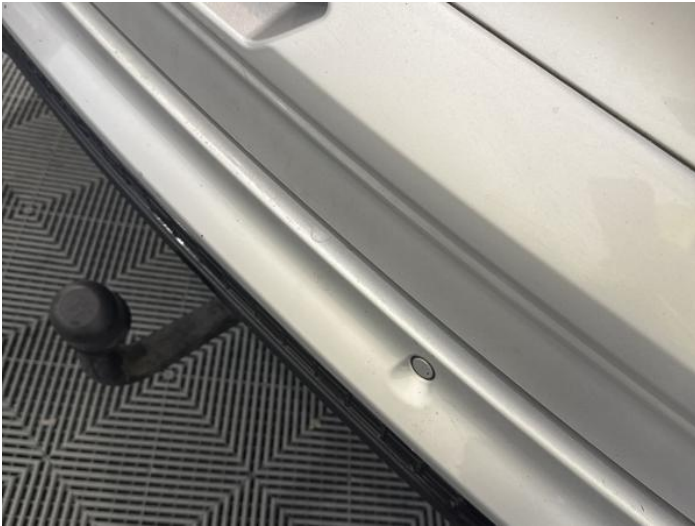
9: Bumper Rear
Scratched
25 to 100mm Thru Paint

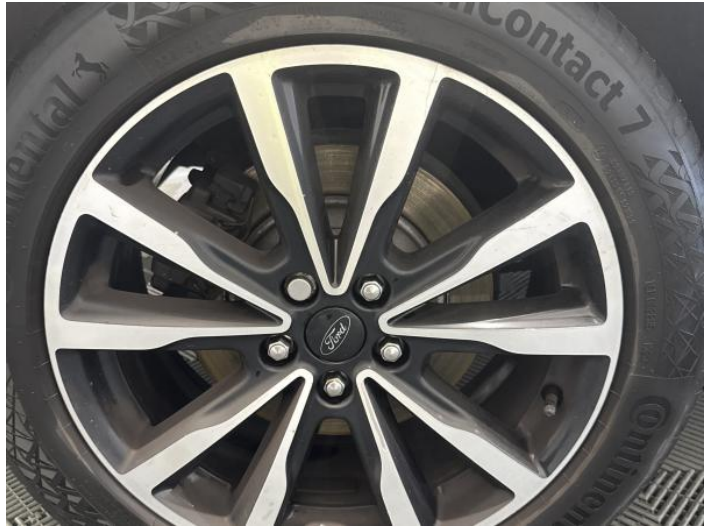
10: Wheel osr
Scratched
Up To 50mm

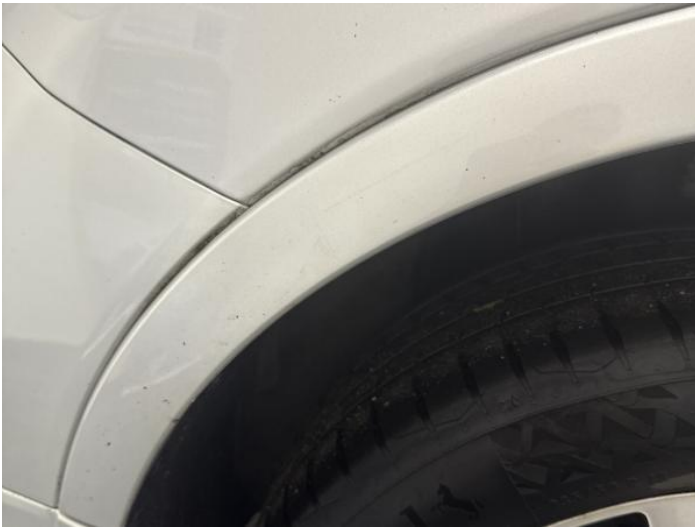
11: Qtr Panel Arch Extension os
Scratched (Painted)
Over 25mm Thru Paint

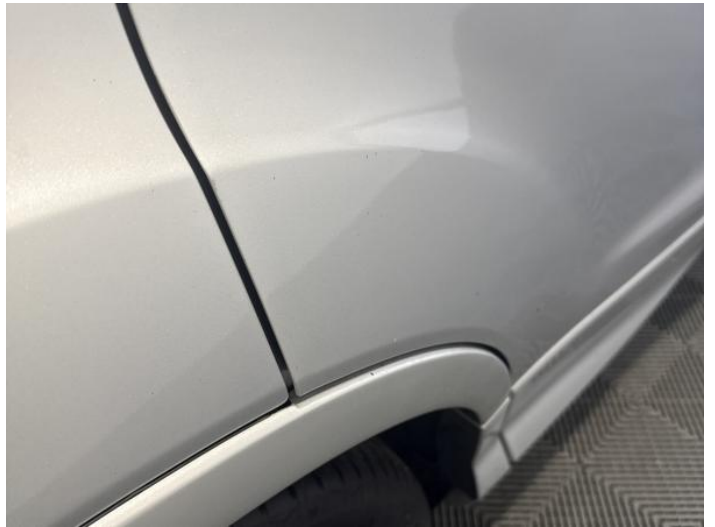
12: Door osr
Chipped
1 To 5

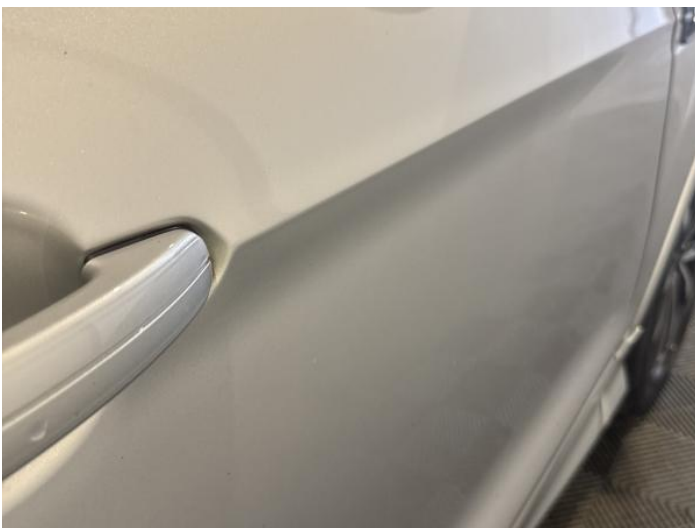
13: Door osf
Dented
2 Or Less UpTo 10mm

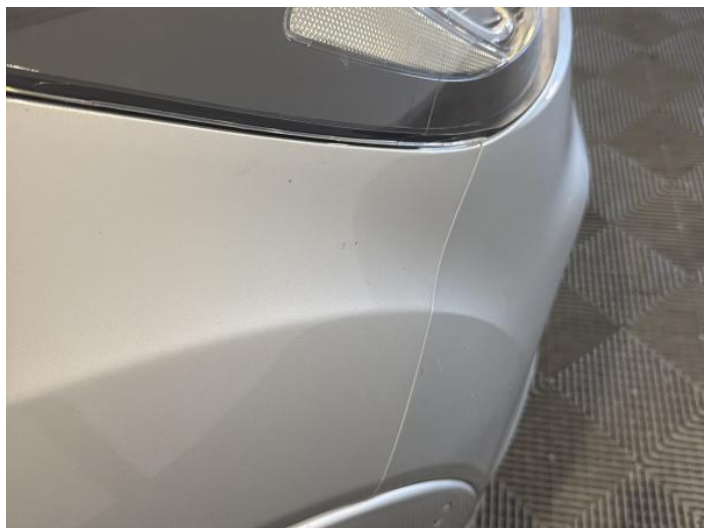
14: Wing osf
Chipped
1 To 5

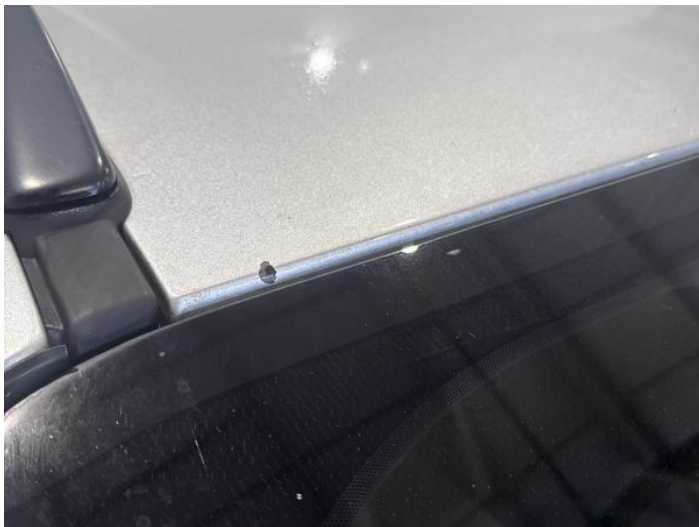
15: Roof
Chipped
Over 5mm
