VEHICLE INSPECTION REPORT

HY64XRA

Audi Q3 1.4T FSI SE 5dr

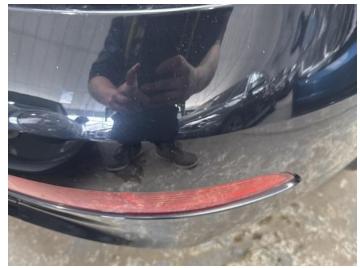
2: Bumper Rear Scratched Over 25mm Not Thru Paint

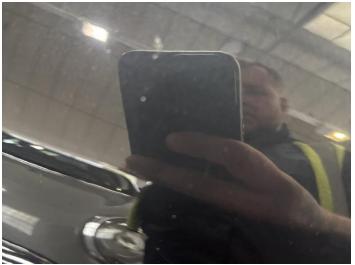
3: Boot Lid Chipped 1 To 5

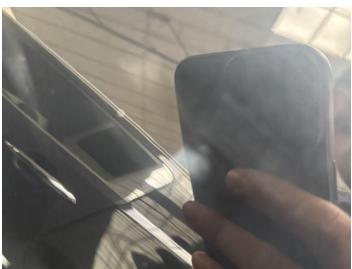
4: Qtr Panel nsr Chipped 1 To 5

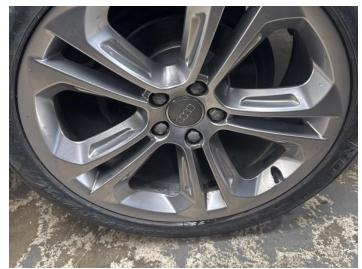
5: Wheel nsr Scratched Up To 50mm

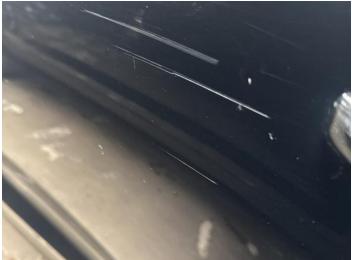
6: Door nsr Scratched Over 25mm Thru Paint

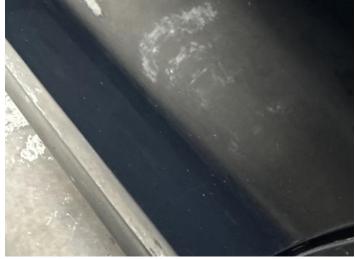
7: Door nsf Chipped 1 To 5

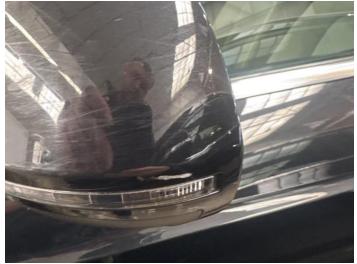
9: Door Mirror Assy nsf Scratched (Painted) Over 25mm Thru Paint

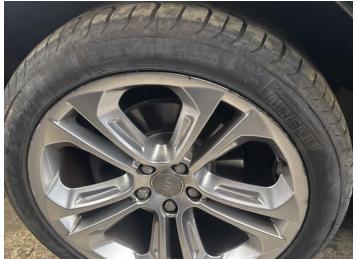
11: Wheel nsf Scratched Over 50mm

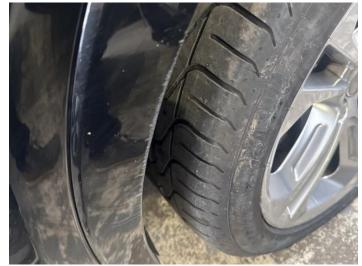
13: Wing Front Arch Extension ns Scratched (Painted) Over 25mm Thru Paint

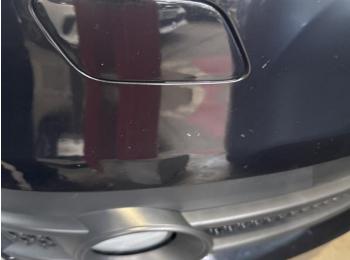
14: Bumper Front ChippedMultiple Chips

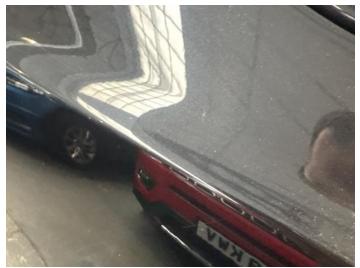
15: Wing osf Chipped 1 To 5

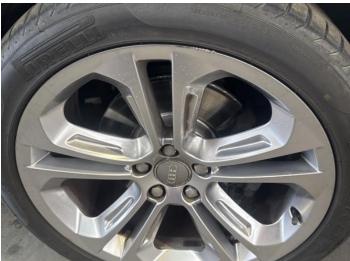
16: Wheel osf Scratched Up To 50mm

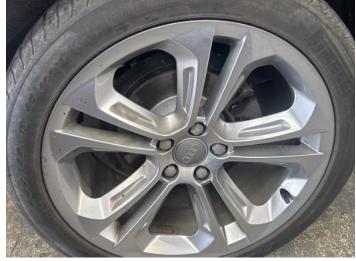
19: Wheel osr Scratched Over 50mm
