# VEHICLE INSPECTION REPORT

**GJ67HGZ**

## Vauxhall Mokka X 1.4T Active 5dr

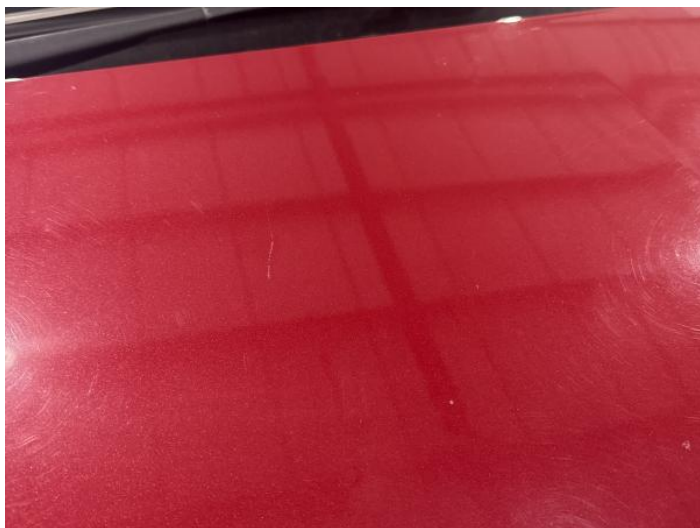
1: Bonnet  
Scratched  
Over 25mm Thru Paint

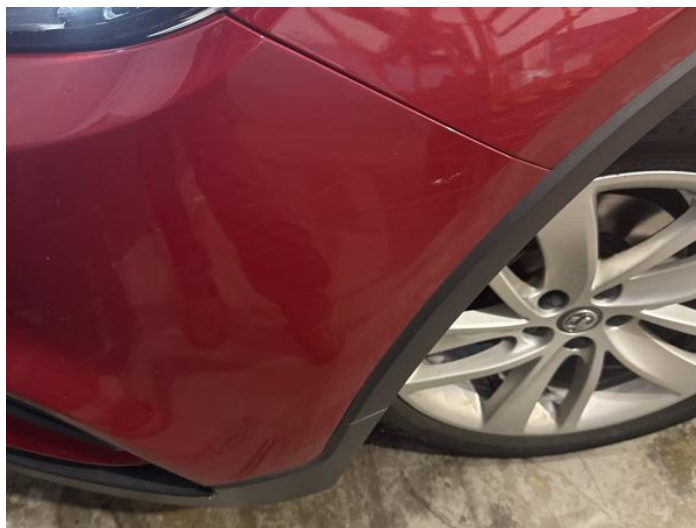
2: Bumper Front  
Scratched  
25 to 100mm Thru Paint

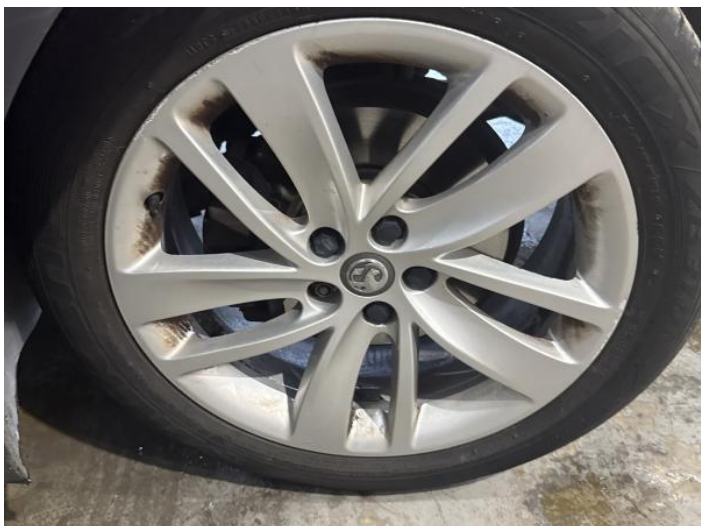
3: Wheel nsf  
Scratched  
Over 50mm

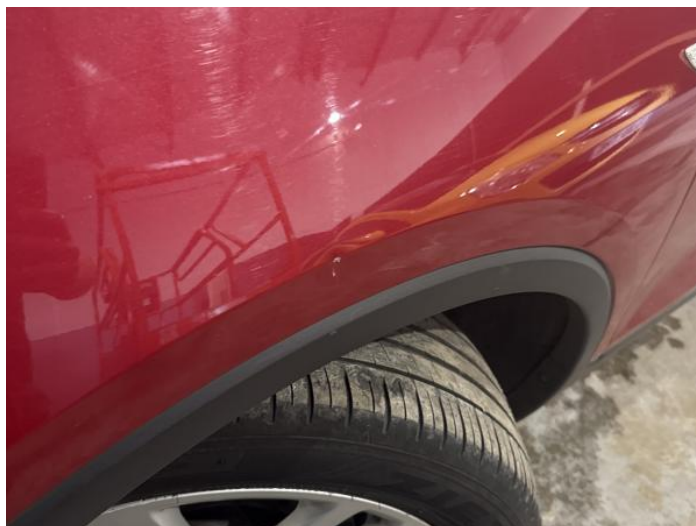
4: Wing nsf  
Dented  
With Paint Damage

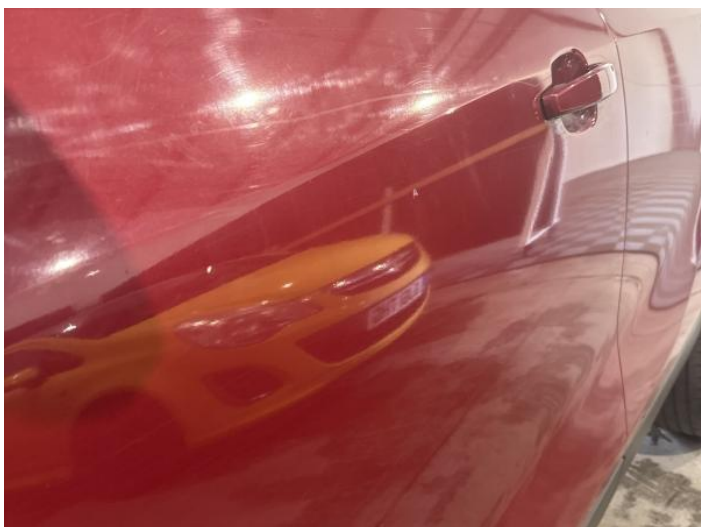
5: Door nsf  
Scratched  
Over 25mm Thru Paint

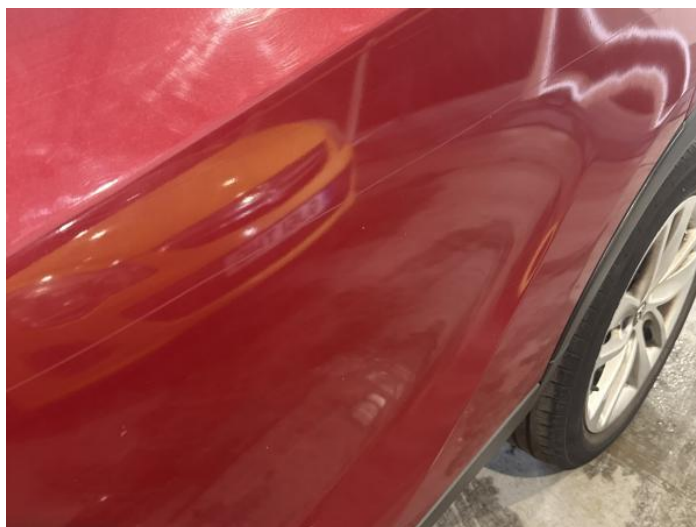
6: Door nsr  
Scratched  
Over 25mm Thru Paint

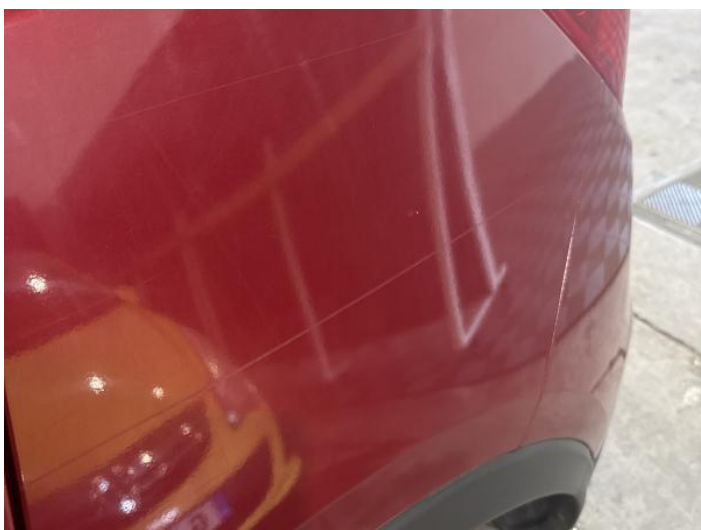
7: Qtr Panel nsr  
Scratched  
Over 25mm Thru Paint

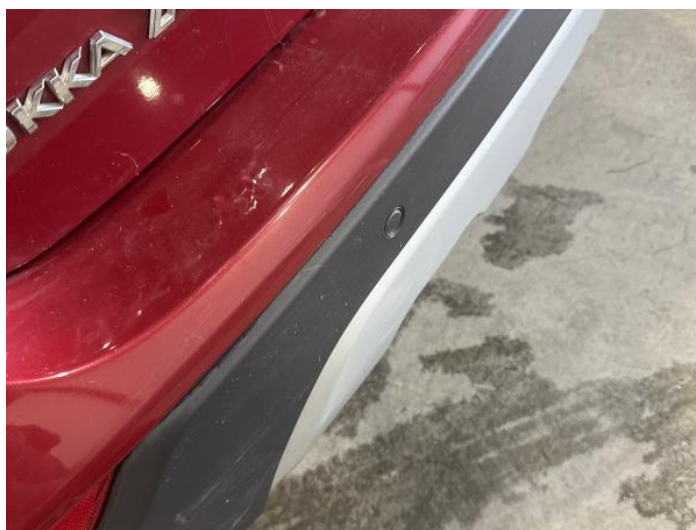
8: Bumper Rear  
Scratched  
Over 100mm Thru Paint

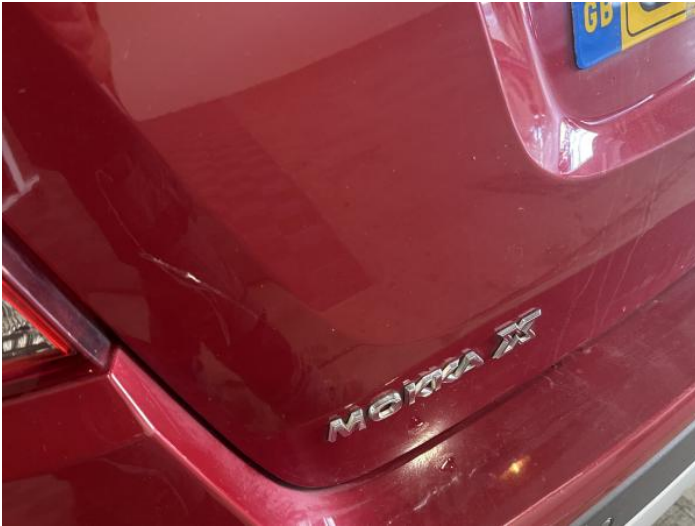
9: Tailgate  
Scratched  
Over 25mm Thru Paint

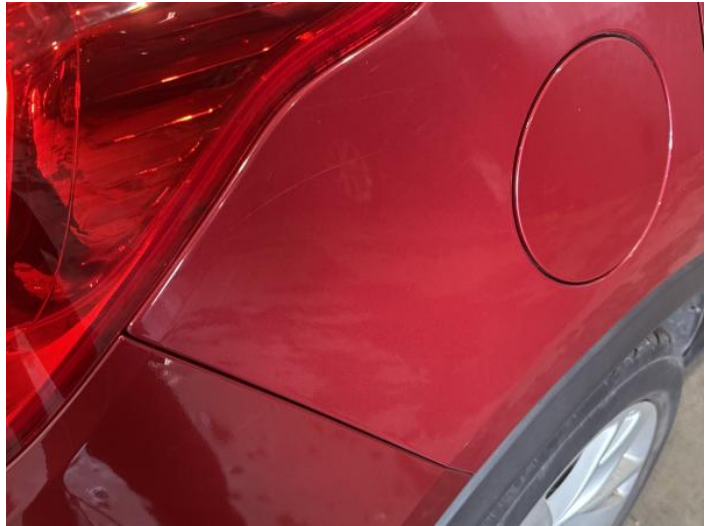
10: Qtr Panel osr  
Scratched  
Over 25mm Thru Paint

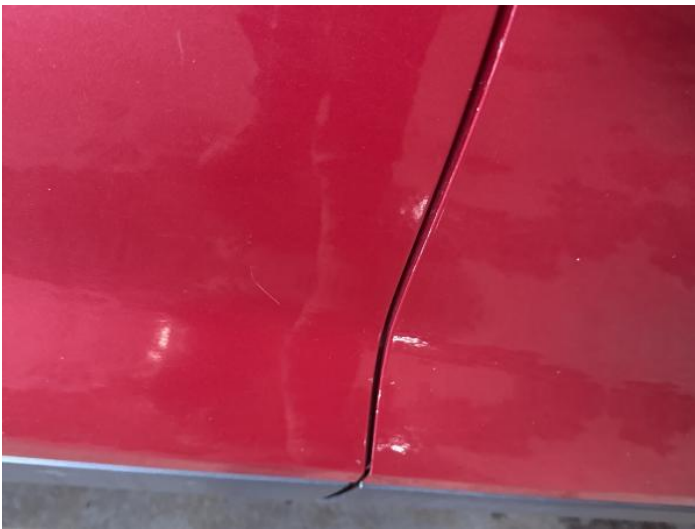
11: Door osr  
Scratched  
Over 25mm Thru Paint

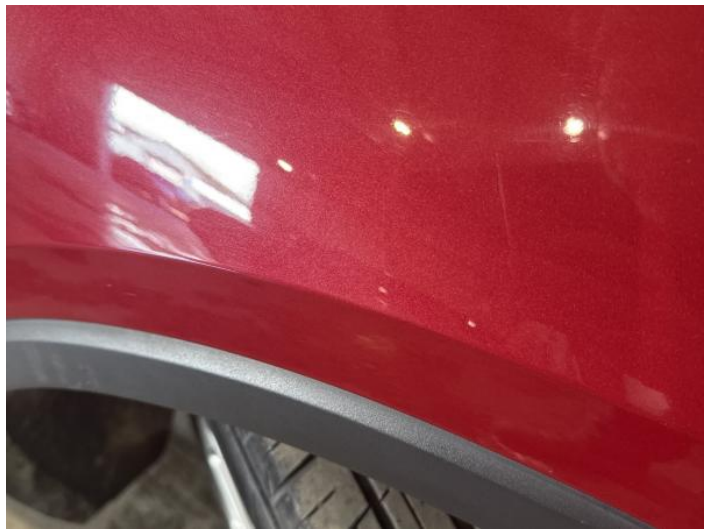
12: Wing osf  
Scratched  
UpTo 25mm Thru Paint

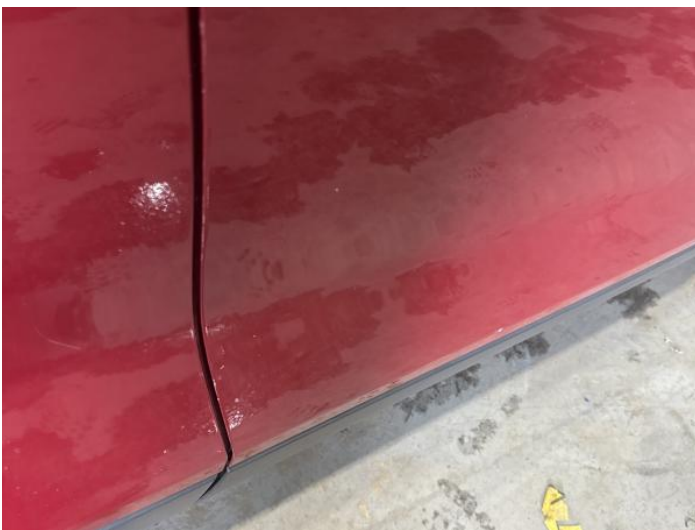
13: Door nsf  
Chipped  
Edge Chip

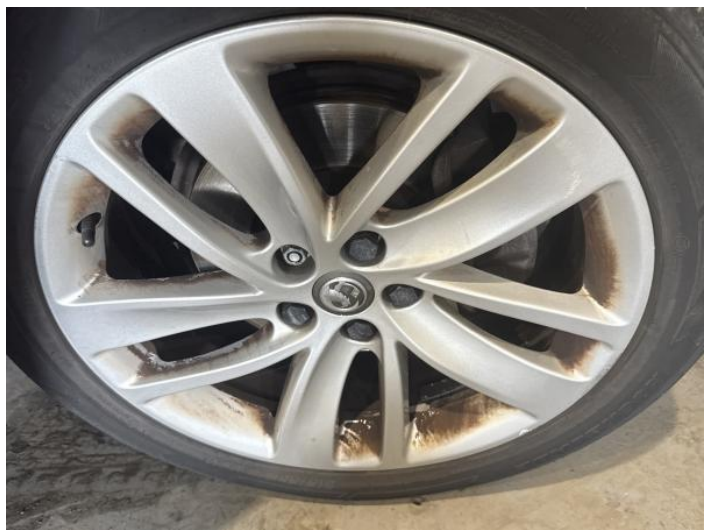
14: Wheel osf  
Scratched  
Up To 50mm

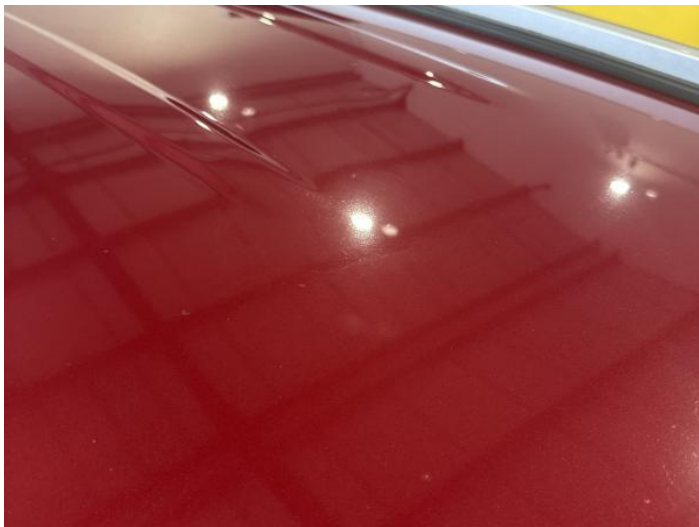
15: Roof  
Dented  
Over 30mm

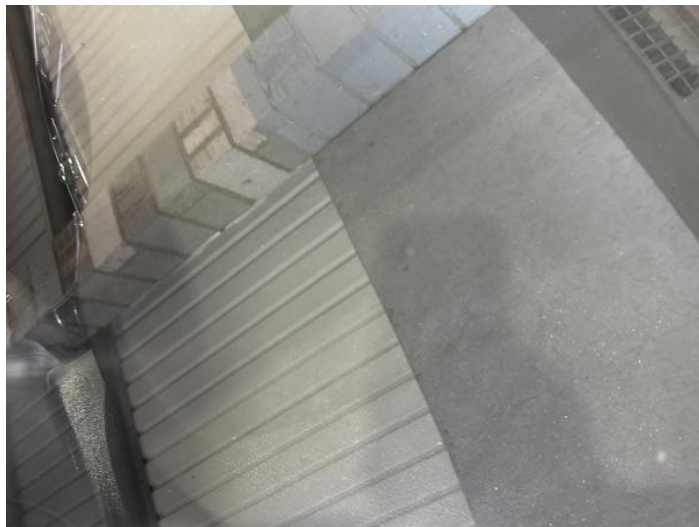
16: Screen Front  
Chipped  
UpTo 10mm
