VEHICLE INSPECTION REPORT

GP21ERJ

BMW 1 Series 118i [136] M Sport 5dr

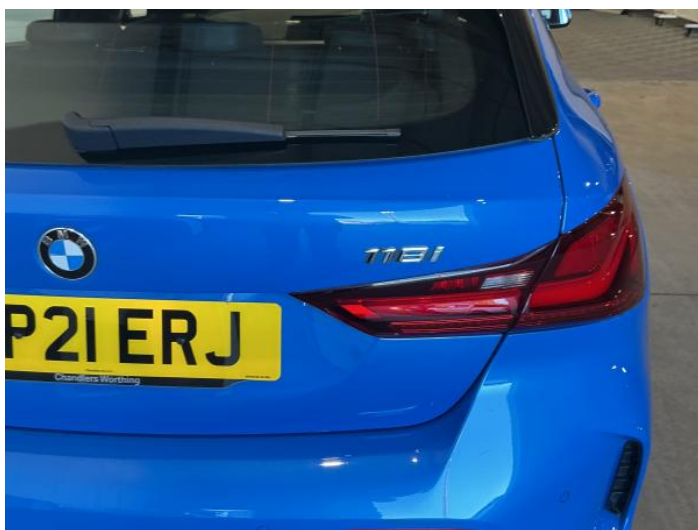
1: Bumper Rear
Scratched
25 to 100mm Thru Paint

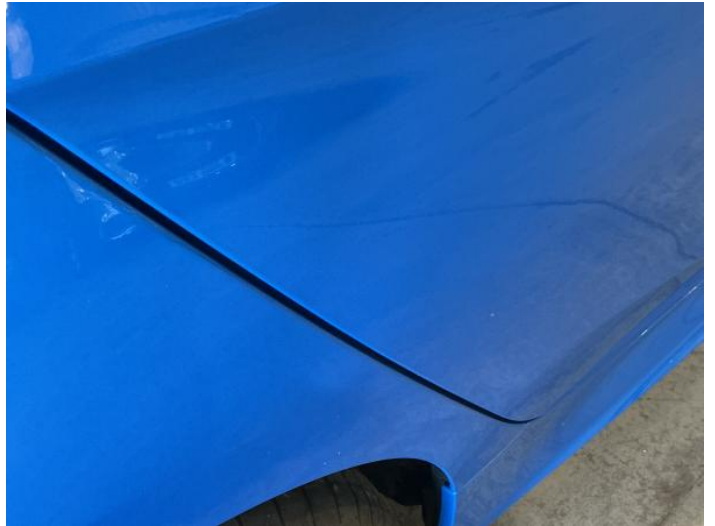
3: Boot Lid
Scratched
Over 25mm Not Thru Paint

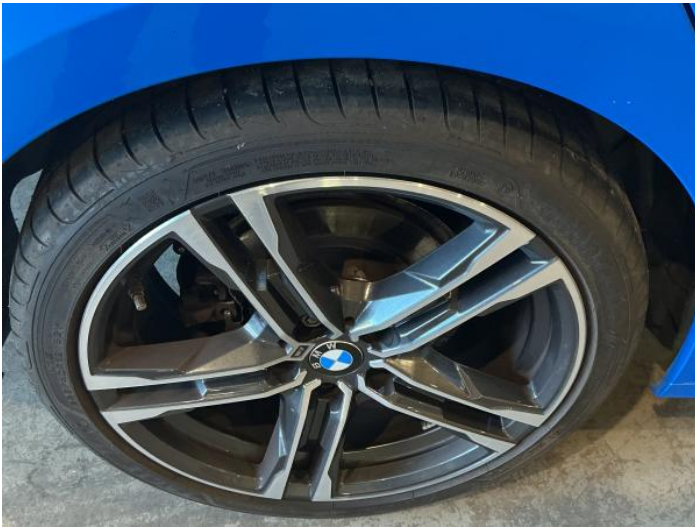
5: Wheel osr
Scratched
Up To 50mm

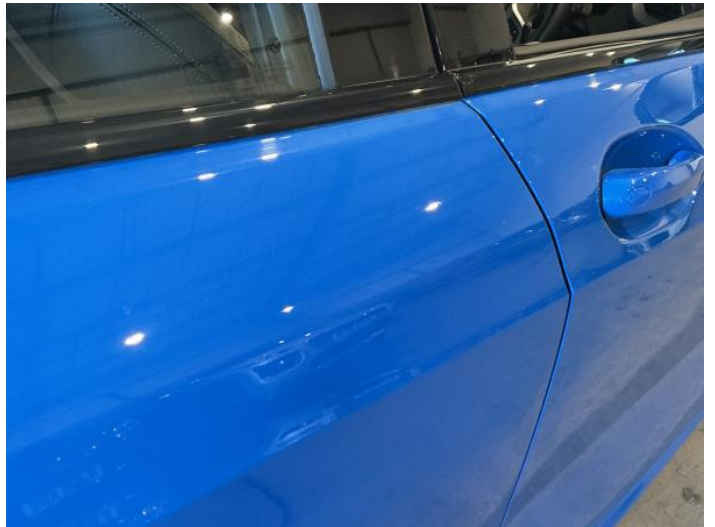
6: Door osr
Chipped
1 To 5

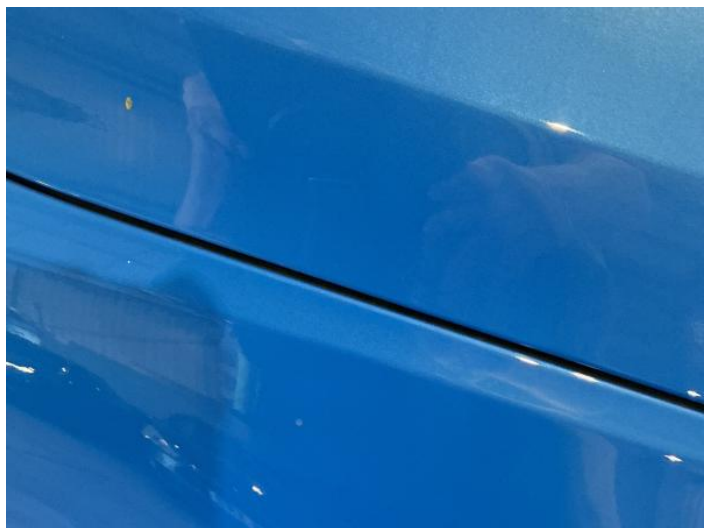
7: Door osf
Scratched
Over 25mm Not Thru Paint

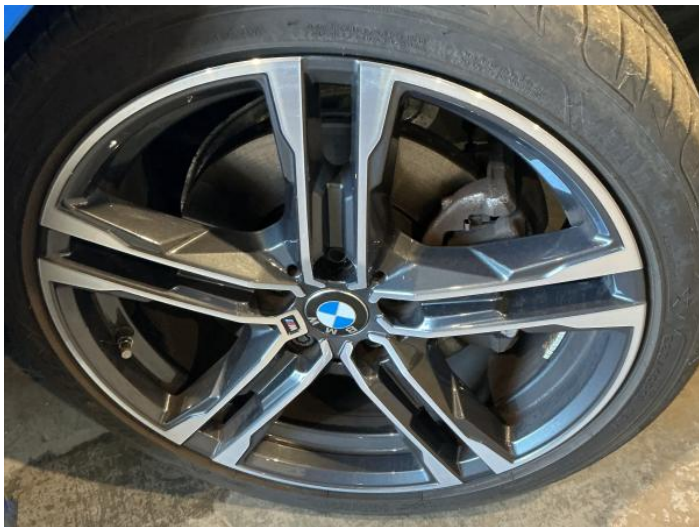
9: Wheel osf
Scratched
Up To 50mm

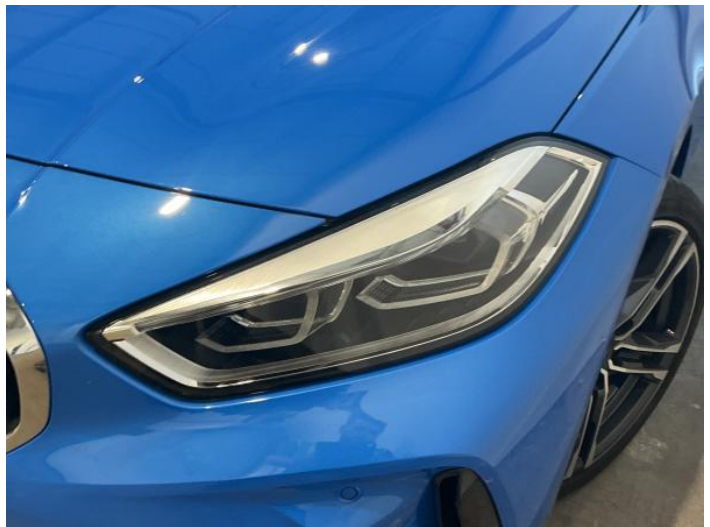
10: Bumper Front
Chipped
Multiple Chips

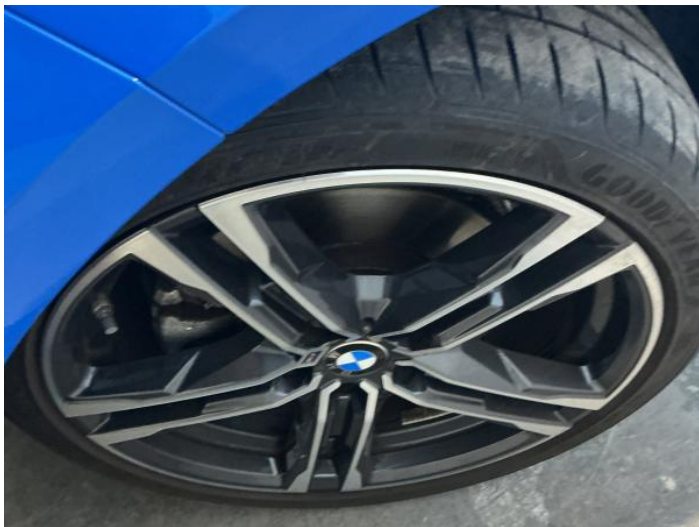
11: Wheel nsf
Scratched
Up To 50mm

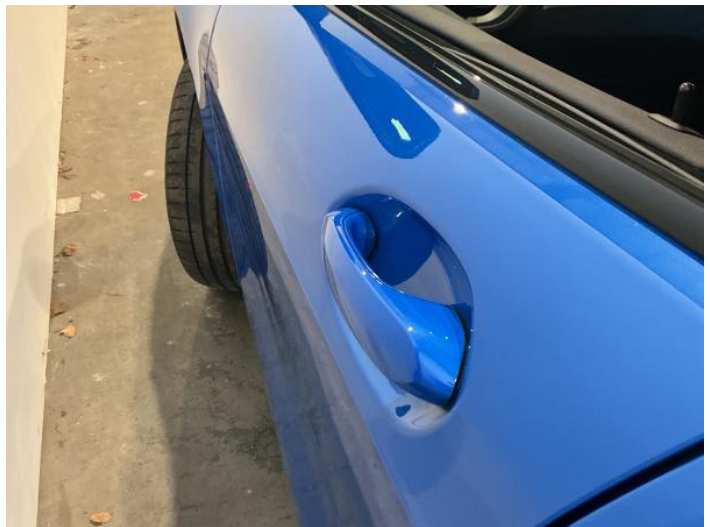
12: Door nsf
Dented
2 Or Less UpTo 10mm

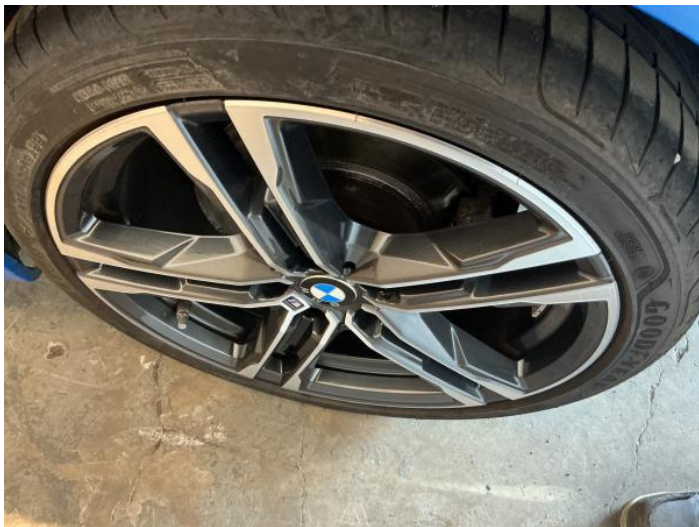
15: Wheel nsr
Scratched
Up To 50mm
