## **VEHICLE INSPECTION REPORT**

LD62TSU

## Volkswagen Golf 1.4 TSI Match 5dr DSG

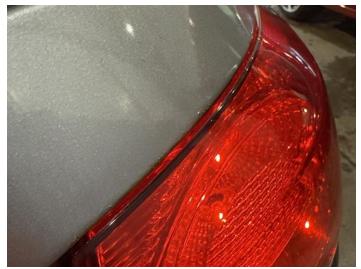
1: Tailgate Rusted UpTo 5mm

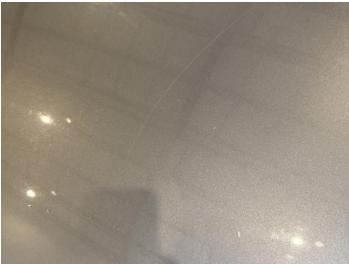
2: Bonnet Scratched Over 25mm Thru Paint

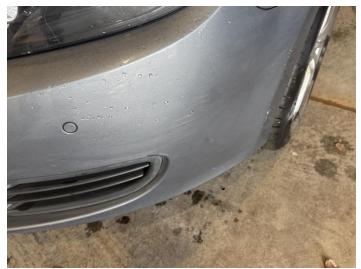
3: Bumper Front Dented With Paint Damage

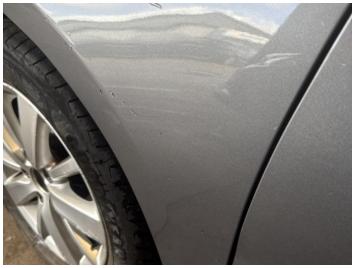
5: Wing nsf Scratched Over 25mm Thru Paint

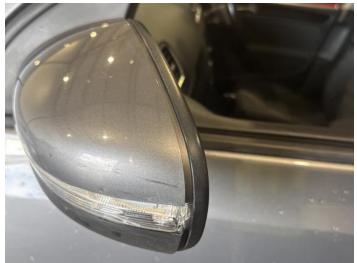
6: Door Mirror Assy nsf Scratched (Painted) UpTo 25mm Thru Paint

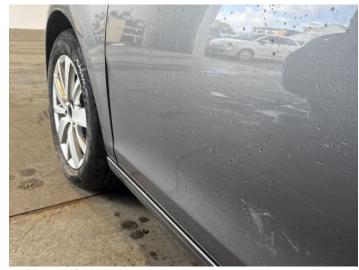
7: Door nsf Dented Over 30mm

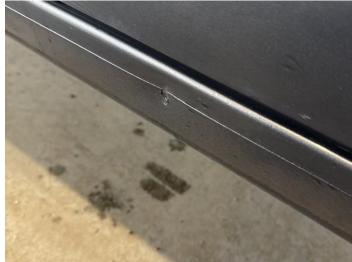
8: Sill ns Dented Between 10mm + 30mm

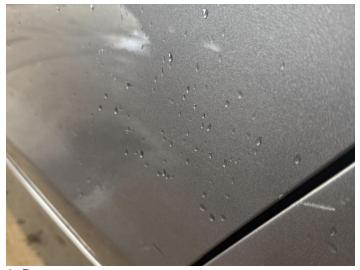
9: Door nsr Scratched Over 25mm Thru Paint

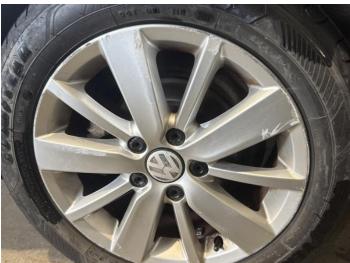
10: Wheel nsr Scratched Over 50mm

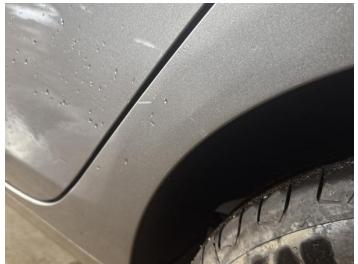
11: Qtr Panel nsr Scratched UpTo 25mm Thru Paint

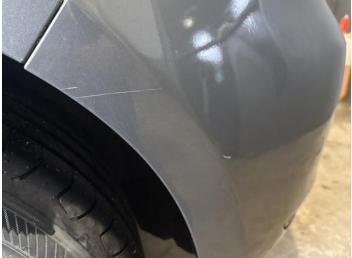
12: Bumper Rear Scratched 25 to 100mm Thru Paint

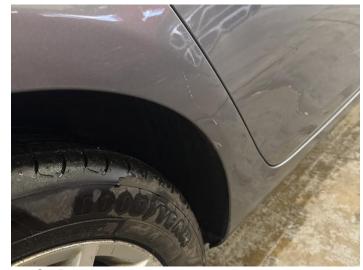
13: Qtr Panel osr Dented With Paint Damage

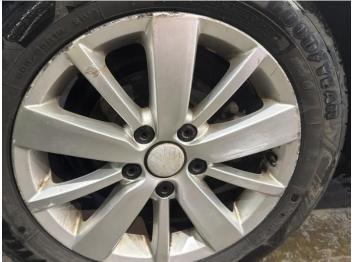
14: Wheel osr Scratched Over 50mm

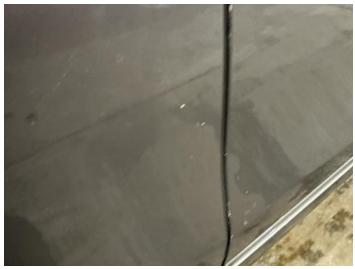
15: Door osr Scratched UpTo 25mm Thru Paint

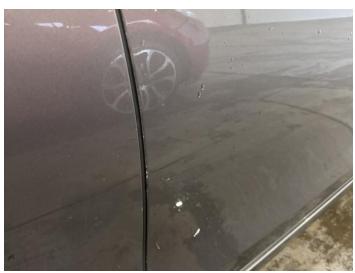
16: Door osf Chipped Edge Chip

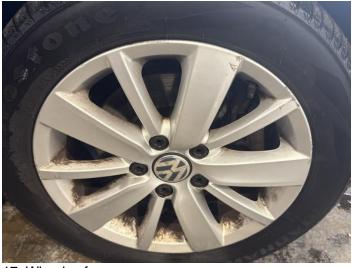
17: Wheel osf Scratched Over 50mm
