VEHICLE INSPECTION REPORT

EA66WWB

Volkswagen Tiguan 2.0 TDi 150 4Motion SE Nav 5dr

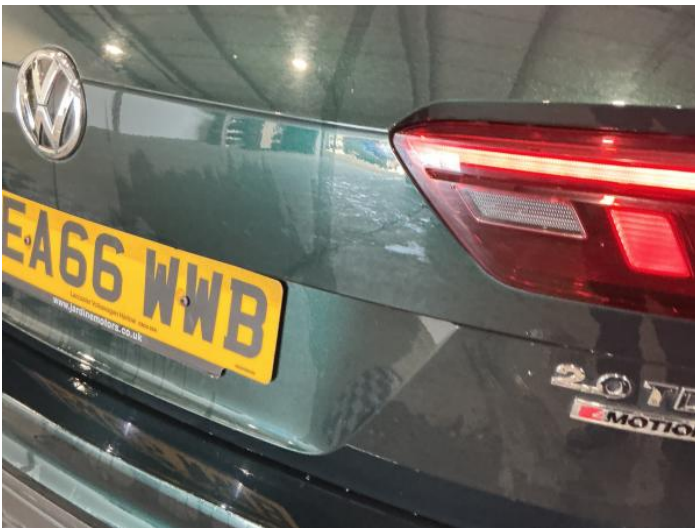
1: Bumper Rear
Scratched
Over 100mm Thru Paint

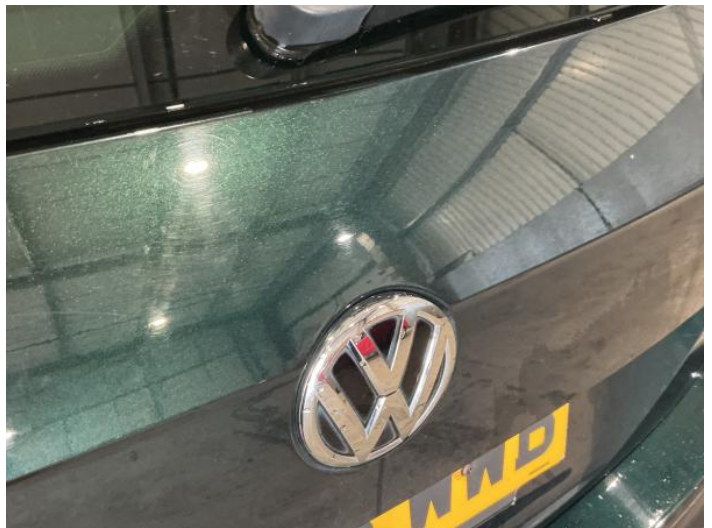
2: Boot Lid
Chipped
1 To 5

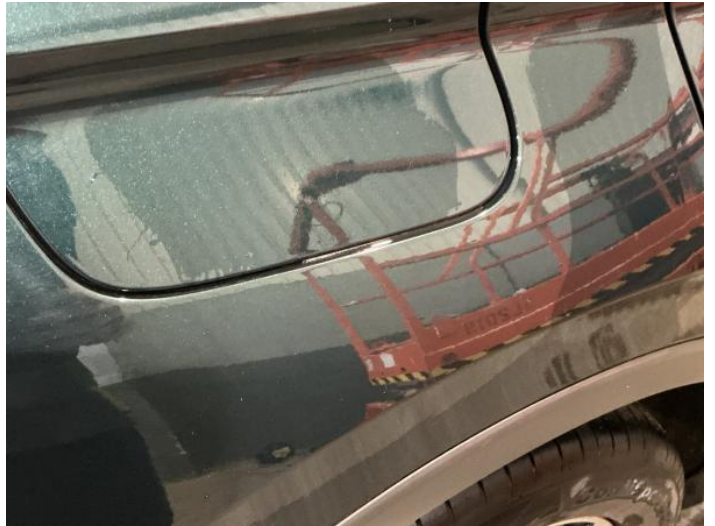
4: Qtr Panel osr
Chipped
1 To 5

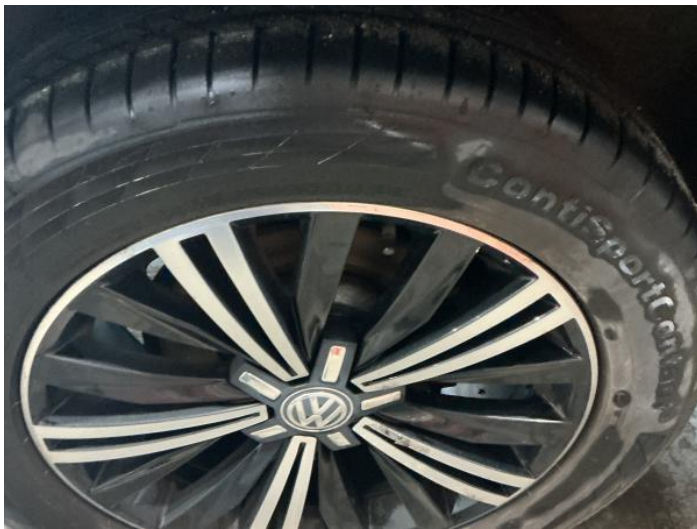
5: Wheel osr
Scratched
Over 50mm

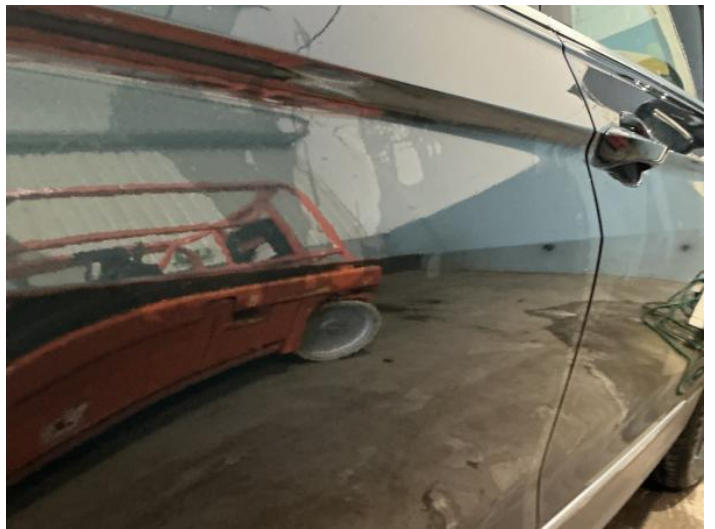
6: Door osr
Dented
Over 2 UpTo 10mm

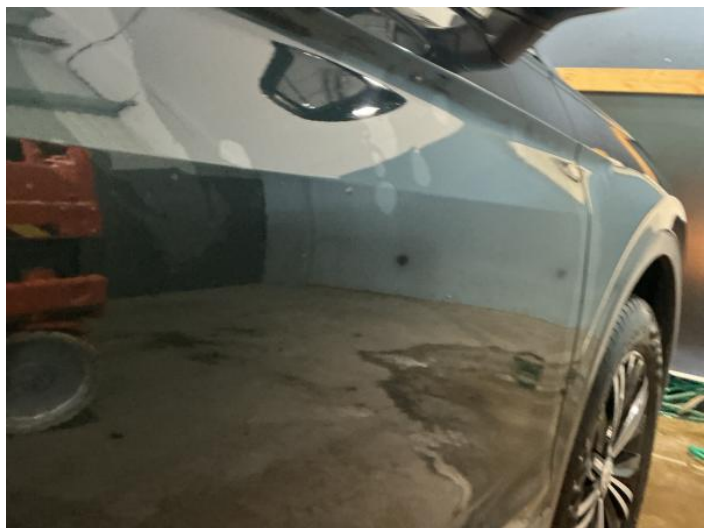
8: Door osf
Dented
Over 2 UpTo 10mm

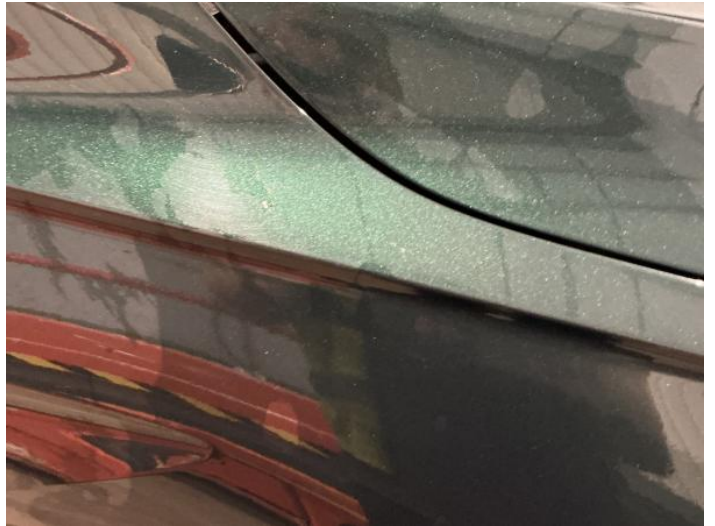
9: Door osf
Scratched
Over 25mm Not Thru Paint

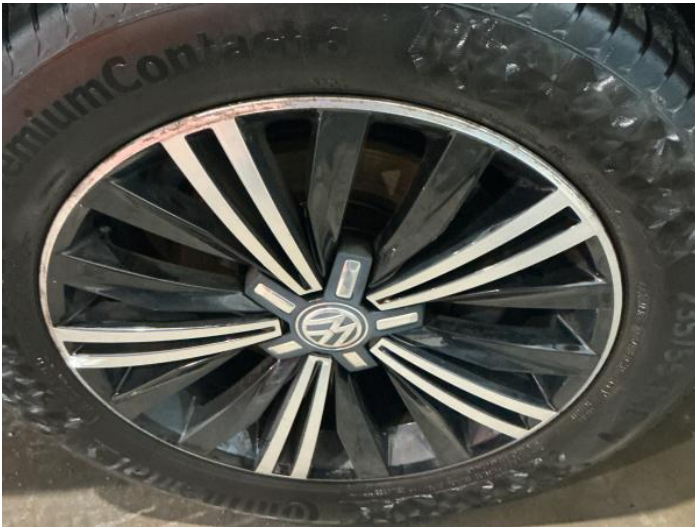
11: Wheel osf
Scratched
Over 50mm

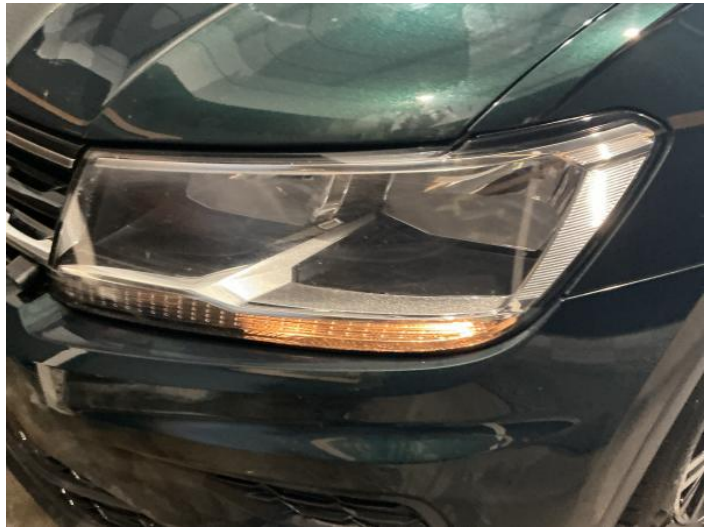
12: Bumper Front
Scratched
25 to 100mm Thru Paint

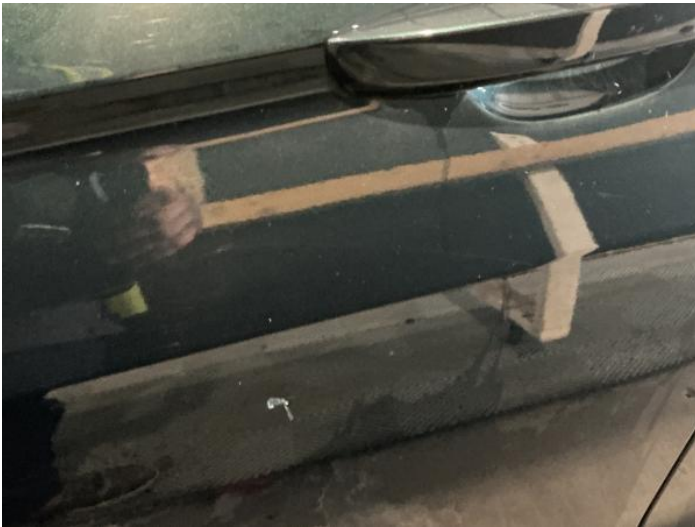
17: Door nsf
Dented
With Paint Damage

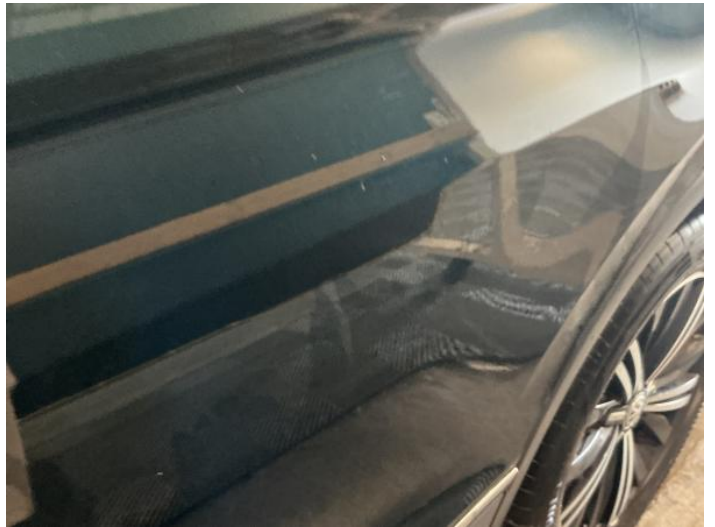
18: Door nsr
Chipped
1 To 5

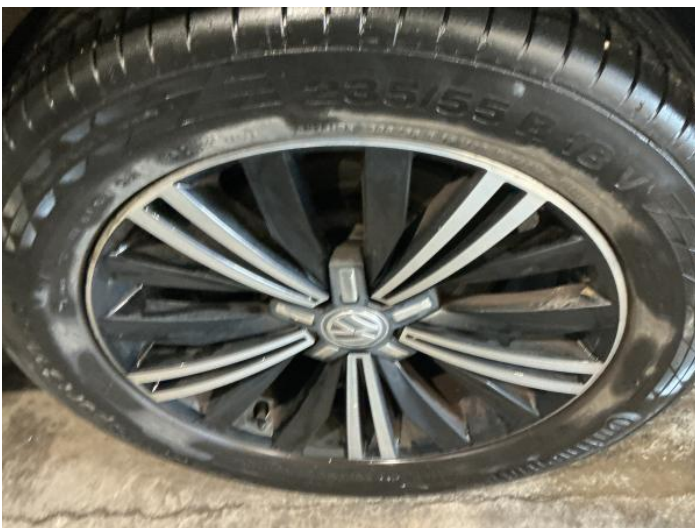
19: Wheel nsr
Scratched
Over 50mm
