VEHICLE INSPECTION REPORT

EA10GZL

Mazda 5 2.0 Takara 5dr Auto

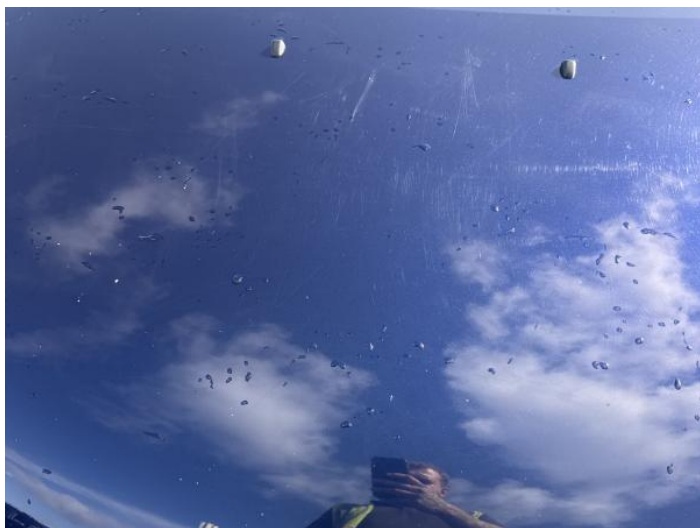
1: Bonnet
Chipped
Multiple Chips

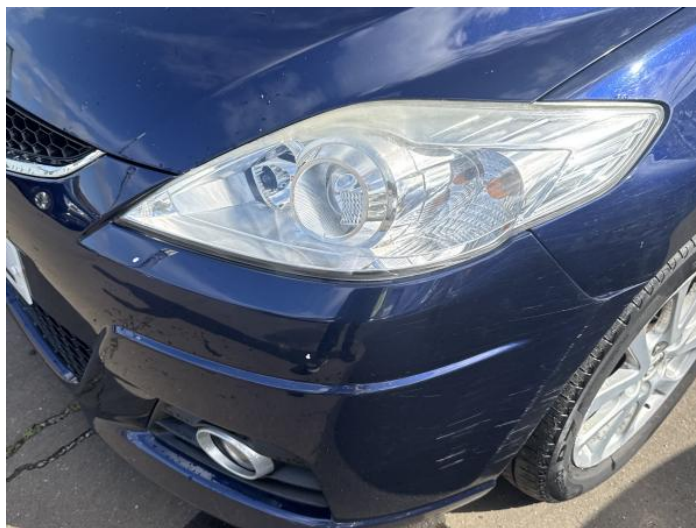
2: Bumper Front
Scratched
Over 100mm Thru Paint

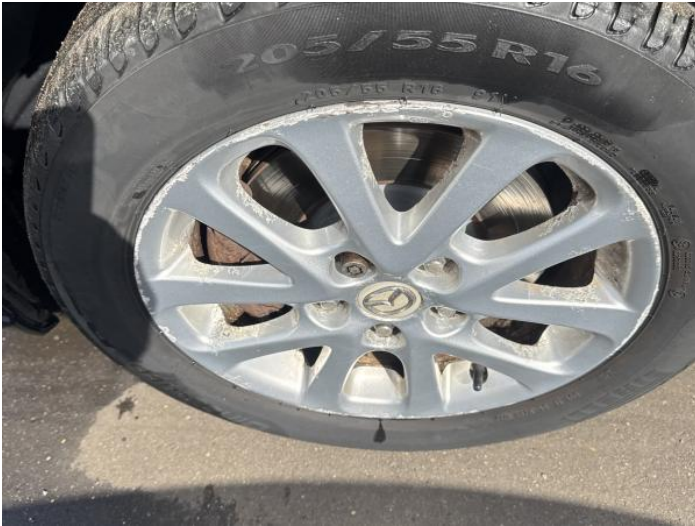
3: Wheel nsf
Scratched
Over 50mm

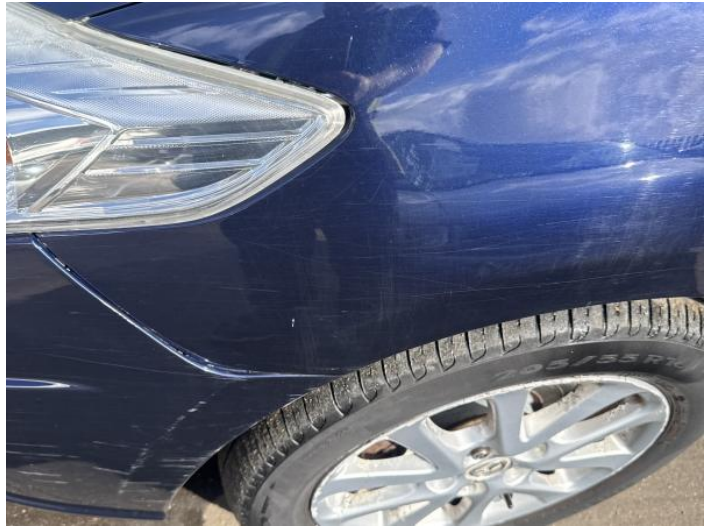
4: Wing nsf
Dented
With Paint Damage

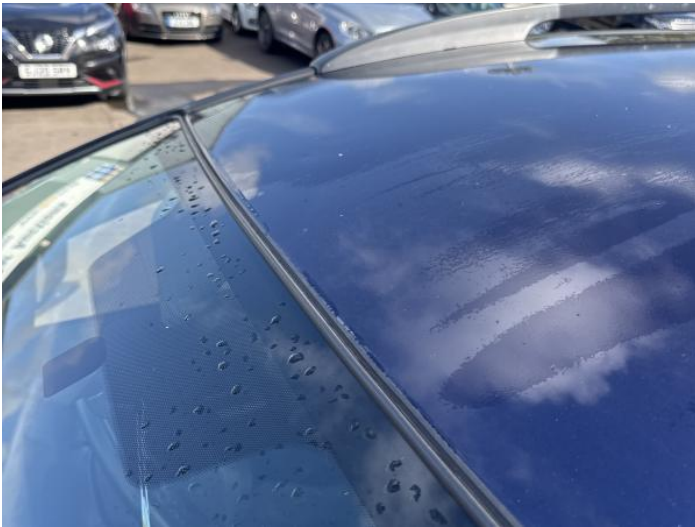
5: Roof
Dented
Over 30mm

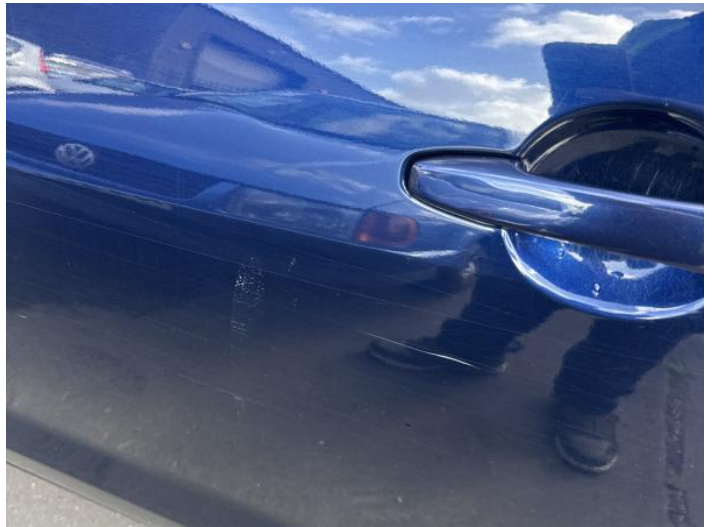
6: Door nsf
Dented
With Paint Damage

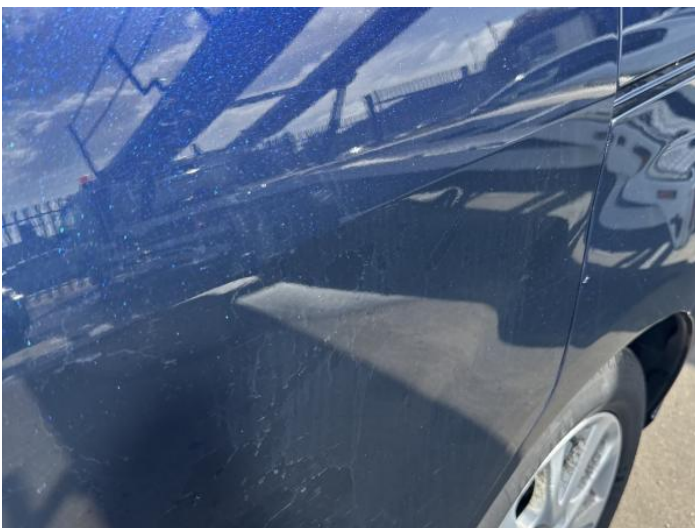
7: Door nsr
Dented
Between 10mm + 30mm

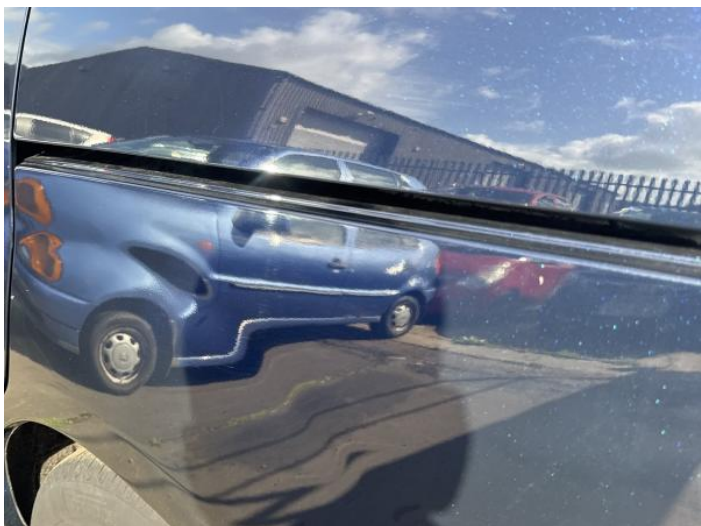
9: Qtr Panel nsr
Poor Previous Repair
Poor Paint

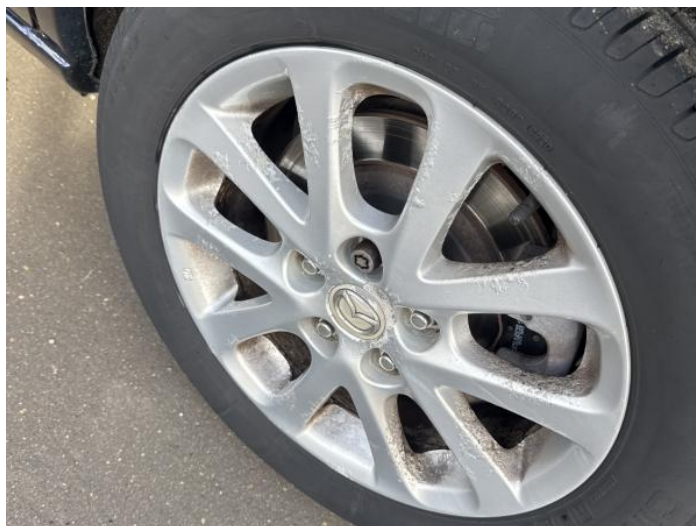
10: Wheel nsr
Scratched
Over 50mm

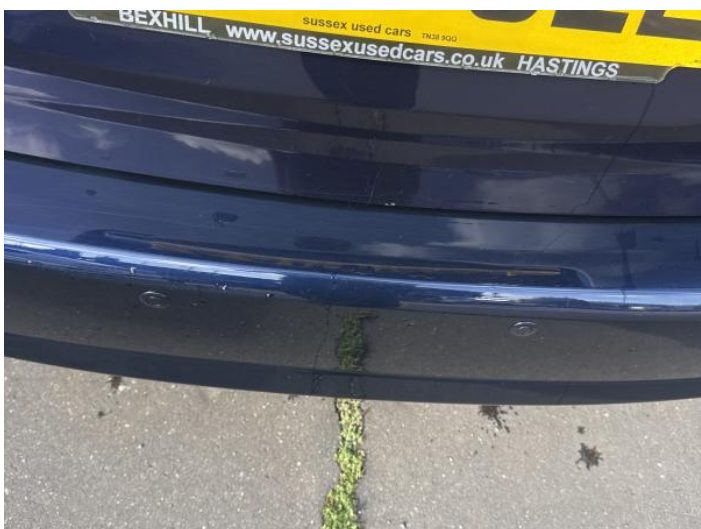
11: Bumper Rear
Chipped
Multiple Chips

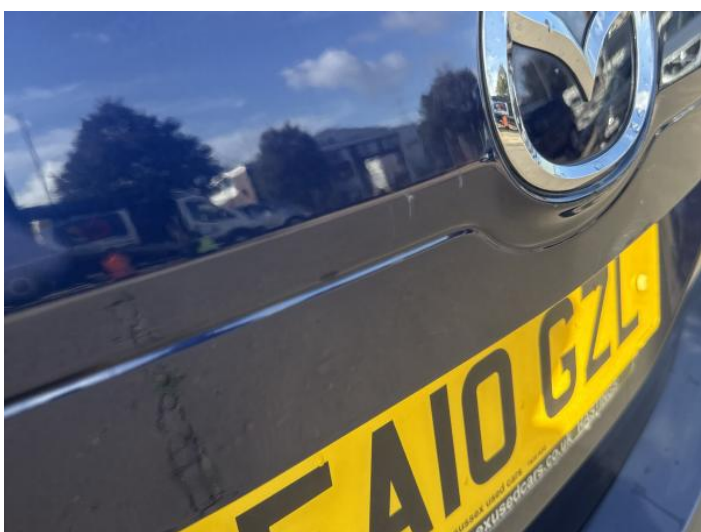
13: Boot Lid
Chipped
1 To 5

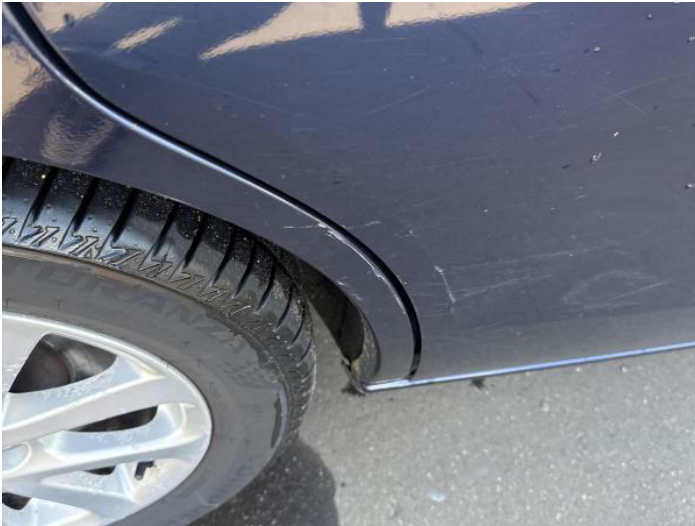
15: Qtr Panel osr
Scratched
Over 25mm Thru Paint

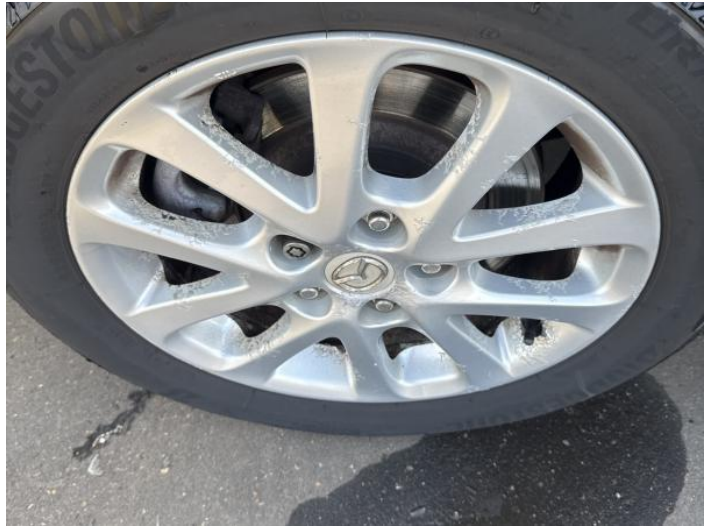
16: Wheel osr
Scratched
Over 50mm

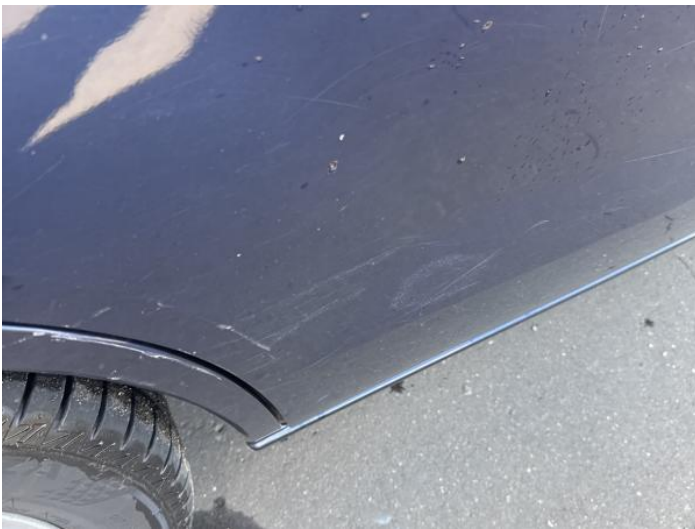
17: Door osr
Dented
With Paint Damage

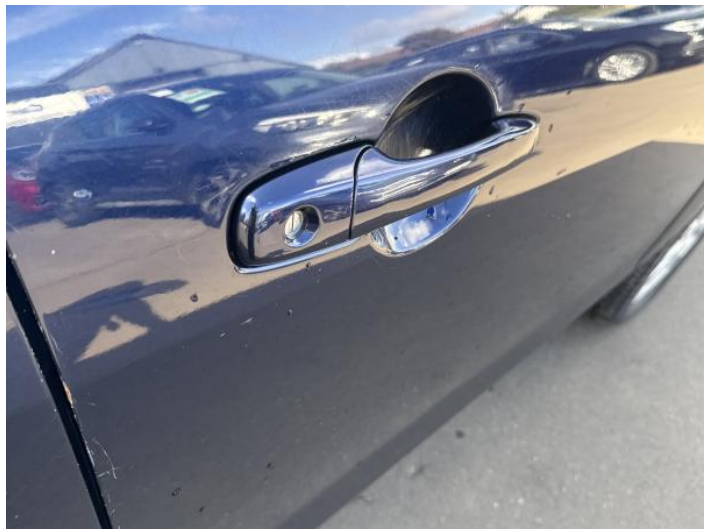
18: Door osf
Dented
Over 30mm

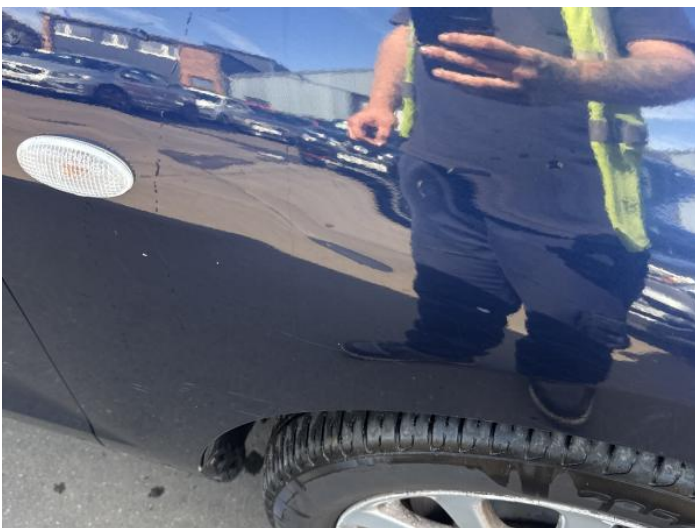
19: Wing osf
Scratched
Over 25mm Thru Paint

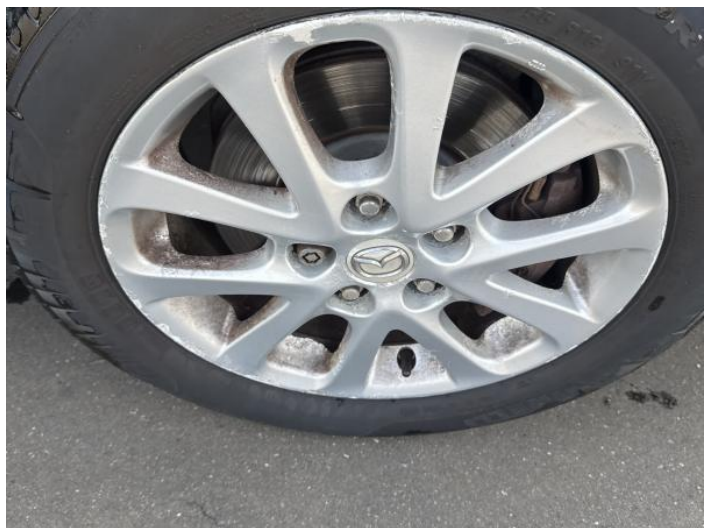
20: Wheel osf
Scratched
Up To 50mm
