# VEHICLE INSPECTION REPORT

**HN14ZXP**

## Skoda Octavia 1.4 TSI Elegance 5dr DSG

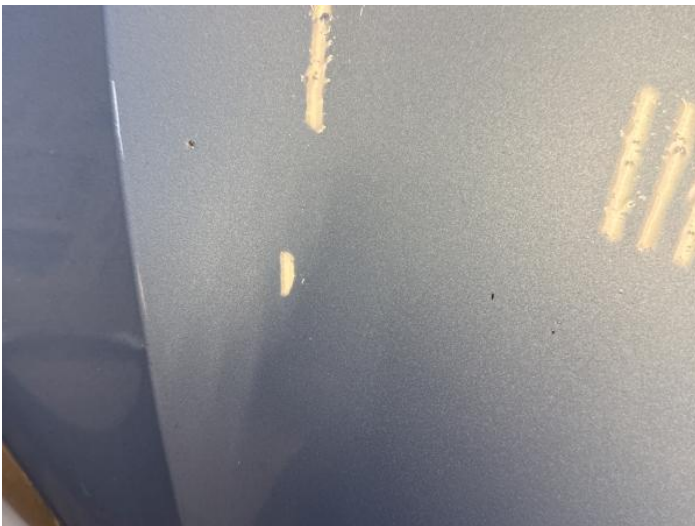
1: Bonnet  
Chipped  
1 To 5

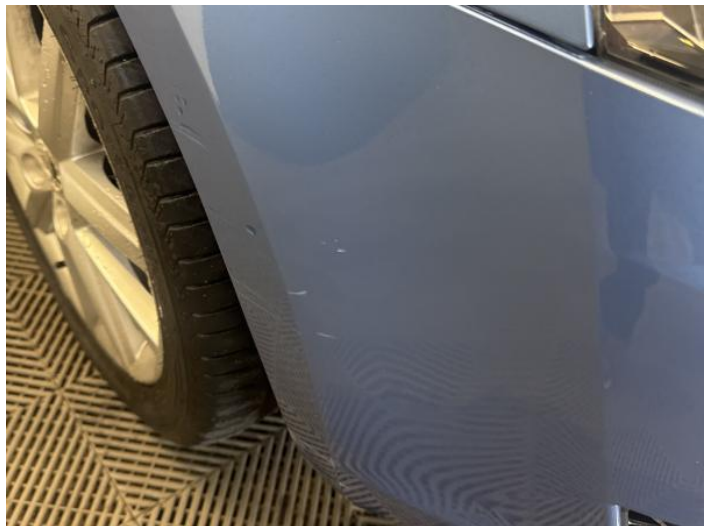
2: Bumper Front  
Scratched  
Over 100mm Thru Paint

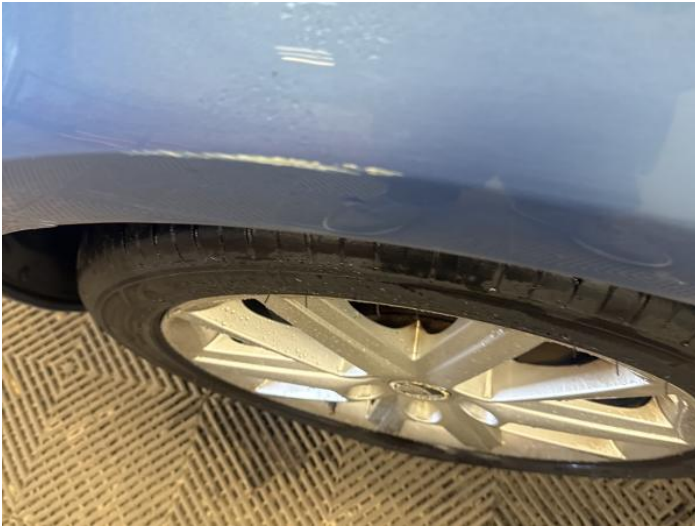
3: Wing nsf  
Dented  
With Paint Damage

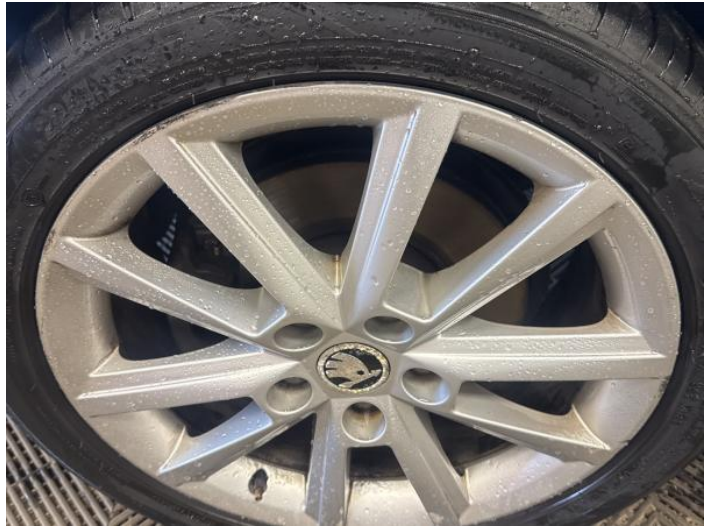
4: Wheel nsf  
Scratched  
Over 50mm

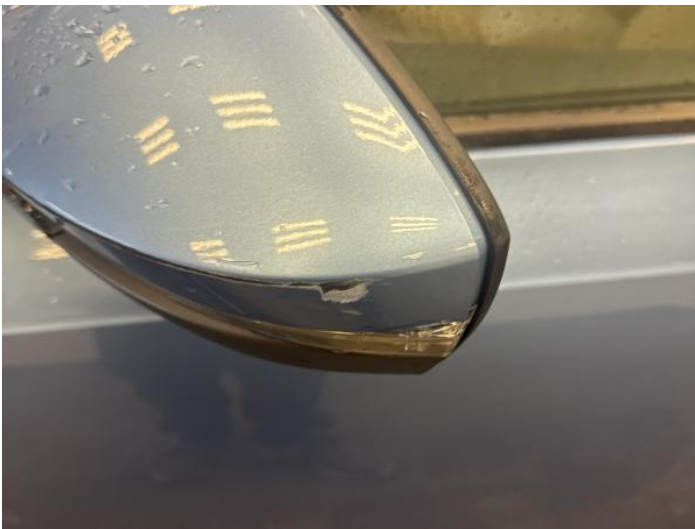
5: Door Mirror Assy nsf  
Scratched (Painted)  
Over 25mm Thru Paint

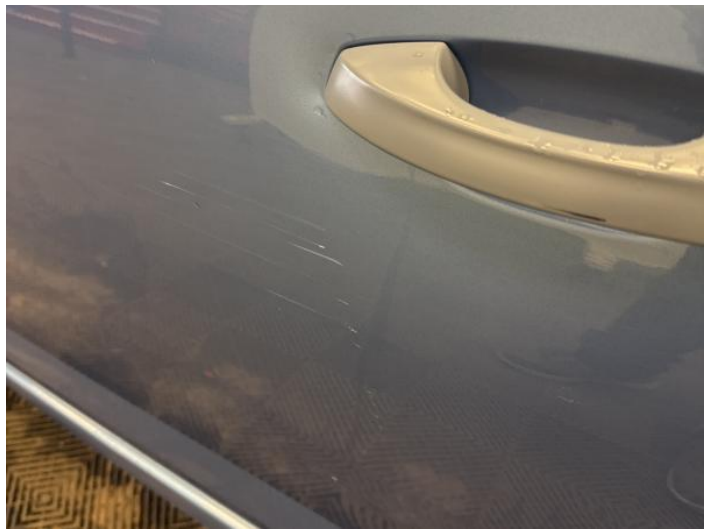
6: Door nsf  
Dented  
With Paint Damage

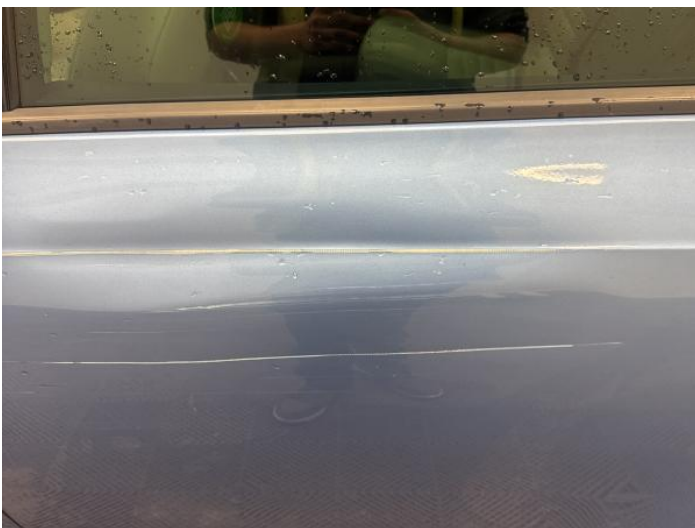
7: Door nsr  
Dented  
With Paint Damage

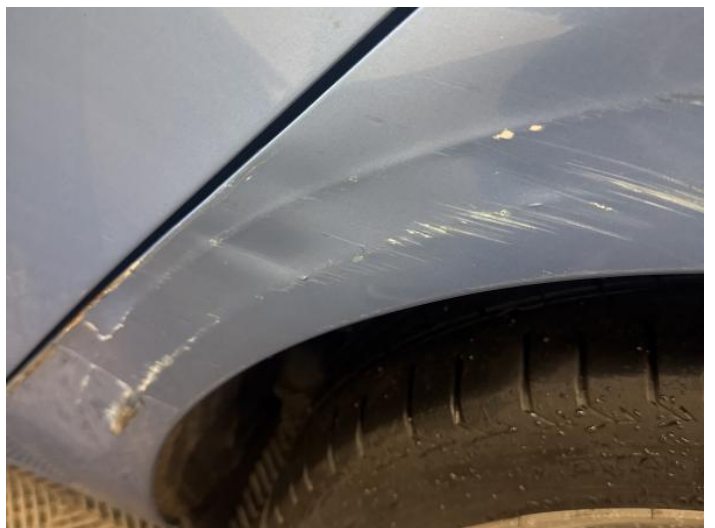
8: Qtr Panel nsr  
Dented  
With Paint Damage

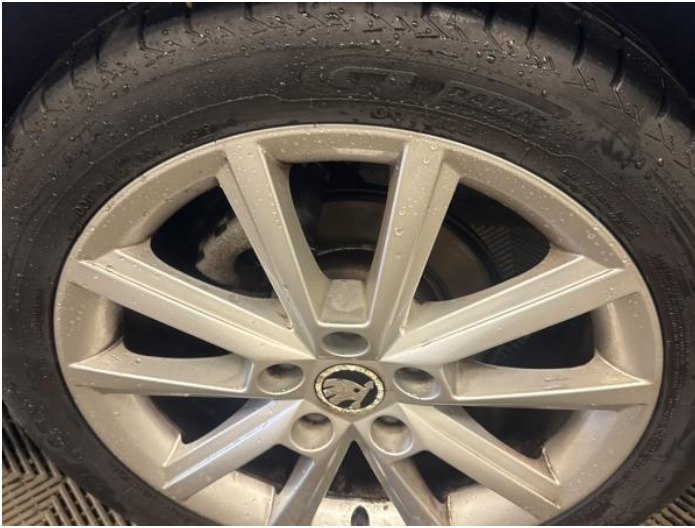
9: Wheel nsr  
Scratched  
Up To 50mm

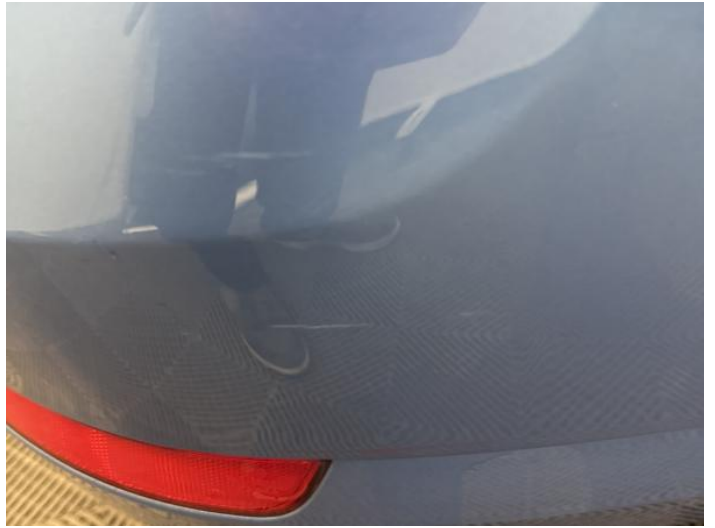
10: Bumper Rear  
Scratched  
Over 100mm Thru Paint

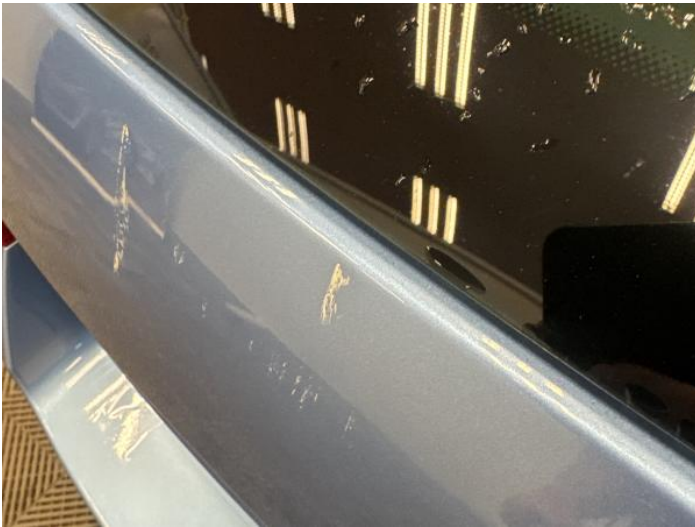
11: Boot Lid  
Scratched  
Over 25mm Thru Paint

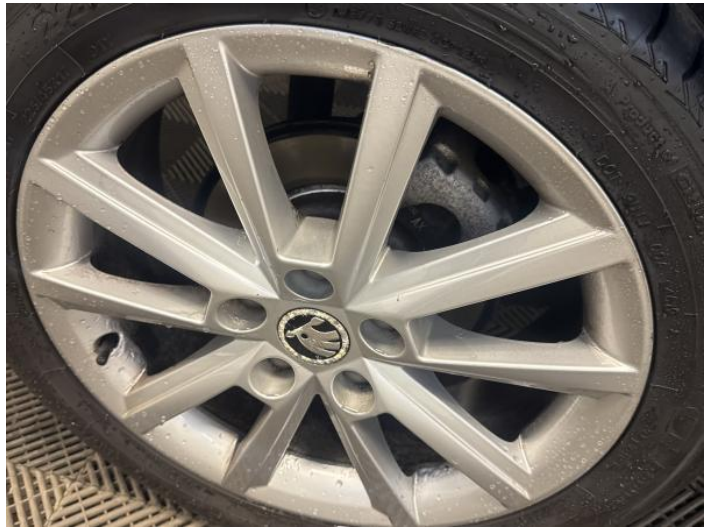
12: Wheel osr  
Scratched  
Up To 50mm

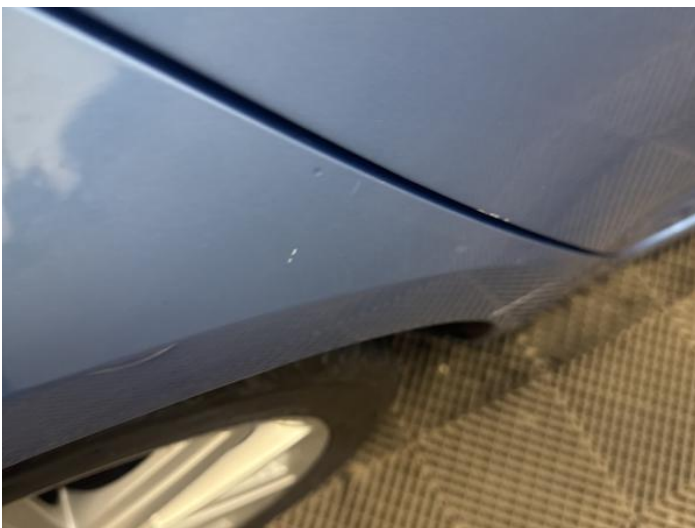
13: Qtr Panel osr  
Chipped  
1 To 5

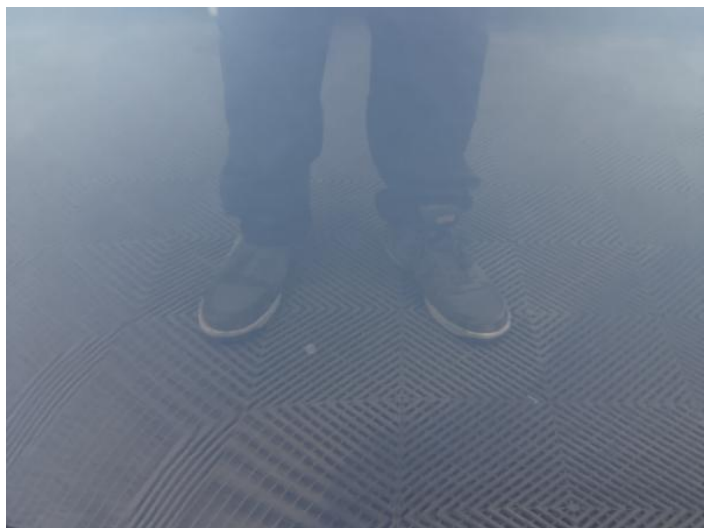
14: Door osr  
Chipped  
1 To 5

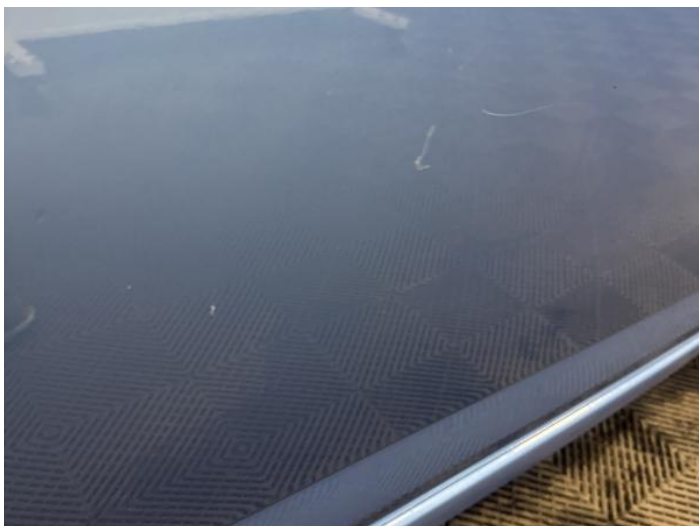
15: Door osf  
Chipped  
Multiple Chips

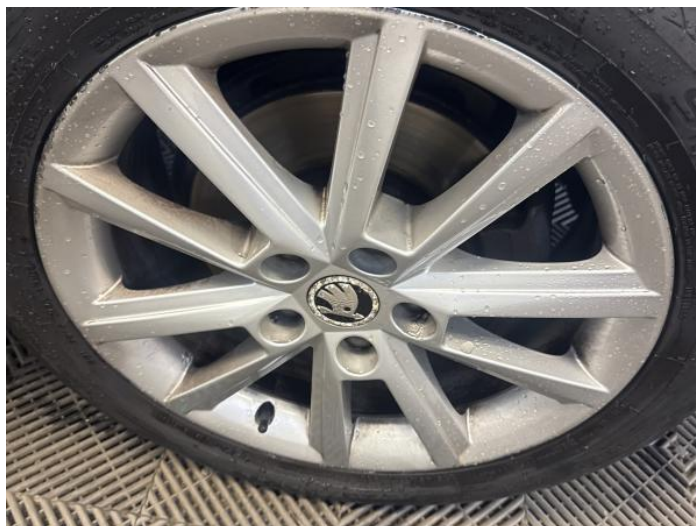
16: Wheel osf  
Scratched  
Up To 50mm
