# VEHICLE INSPECTION REPORT

**GV67GOU**

## Ford Kuga 2.0 TDCi Titanium 5dr 2WD

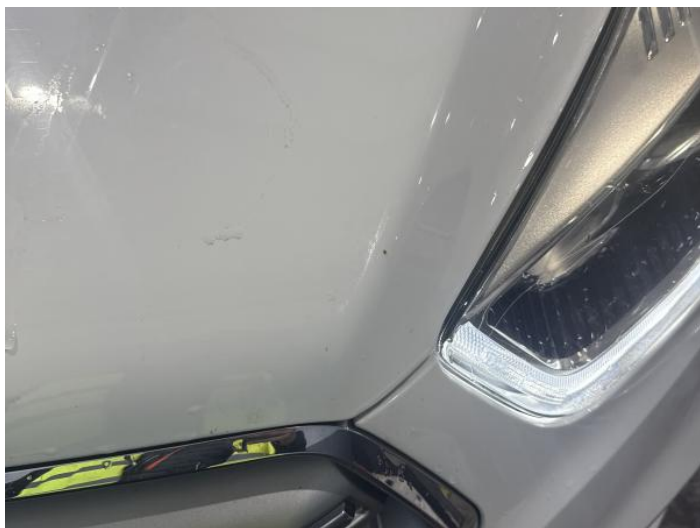
1: Bonnet  
Chipped  
1 To 5

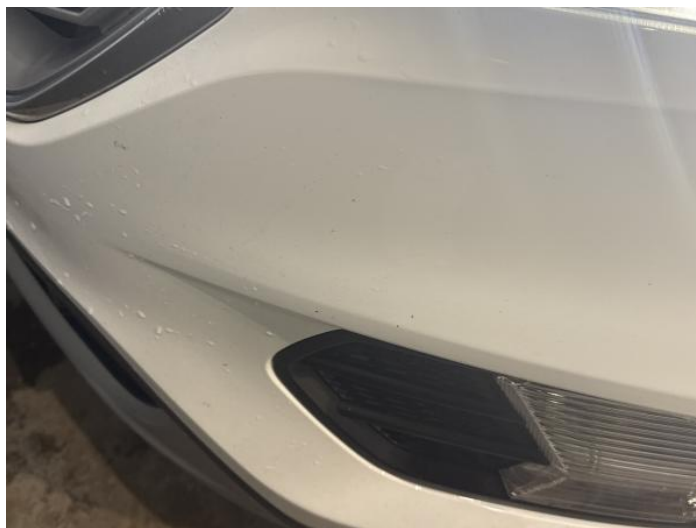
2: Bumper Front  
Chipped  
1 To 5

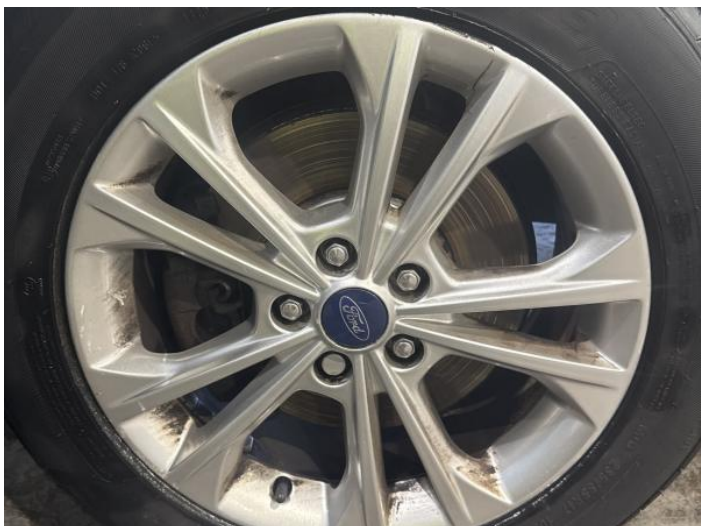
3: Wheel nsf  
Scratched  
Up To 50mm

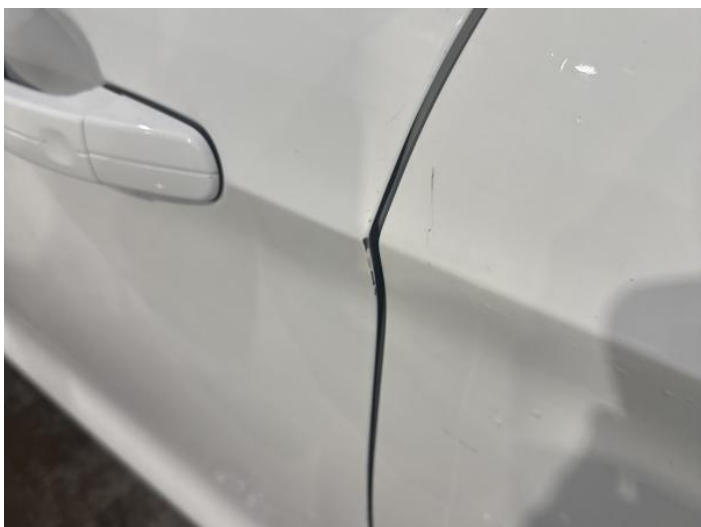
5: Door nsf  
Chipped  
Edge Chip

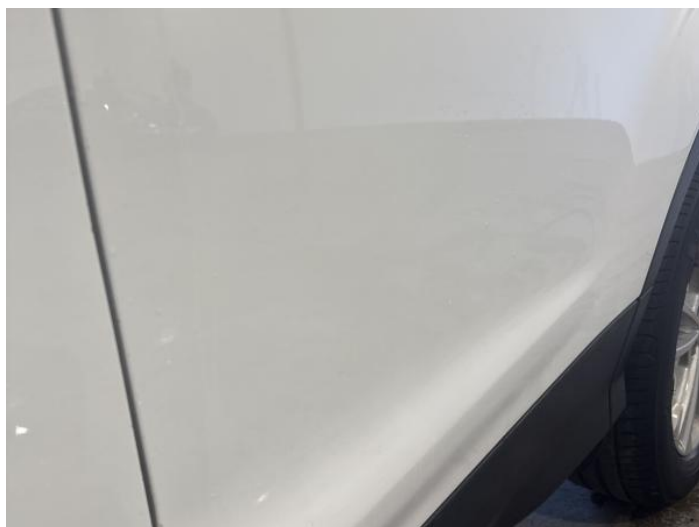
6: Door nsr  
Dented  
With Paint Damage

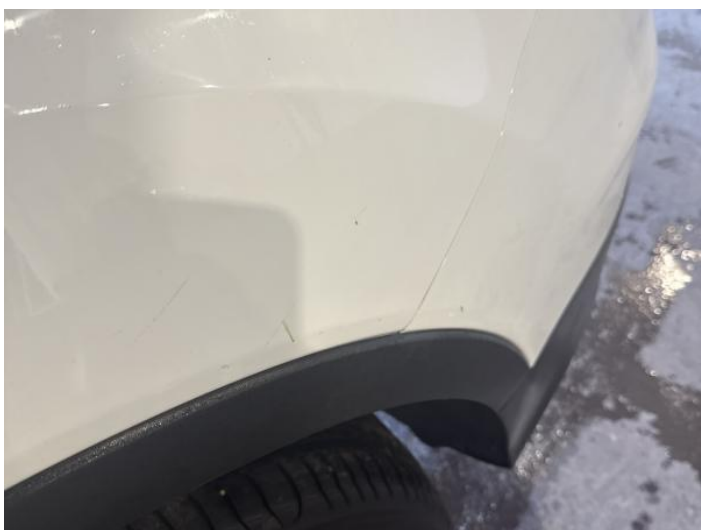
7: Qtr Panel nsr  
Scratched  
Up To 25mm Thru Paint

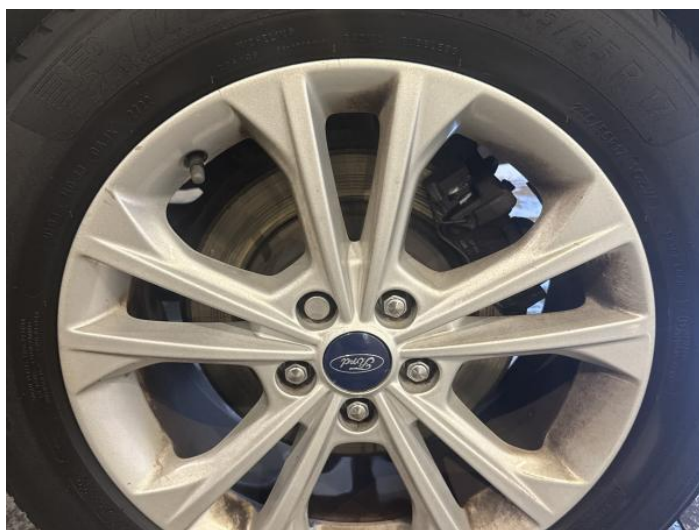
8: Wheel nsr  
Scratched  
Up To 50mm

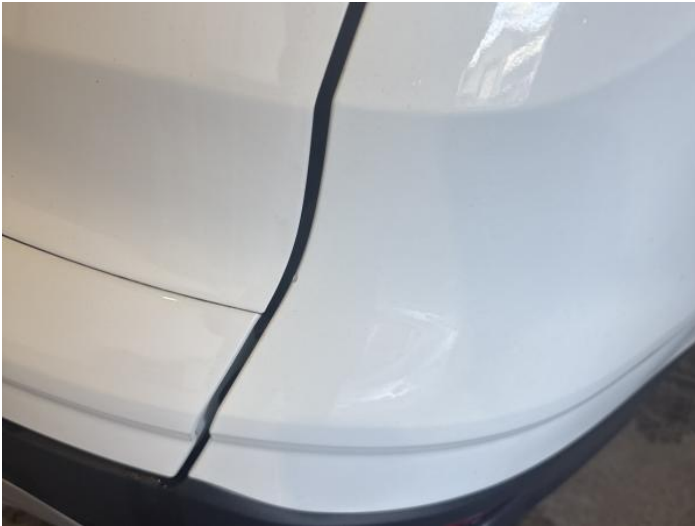
9: Bumper Rear  
Dented  
Between 10mm + 30mm

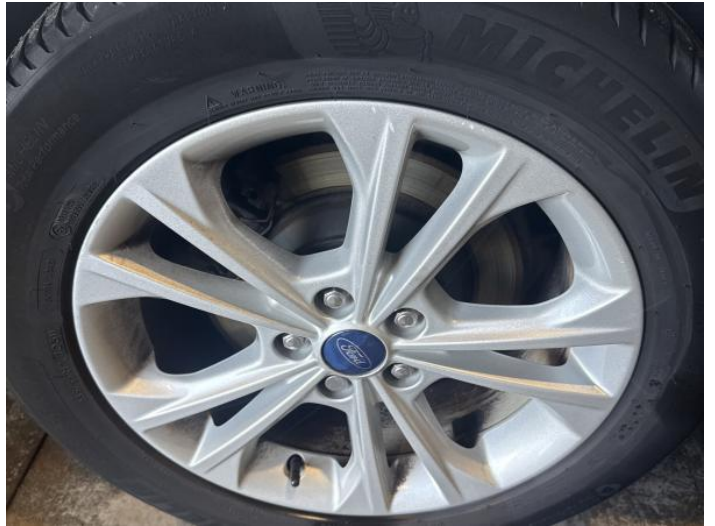
10: Wheel osr  
Scratched  
Up To 50mm

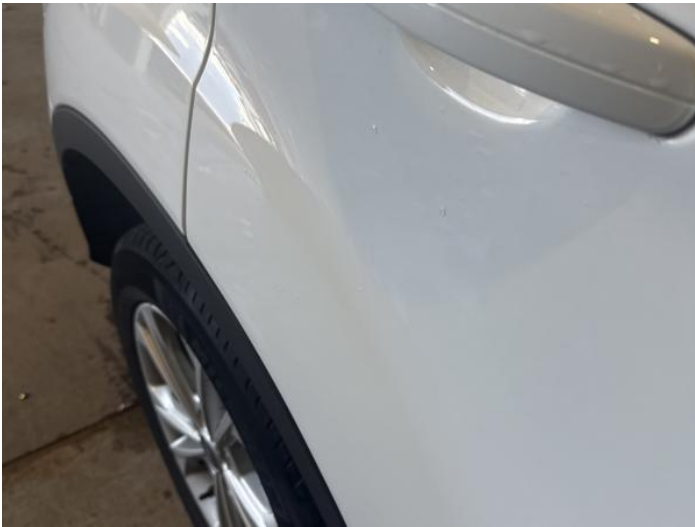
11: Door osr  
Dented  
Between 10mm + 30mm

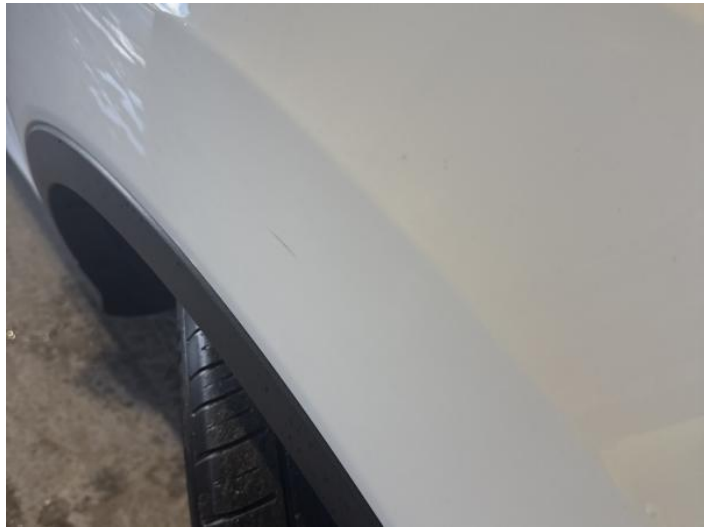
12: Wing osf  
Scratched  
UpTo 25mm Not Thru Paint

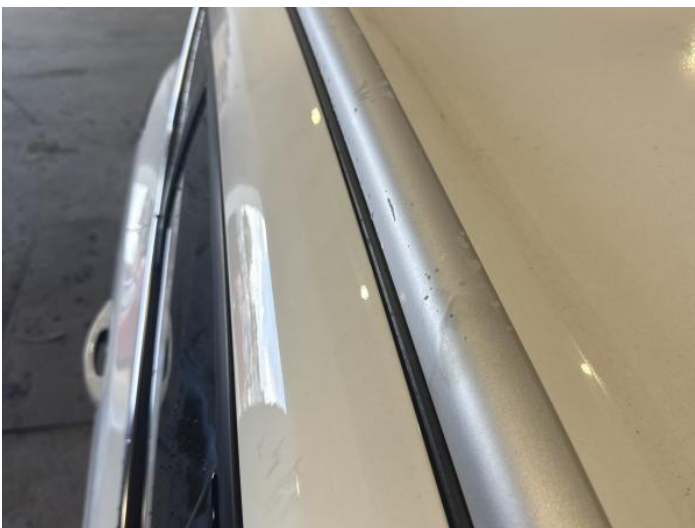
13: Roof  
Dented  
Over 30mm
