VEHICLE INSPECTION REPORT

NY68UGC

Abarth 595 1.4 T-Jet 145 3dr

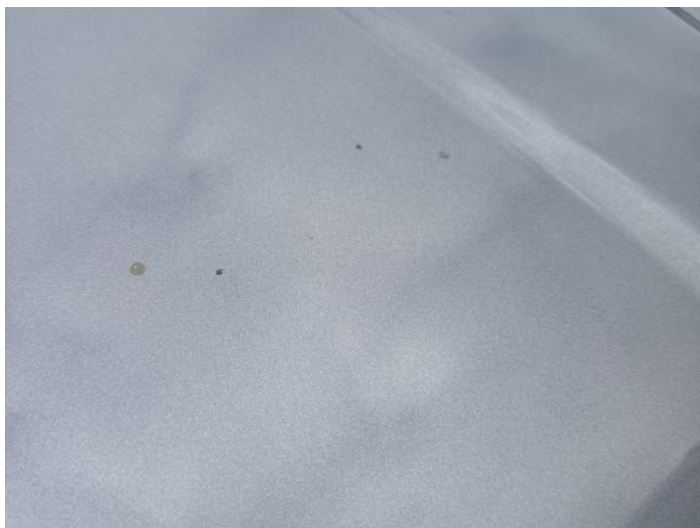
1: Bonnet
Chipped
1 To 5

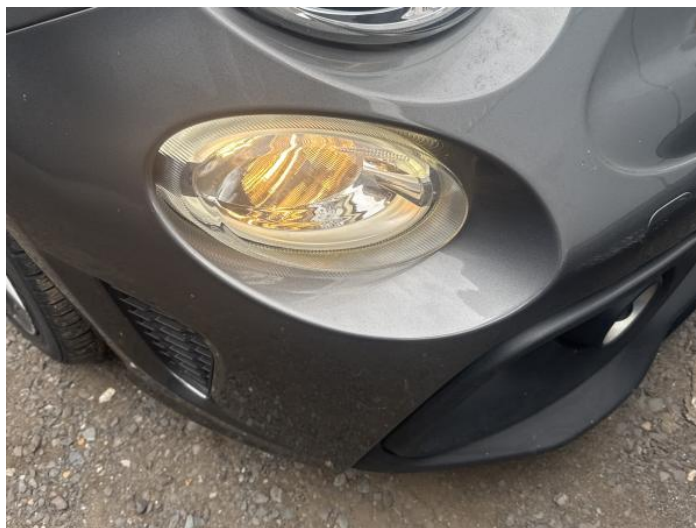
2: Bumper Front
Scratched
25 to 100mm Thru Paint

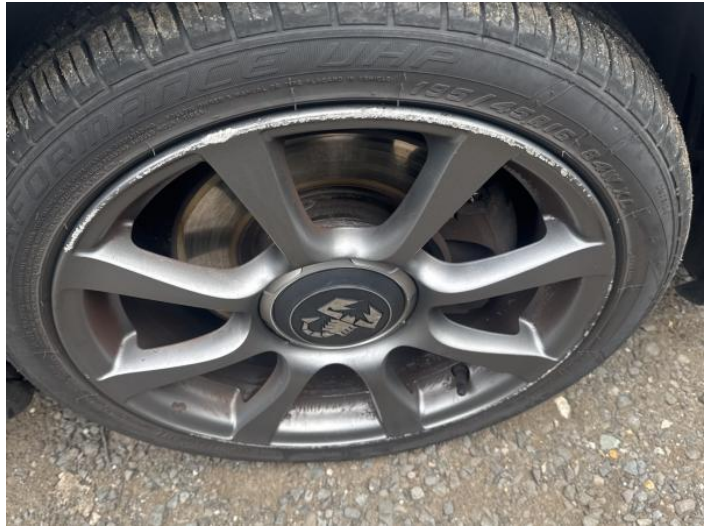
4: Wheel osf
Scratched
Over 50mm

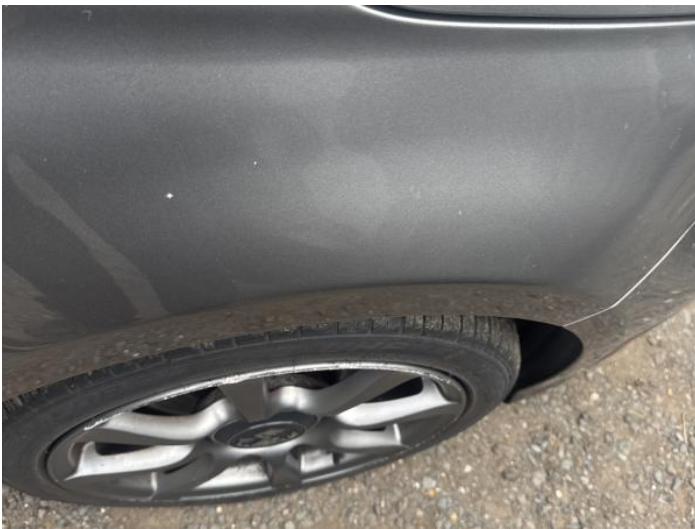
5: Wing osf
Poor Previous Repair
Poor Paint

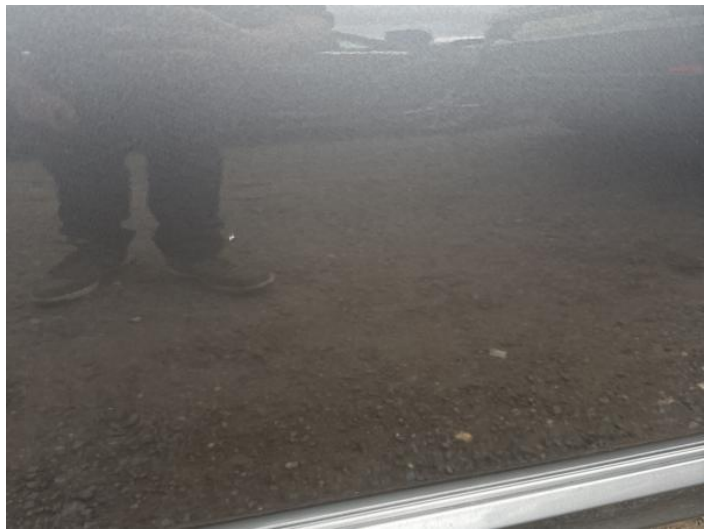
6: Door osf
Chipped
1 To 5

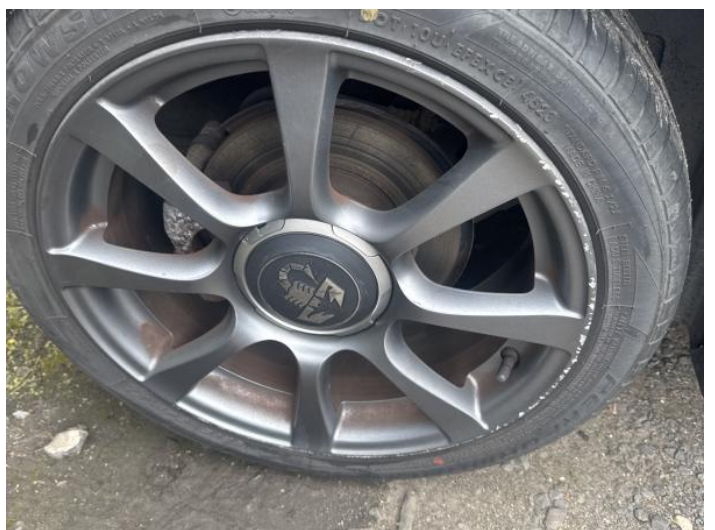
8: Wheel osr
Scratched
Over 50mm

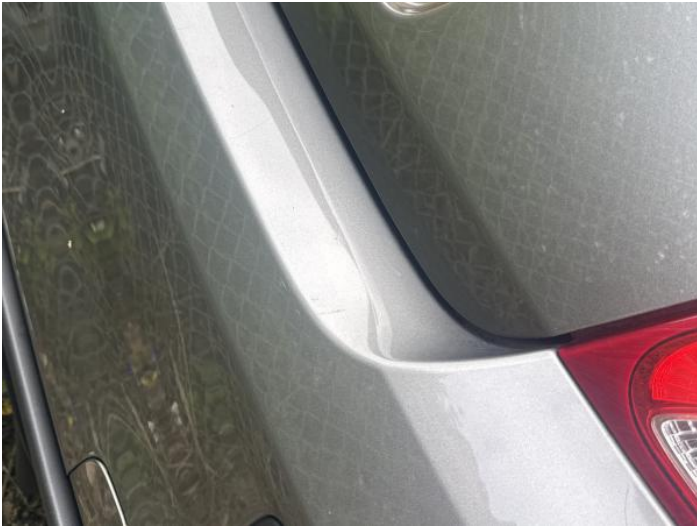
9: Bumper Rear
Chipped
Multiple Chips

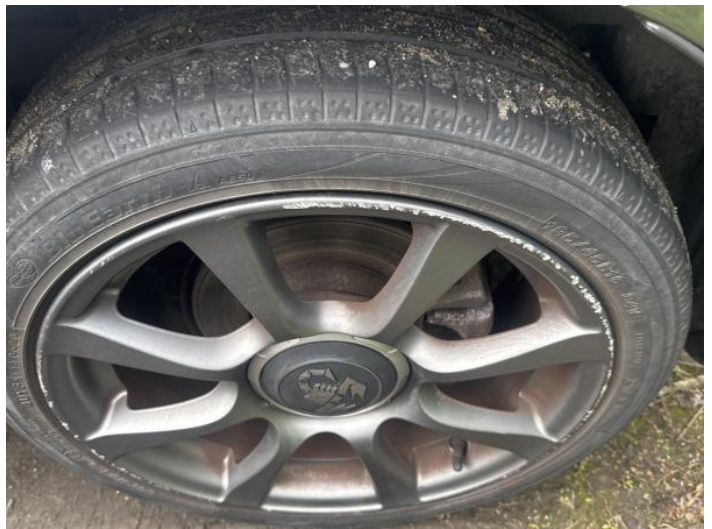
12: Wheel nsr
Scratched
Over 50mm

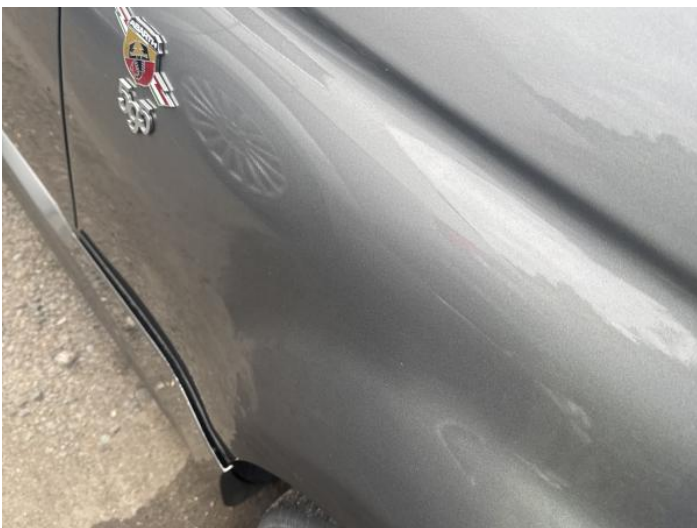
13: Qtr Panel nsr
Poor Previous Repair
Poor Paint

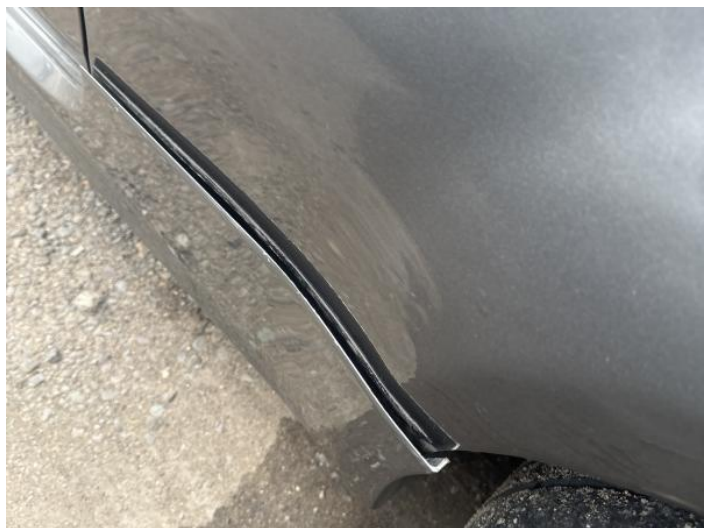
14: Sill Panel Trim ns
Broken
Replace

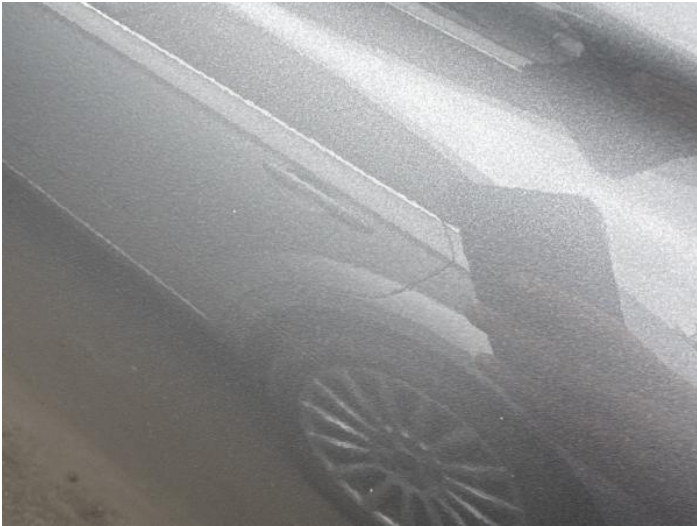
15: Door nsf
Chipped
1 To 5

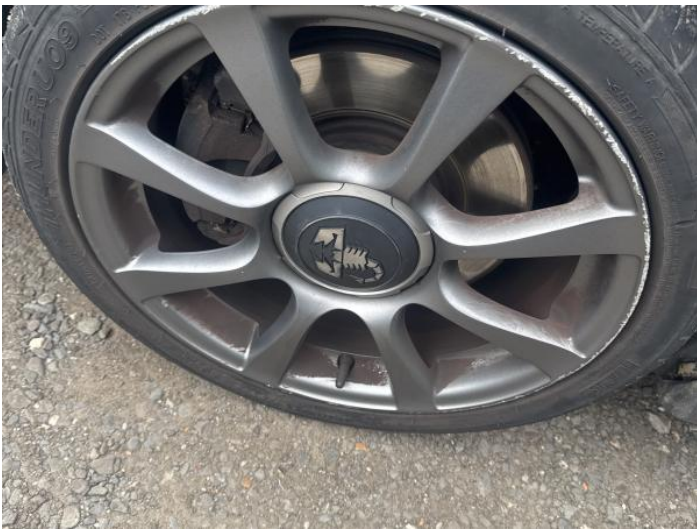
17: Wheel nsf
Scratched
Over 50mm
