# VEHICLE INSPECTION REPORT

**DG69ENH**

## Seat Leon 1.5 TSI EVO 150 FR Black Edition [EZ] 5dr DSG

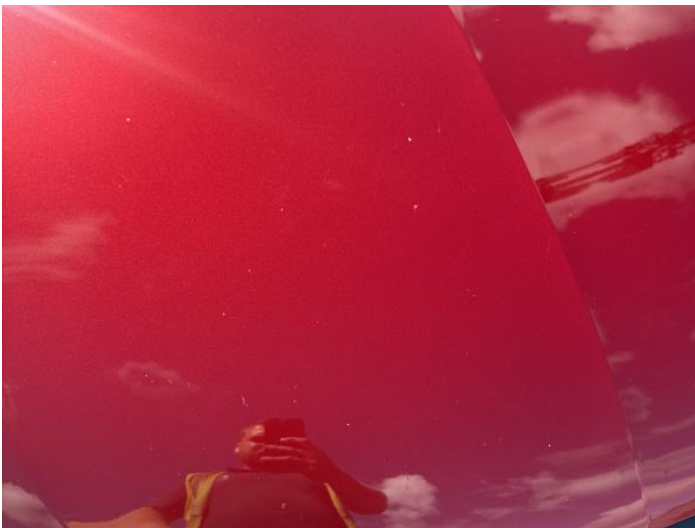
1: Bonnet  
Chipped  
Multiple Chips

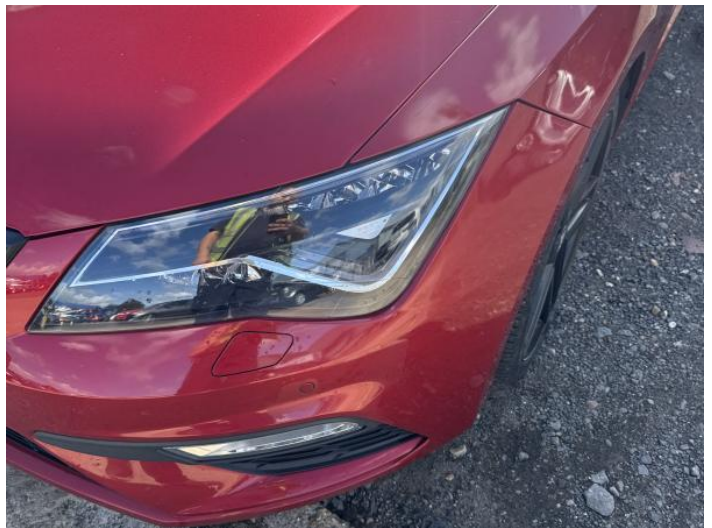
2: Bumper Front  
Poor Previous Repair  
Paint Flake

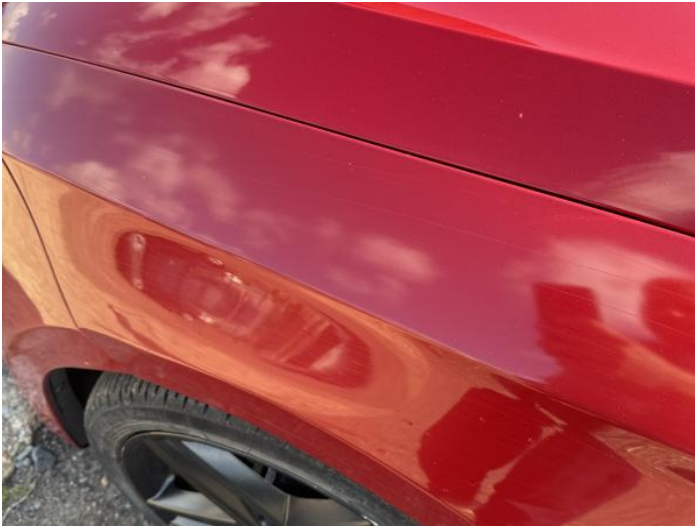
3: Wing nsf  
Poor Previous Repair  
Poor Paint

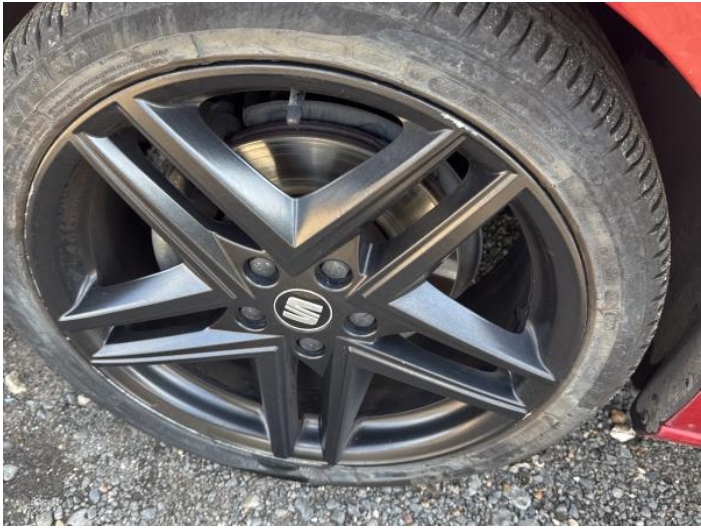
4: Wheel nsf  
Scratched  
Over 50mm

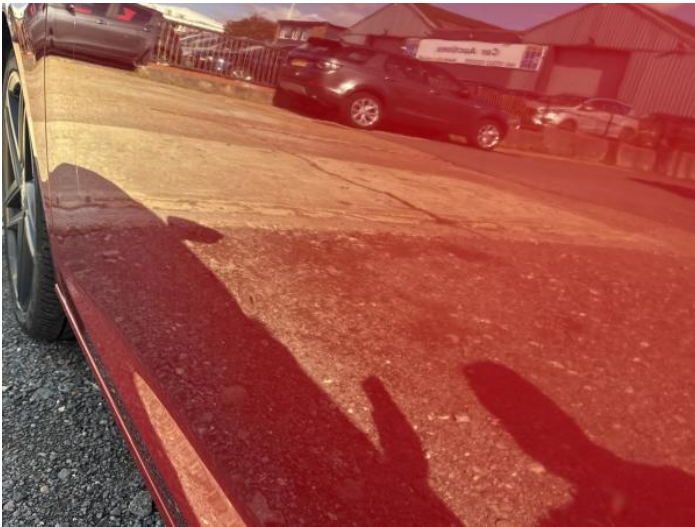
5: Door nsf  
Dented  
Over 2 UpTo 10mm

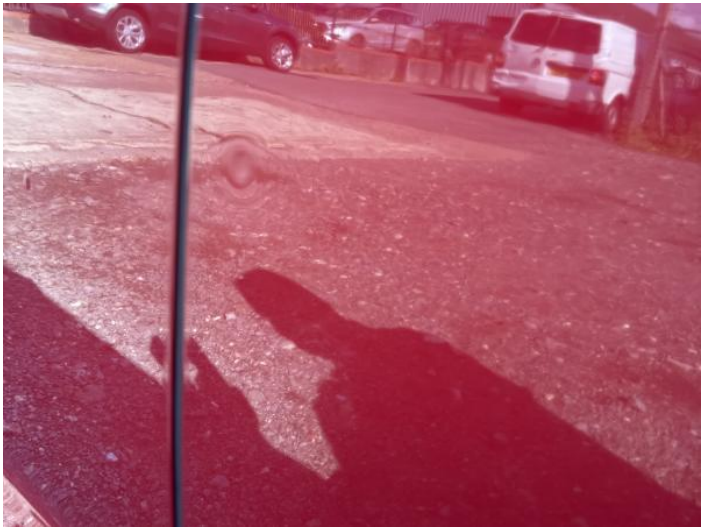
6: Door nsr  
Dented  
2 Or Less UpTo 10mm

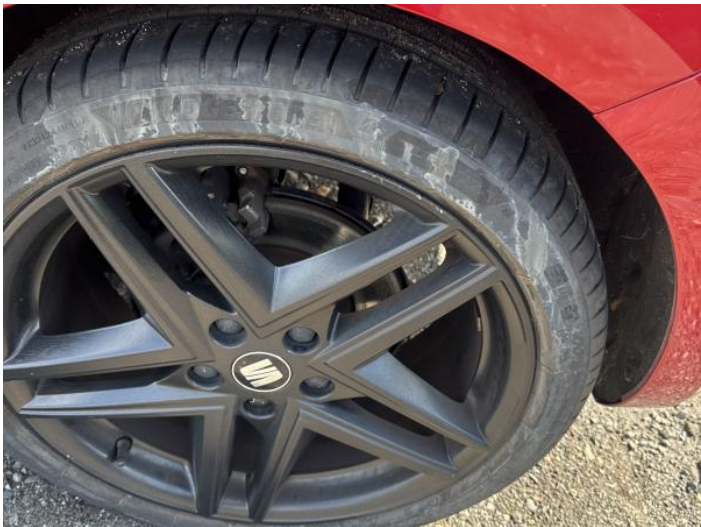
8: Wheel nsr  
Scratched  
Up To 50mm

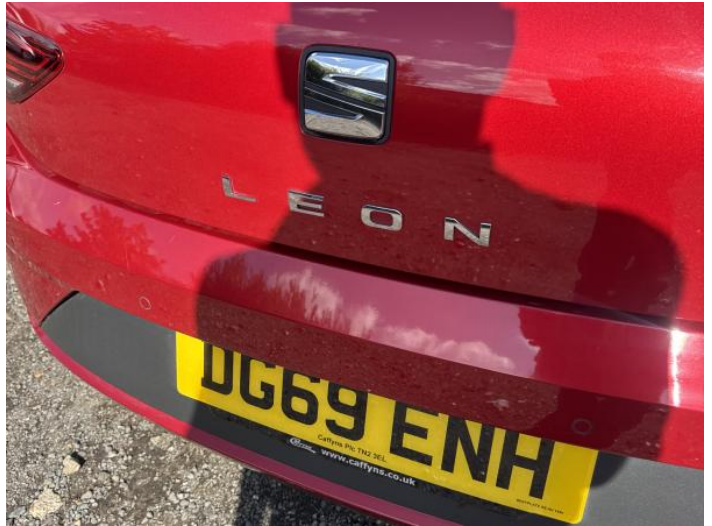
10: Bumper Rear  
Scratched  
25 to 100mm Thru Paint

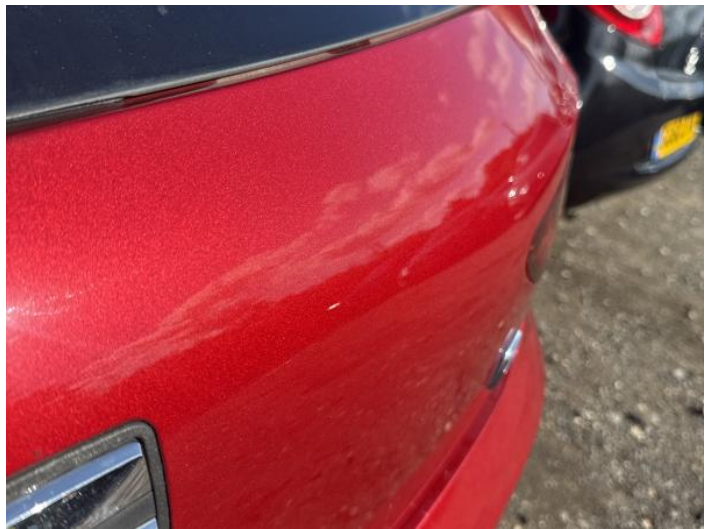
12: Boot Lid  
Dented  
Over 2 UpTo 10mm

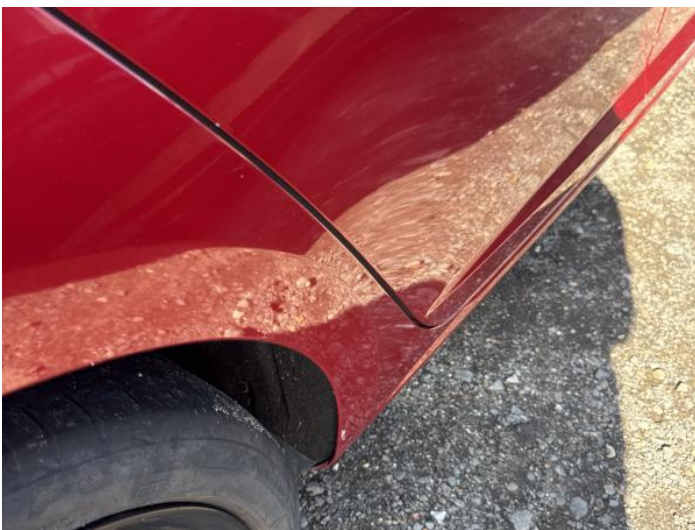
13: Qtr Panel osr  
Scratched  
UpTo 25mm Thru Paint

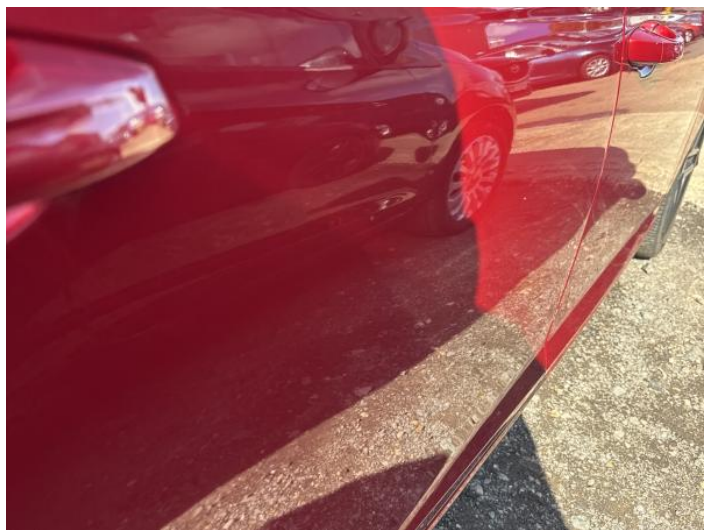
14: Door osr  
Chipped  
1 To 5

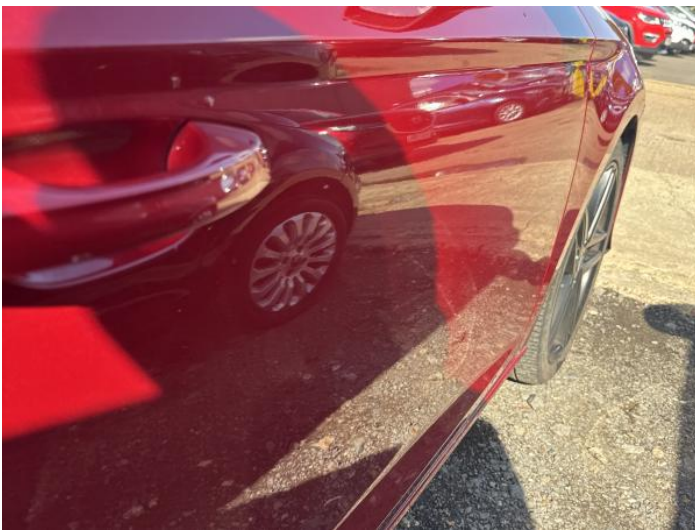
16: Door osr  
Scratched  
Over 25mm Not Thru Paint

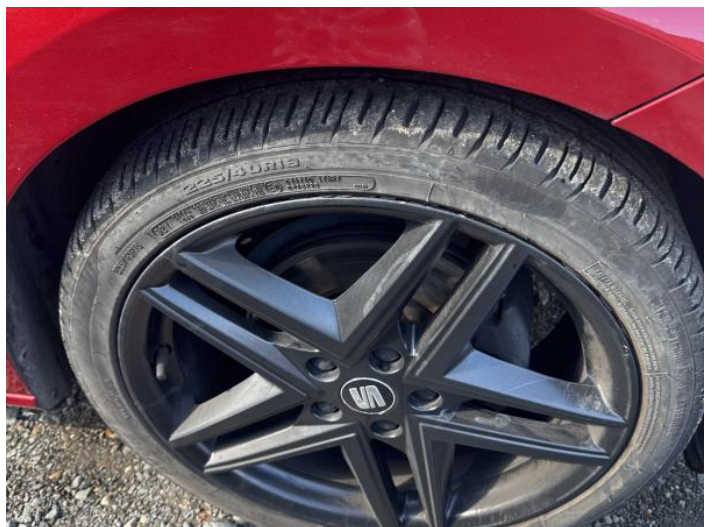
19: Wing osf  
Chipped  
1 To 5
