VEHICLE INSPECTION REPORT

KN15ZHZ

Mercedes-Benz C Class C200 Sport 4dr Auto

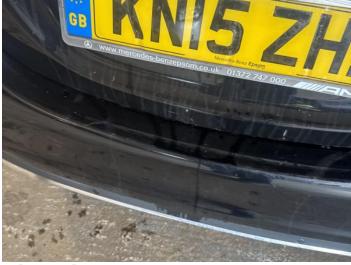
1: Bumper Rear Poor Previous Repair Poor Paint

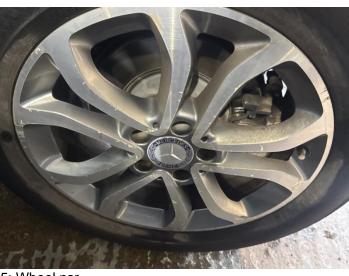
5: Wheel nsr Scratched Over 50mm

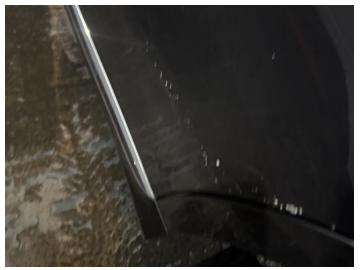
6: Door nsr Scratched Over 25mm Thru Paint

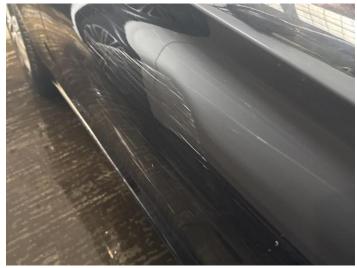
7: Door nsf Dented With Paint Damage

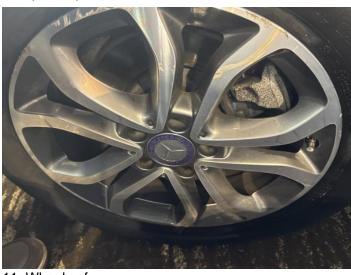
11: Wheel nsf Scratched Over 50mm

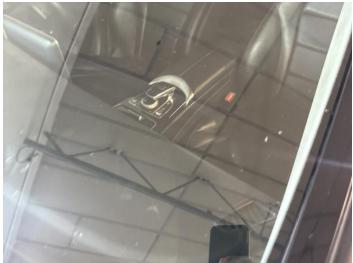
10: Screen Front Chipped UpTo 10mm

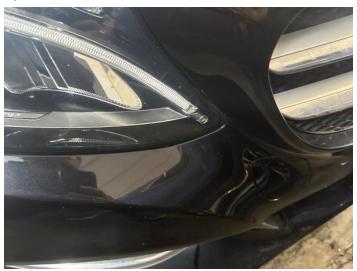
12: Bumper Front Poor Previous Repair Poor Paint

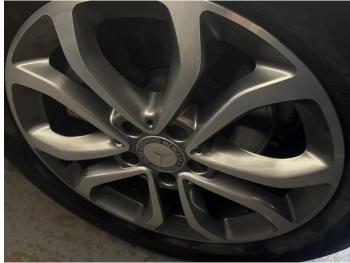
13: Wheel osf Scratched Over 50mm

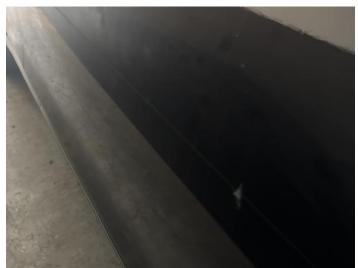
14: Door osf Chipped Multiple Chips

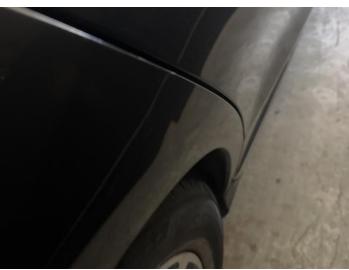
16: Qtr Panel osr Dented 2 Or Less UpTo 10mm

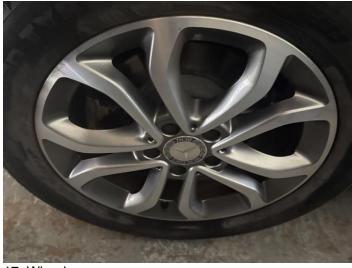
17: Wheel osr Scratched Over 50mm 18: Tyre nsf Worn Replace
