VEHICLE INSPECTION REPORT

LE16PFG

Mercedes-Benz C Class C220d Sport Premium 5dr Auto

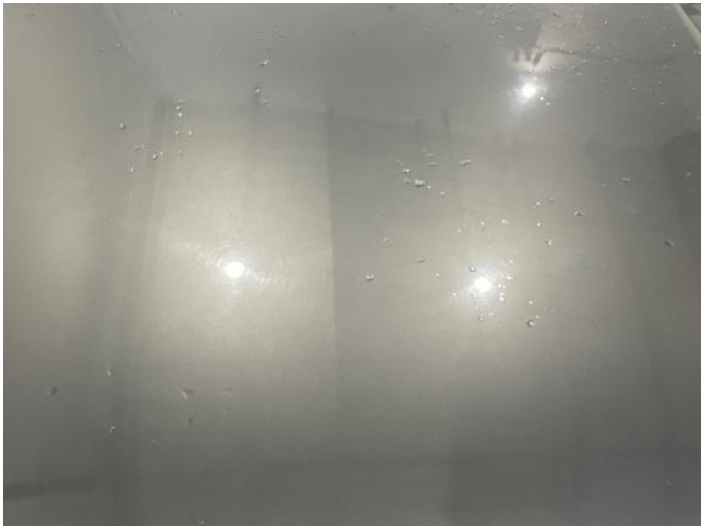
2: Bonnet
Chipped
1 To 5

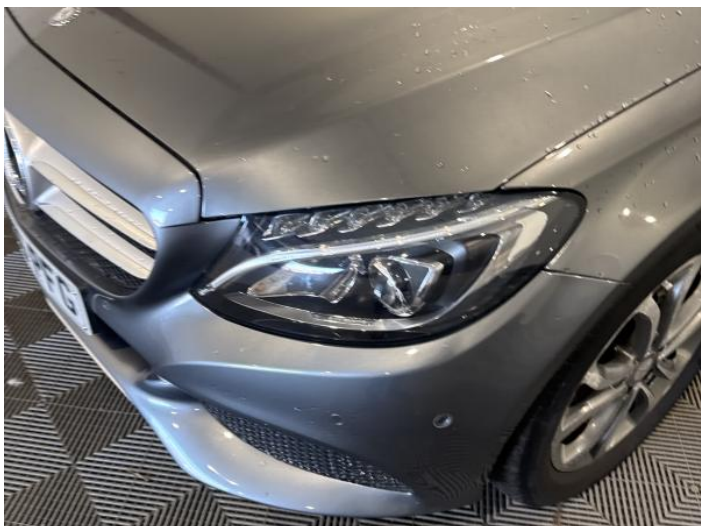
3: Bumper Front
Chipped
Multiple Chips

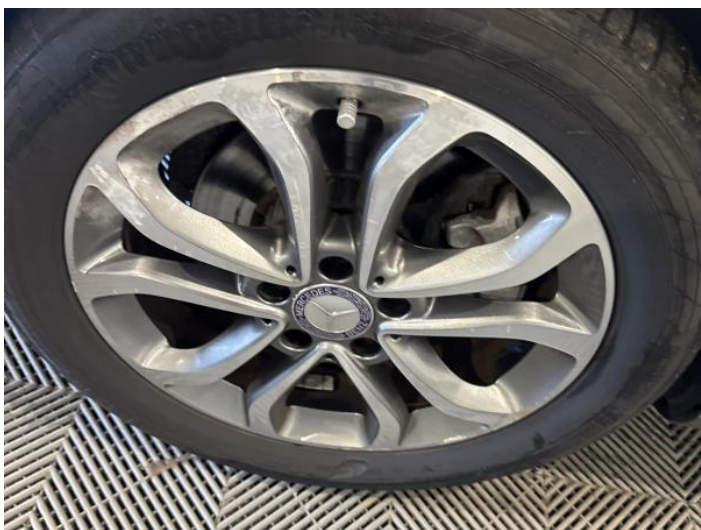
5: Wheel nsf
Scratched
Over 50mm

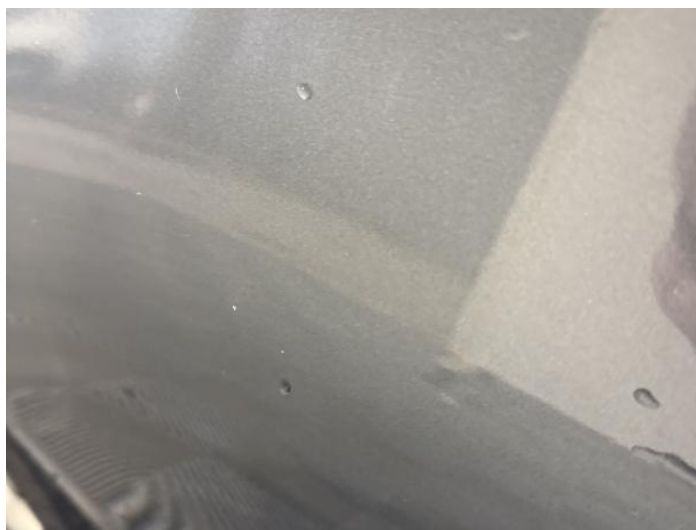
6: Wing nsf
Dented
Over 2 UpTo 10mm

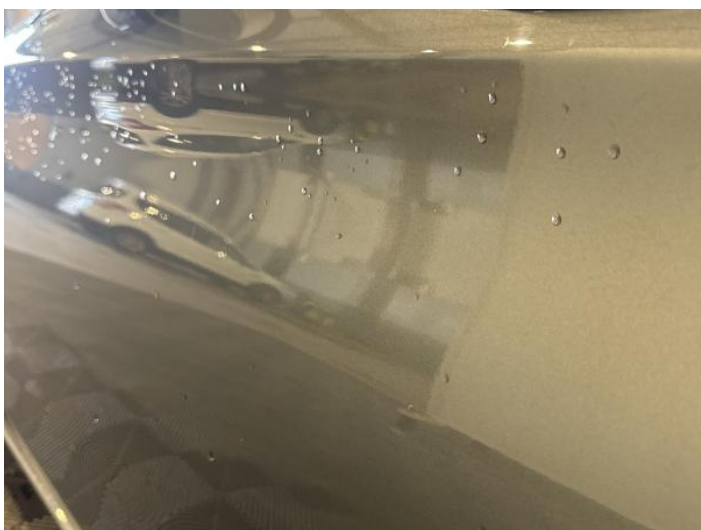
7: Door nsf
Chipped
1 To 5

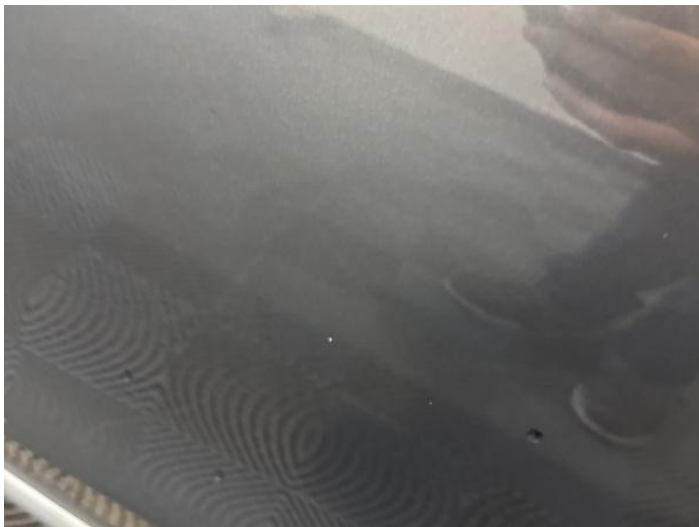
9: Door nsr
Chipped
1 To 5

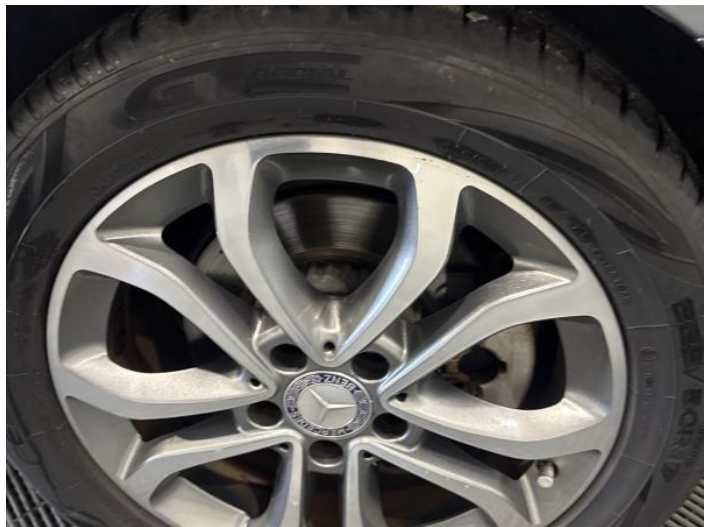
10: Wheel nsr
Scratched
Up To 50mm

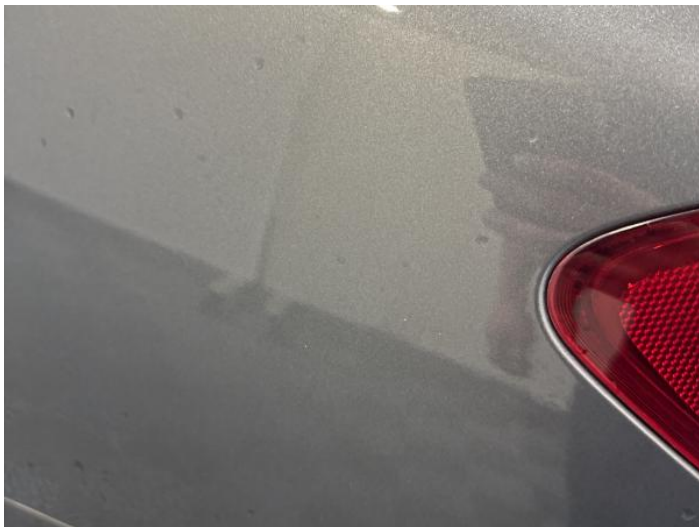
11: Qtr Panel nsr
Chipped
1 To 5

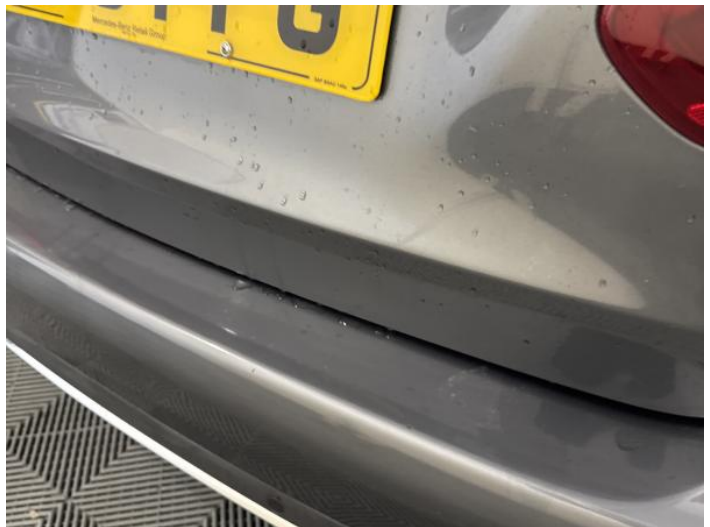
12: Bumper Rear
Chipped
Multiple Chips

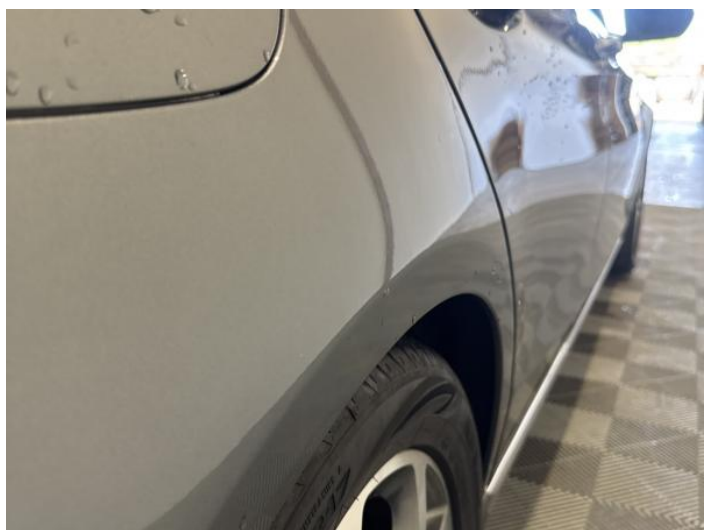
14: Qtr Panel osr
Poor Previous Repair
Poor Paint

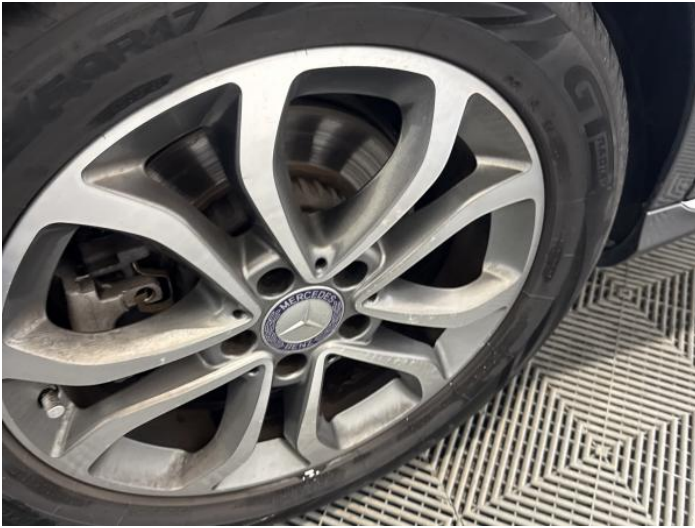
15: Wheel osr
Scratched
Over 50mm

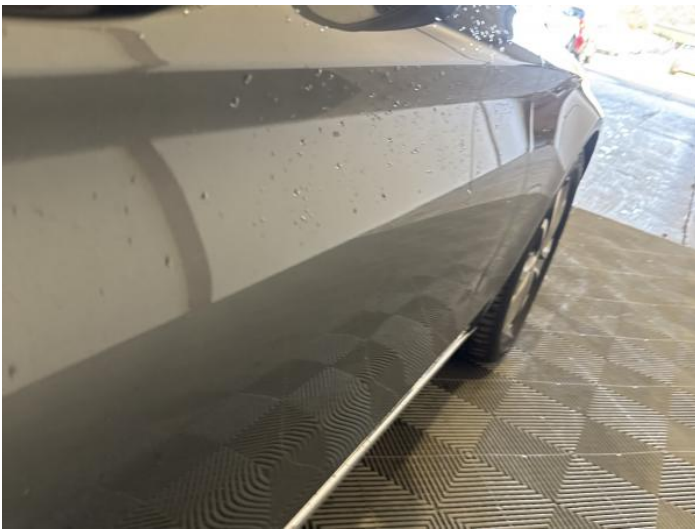
17: Door osf
Dented
Over 30mm

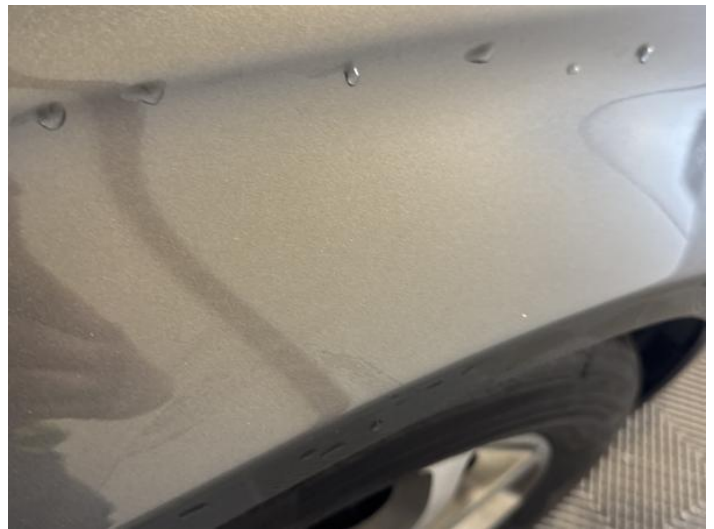
18: Wing osf
Chipped
1 To 5

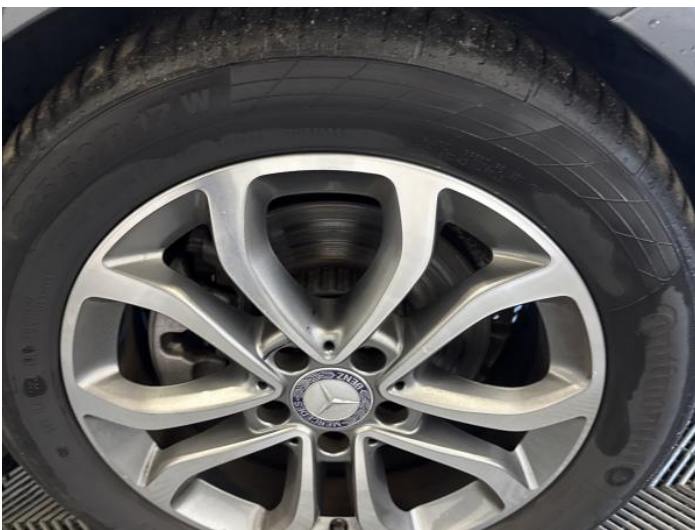
19: Wheel osf
Scratched
Up To 50mm

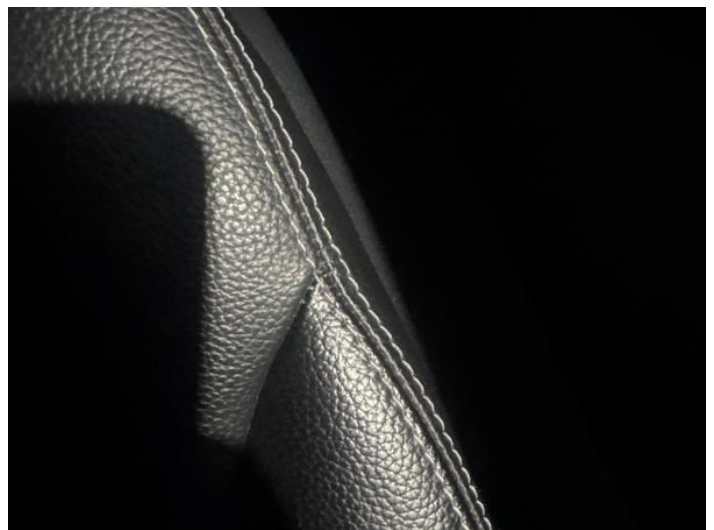
20: Seat Base Cover osf
Torn
UpTo 3mm
