VEHICLE INSPECTION REPORT

FM17BUU

Kia Sportage 1.7 CRDi ISG 2 5dr DCT Auto

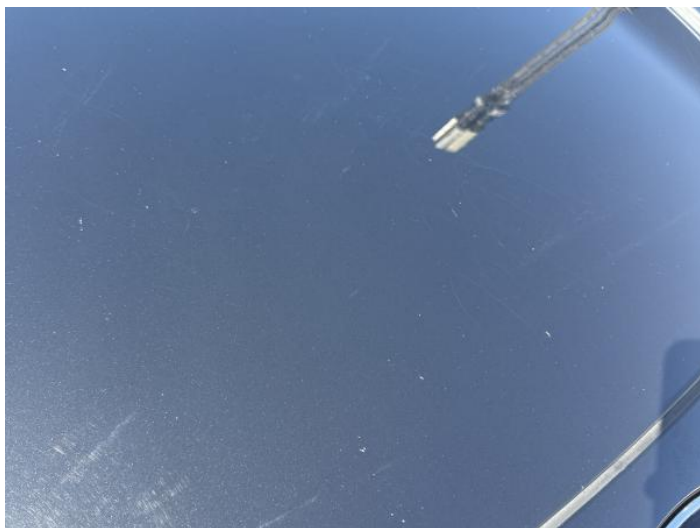
1: Bonnet  
Chipped  
Multiple Chips

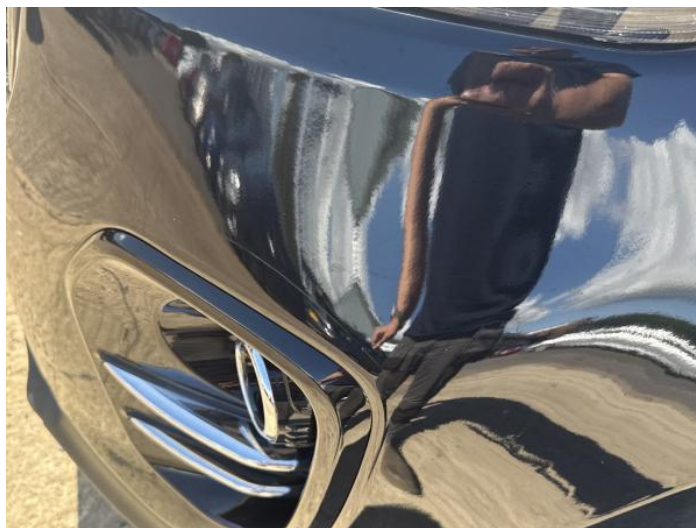
2: Bumper Front  
Scratched  
Over 100mm Thru Paint

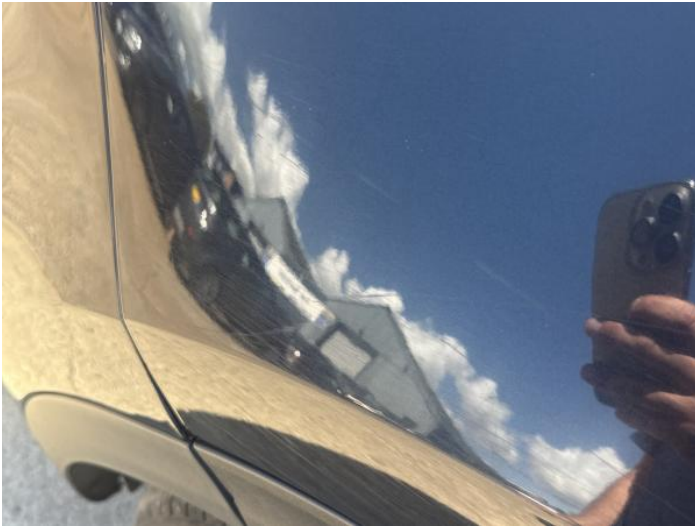
3: Wing nsf  
Scratched  
Over 25mm Thru Paint

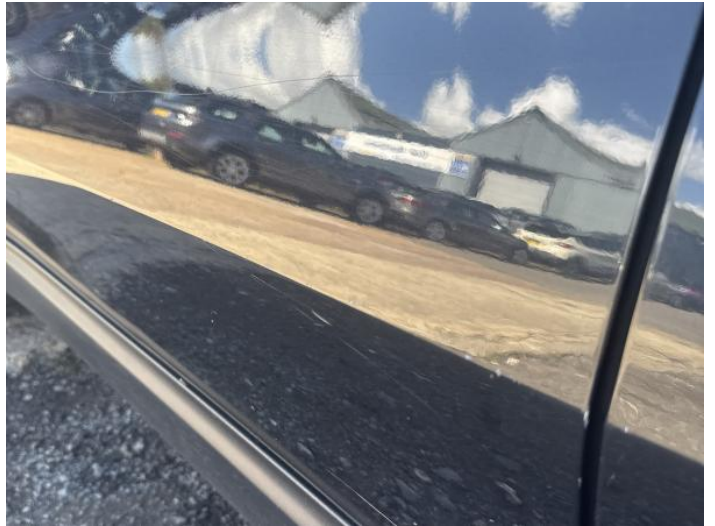
4: Door nsf  
Scratched  
Over 25mm Thru Paint

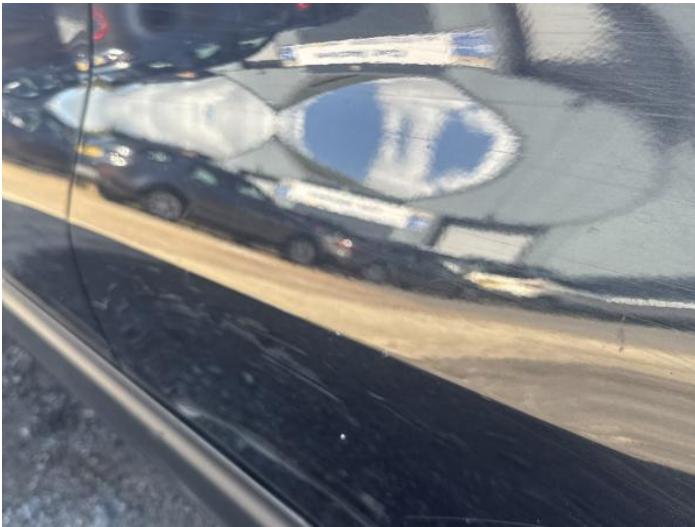
5: Door nsr  
Dented  
With Paint Damage

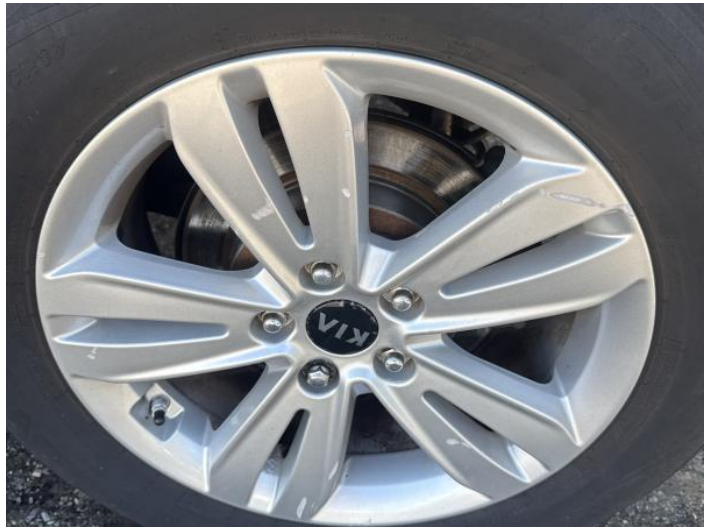
6: Wheel nsr  
Scratched  
Over 50mm

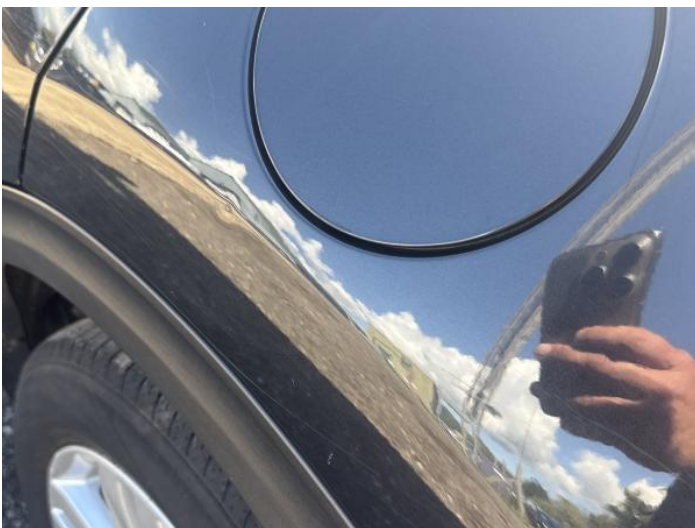
7: Qtr Panel nsr  
Dented  
With Paint Damage

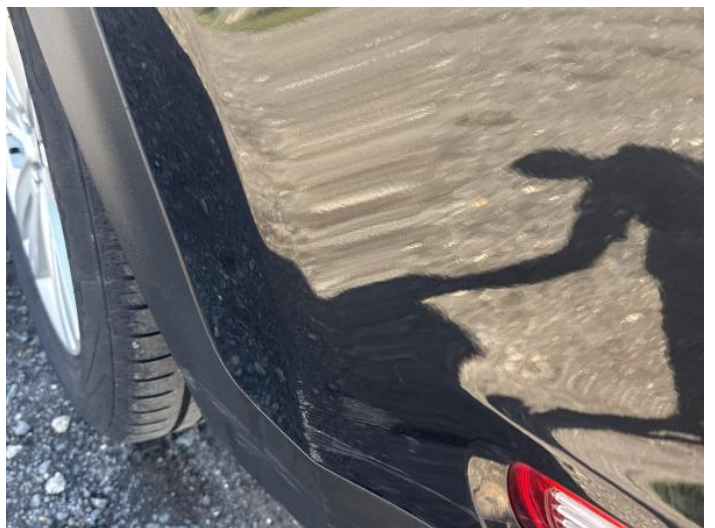
8: Bumper Rear  
Scratched  
Over 100mm Thru Paint

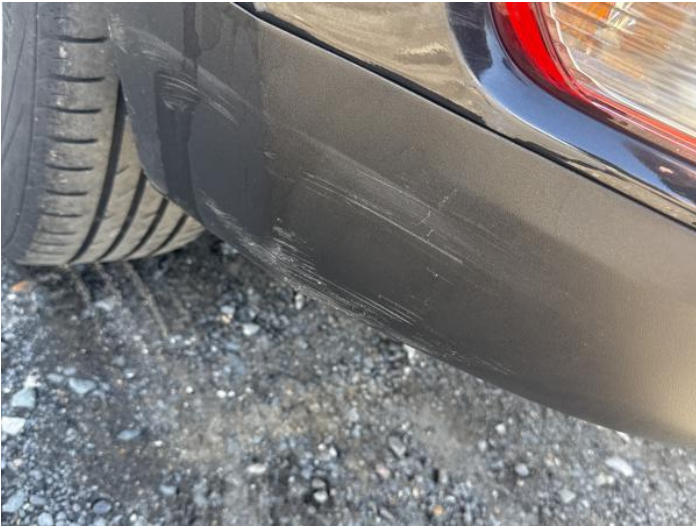
9: Bumper Rear Moulding  
Scuffed (Unpainted)  
Over 100mm

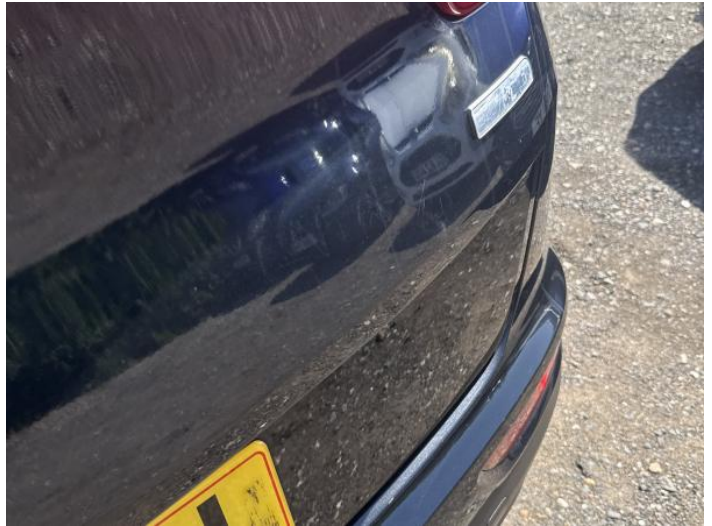
10: Tailgate  
Scratched  
Over 25mm Thru Paint

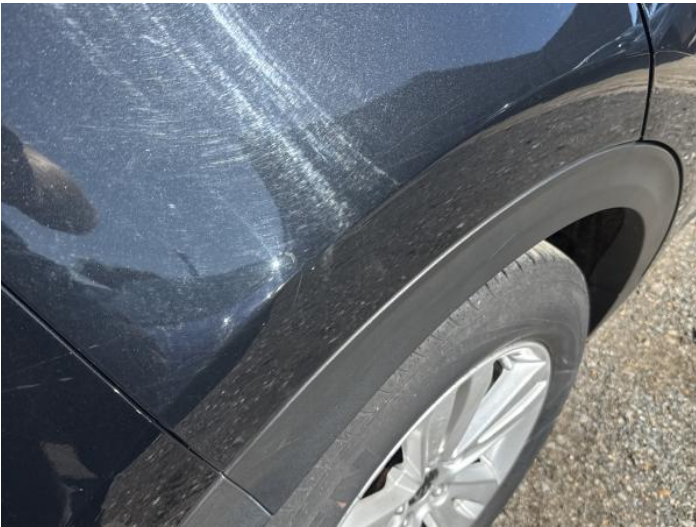
11: Qtr Panel osr  
Scratched  
Over 25mm Thru Paint

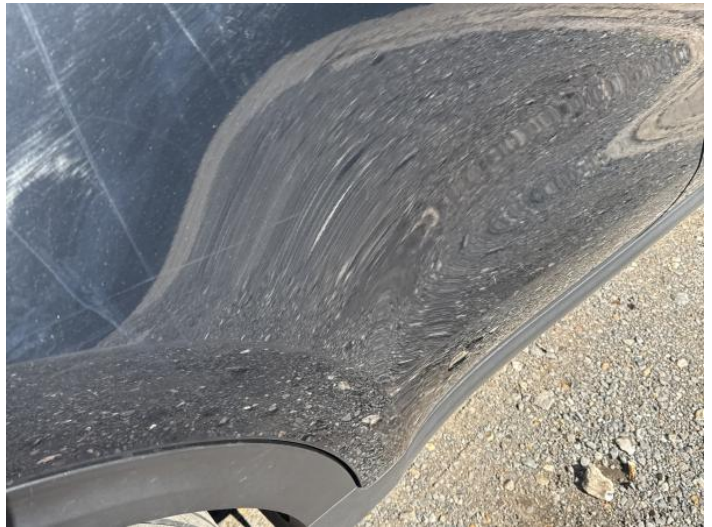
12: Door osr  
Scratched  
Over 25mm Thru Paint

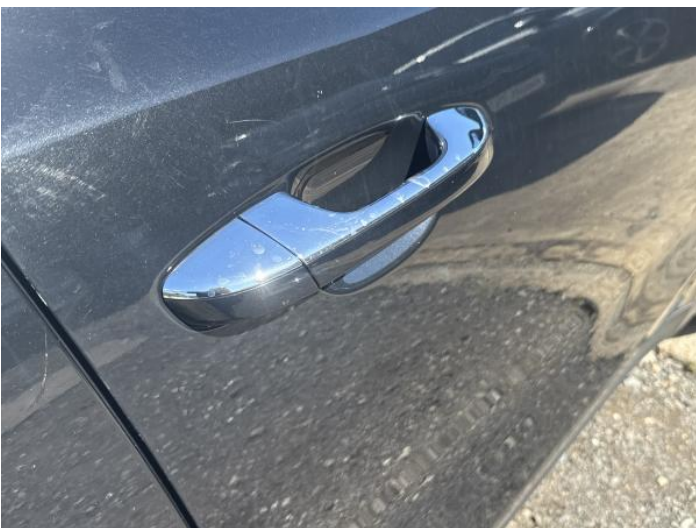
13: Door osf  
Scratched  
Over 25mm Thru Paint

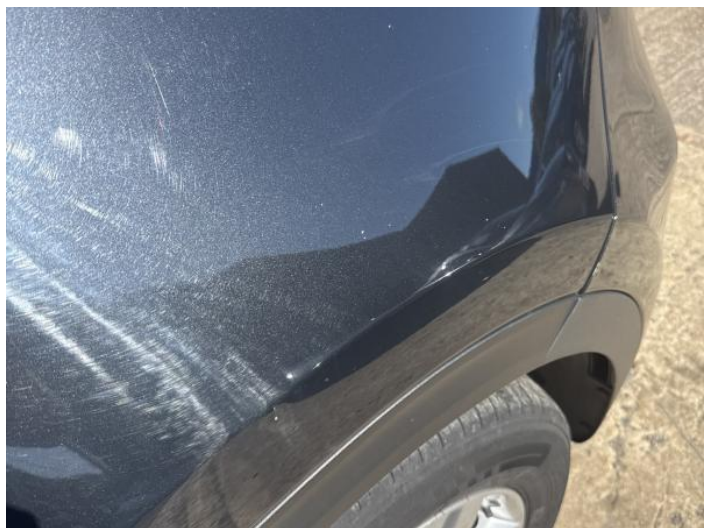
14: Wing osf  
Chipped  
Multiple Chips

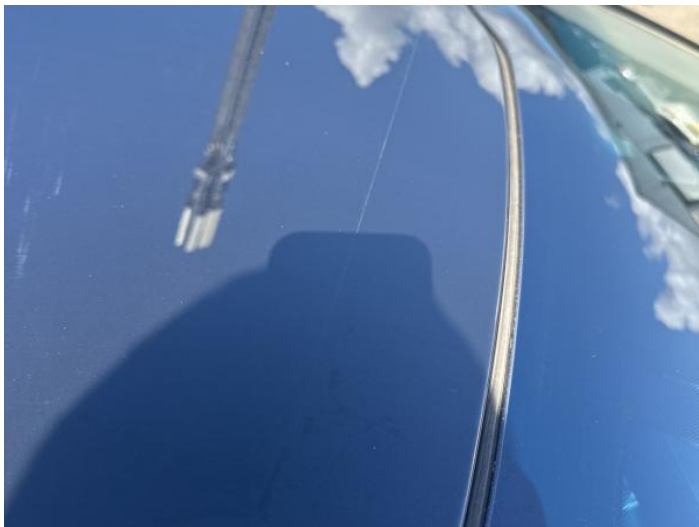
15: Roof  
 Scratched  
 Over 25mm Thru Paint
