VEHICLE INSPECTION REPORT

DF16FME

Renault Captur 1.5 dCi 90 Dynamique S Nav 5dr

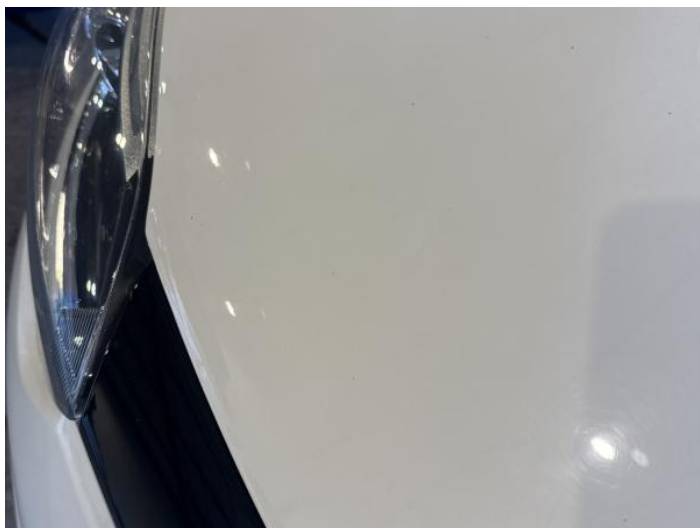
1: Bonnet
Chipped
1 To 5

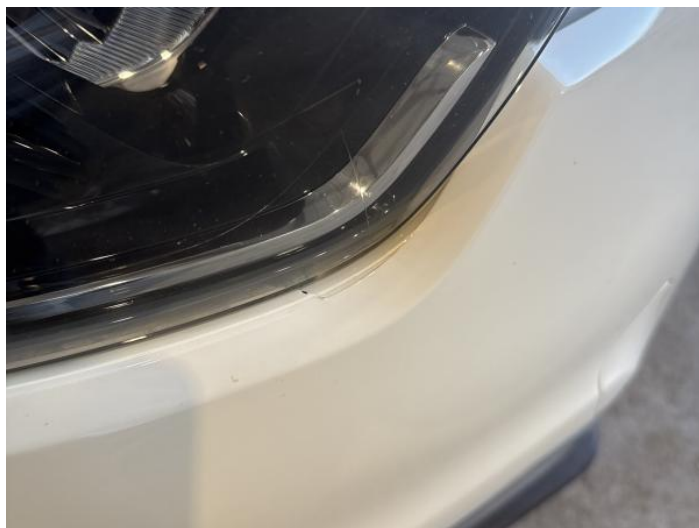
2: Bumper Front
Cracked
UpTo 25mm

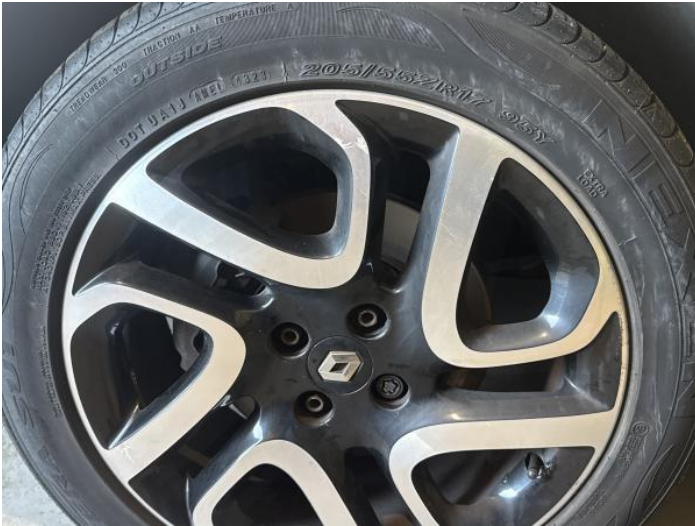
3: Wheel nsf
Scratched
Over 50mm

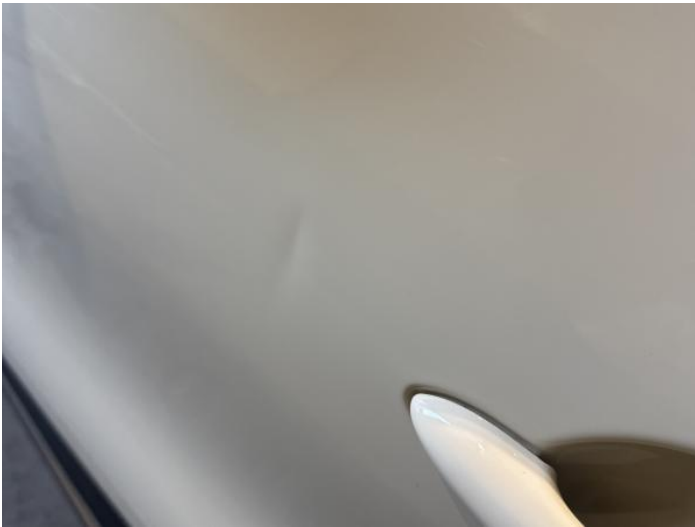
5: Door nsf
Dented
Over 30mm

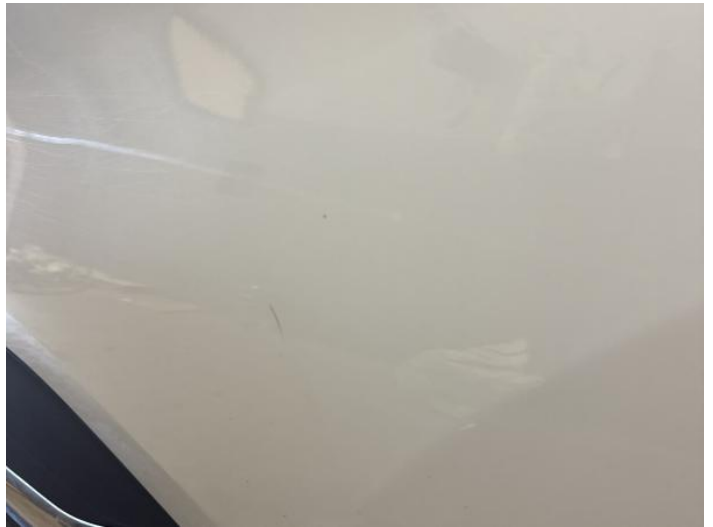
6: Door nsr
Scratched
Over 25mm Thru Paint

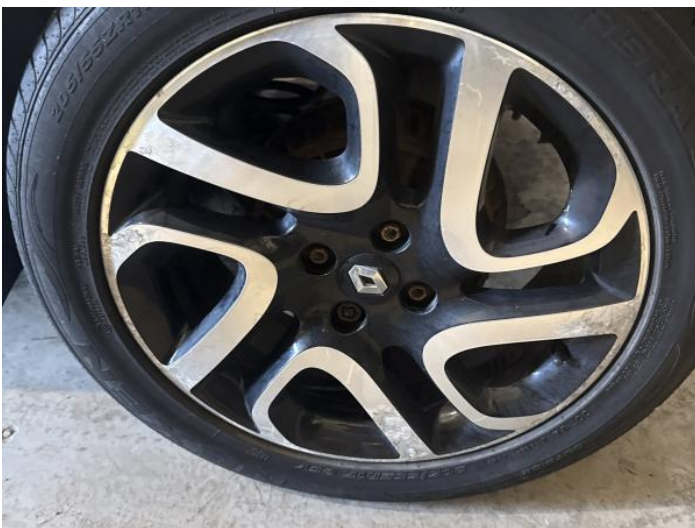
7: Wheel nsr
Scratched
Over 50mm

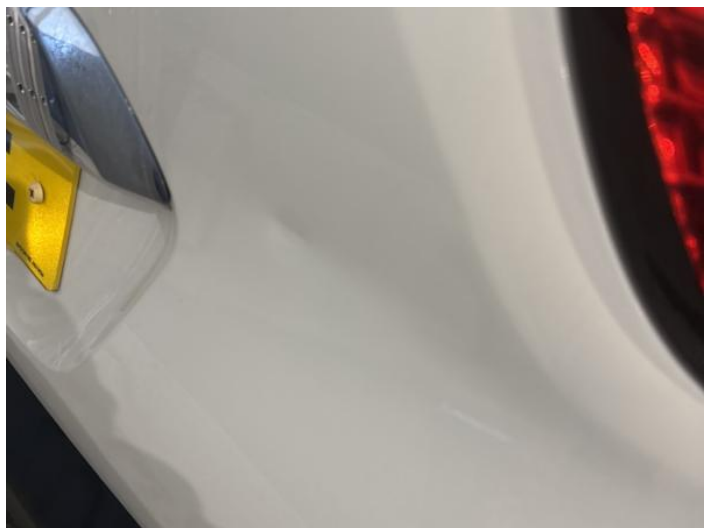
8: Tailgate
Dented
Between 10mm + 30mm

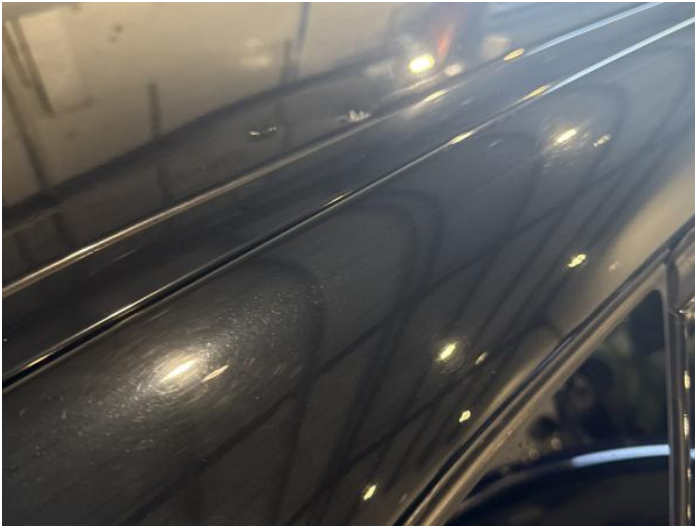
9: Roof
Dented
Over 30mm

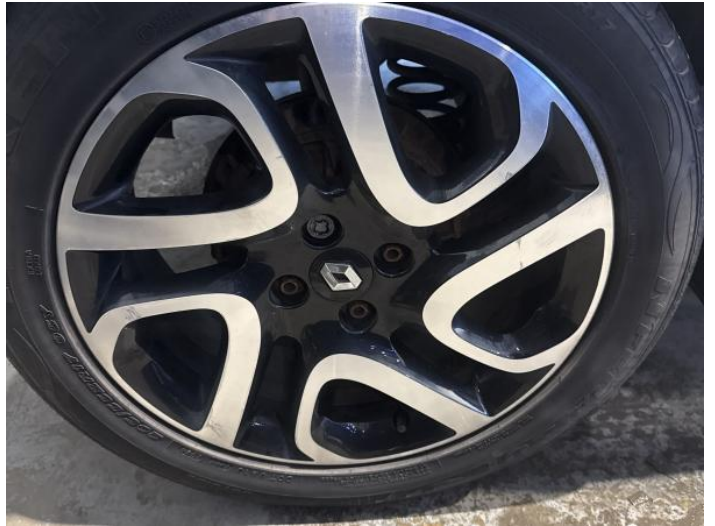
10: Wheel osr
Scratched
Over 50mm

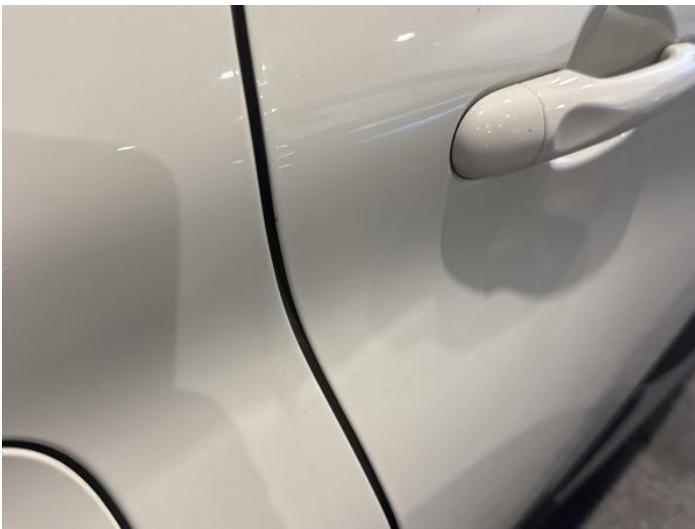
11: Door osr
Chipped
Edge Chip

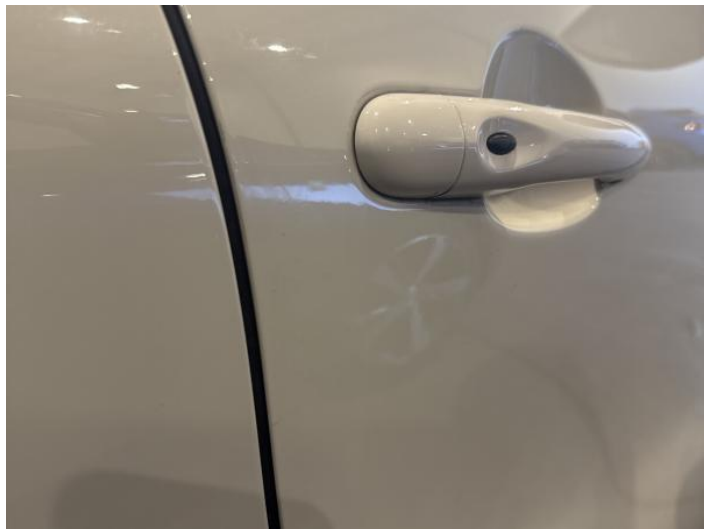
12: Door osf
Scratched
UpTo 25mm Thru Paint

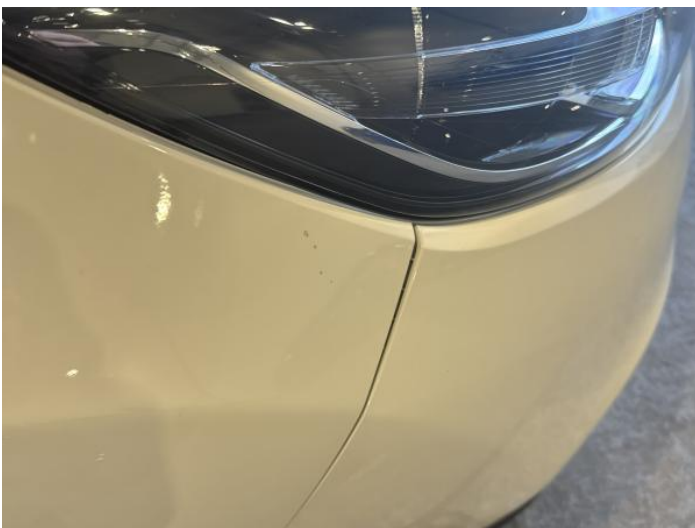
13: Wing osf
Chipped
1 To 5

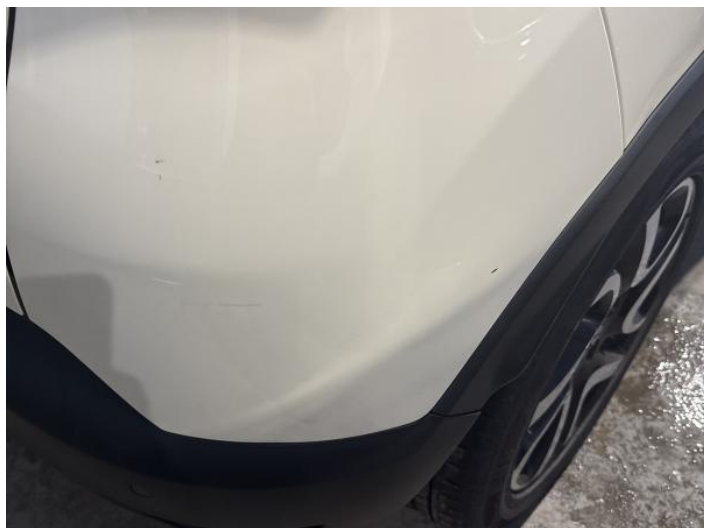
14: Bumper Rear
Scratched
25 to 100mm Thru Paint

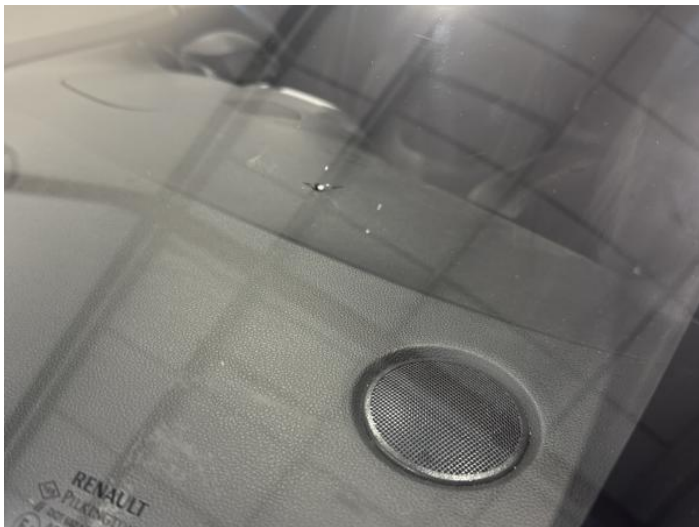
15: Screen Front
Chipped
Over 10mm
