VEHICLE INSPECTION REPORT

WU12KWZ

Ford Mondeo 2.0 TDCi 140 Edge 5dr

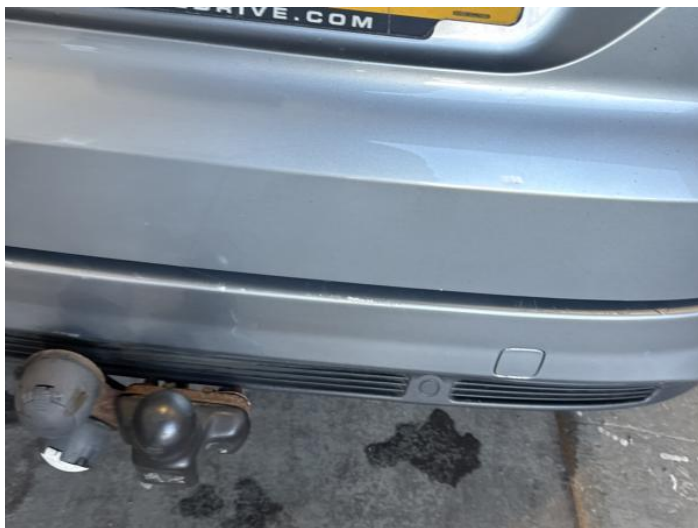
1: Bumper Rear
Scratched
Over 100mm Thru Paint

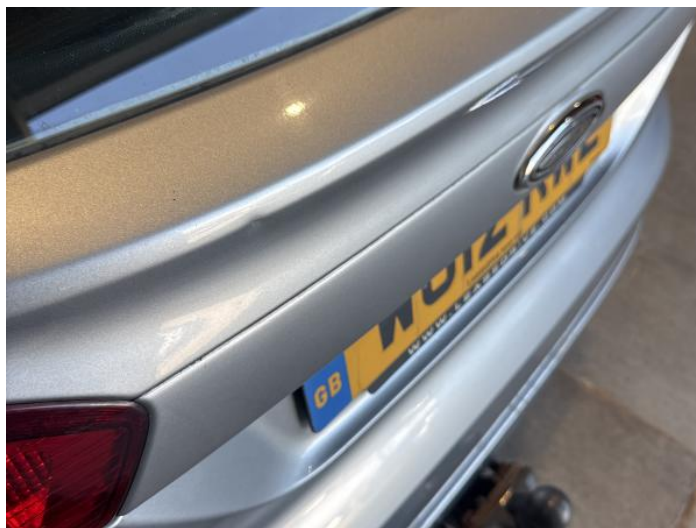
2: Boot Lid
Dented
With Paint Damage

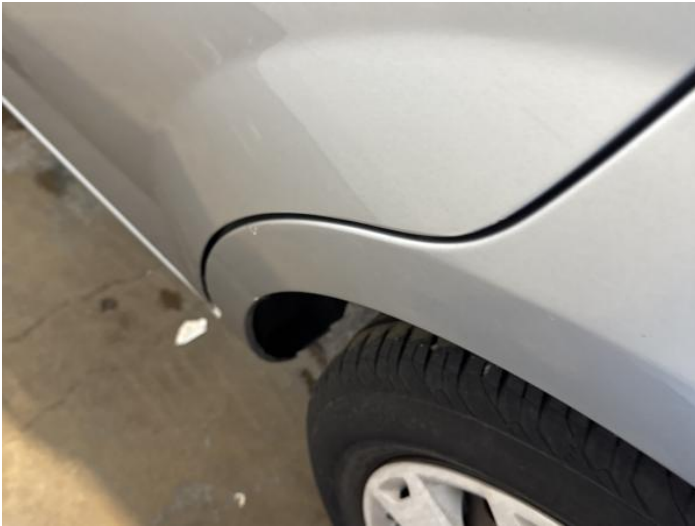
3: Qtr Panel nsr
Dented
With Paint Damage

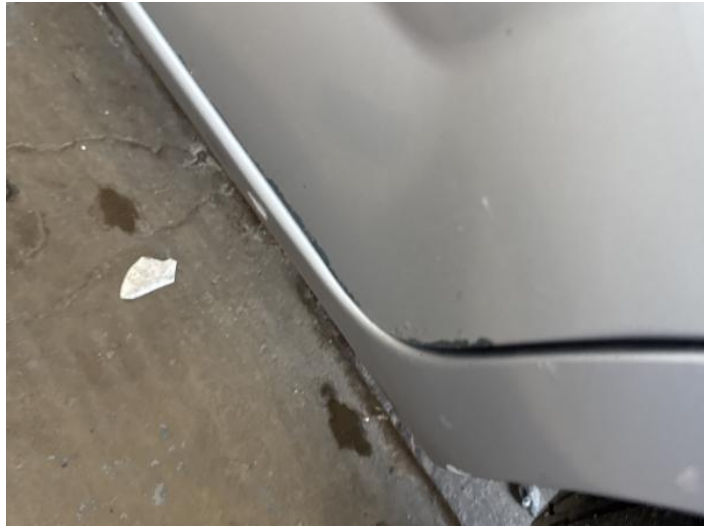
4: Door nsr
Rusted
Over 5mm

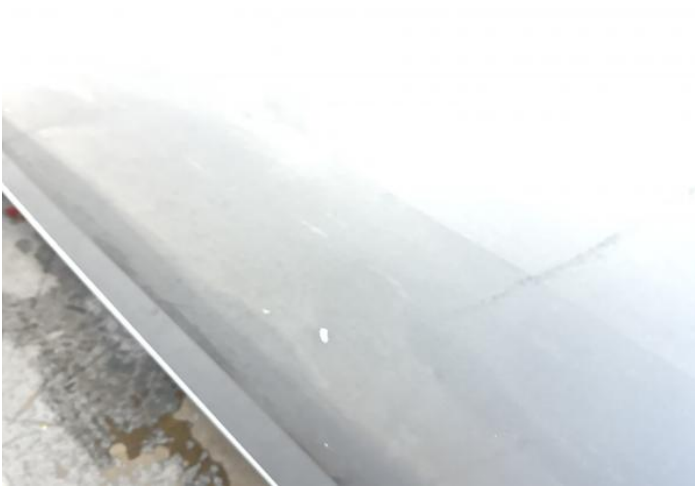
5: Door nsf
Dented
With Paint Damage

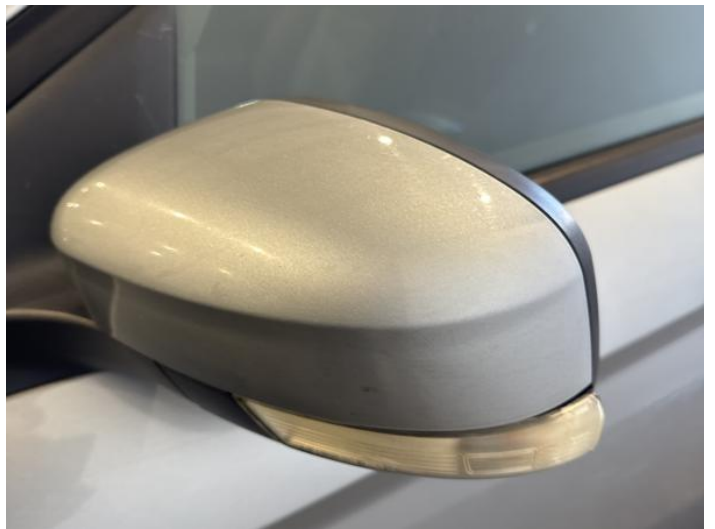
6: Door Mirror Assy nsf
Broken
Replace

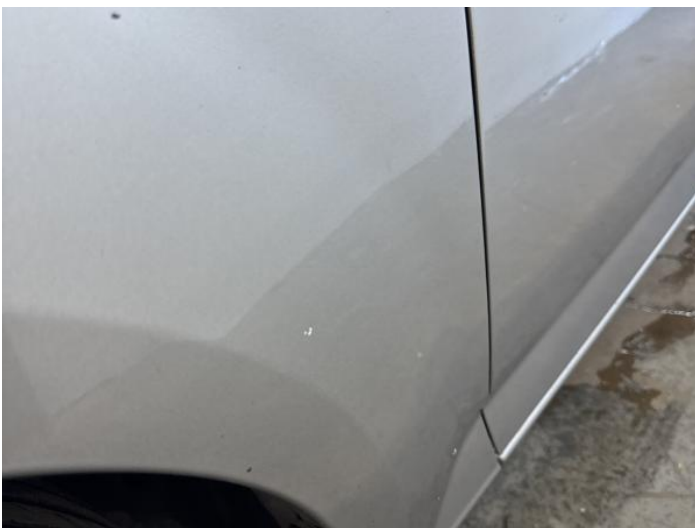
7: Wing nsf
Poor Previous Repair
Poor Paint

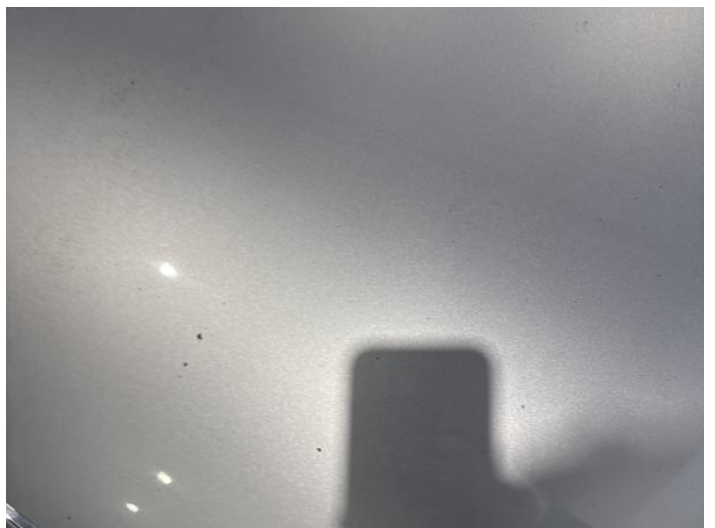
8: Bonnet
Chipped
Multiple Chips

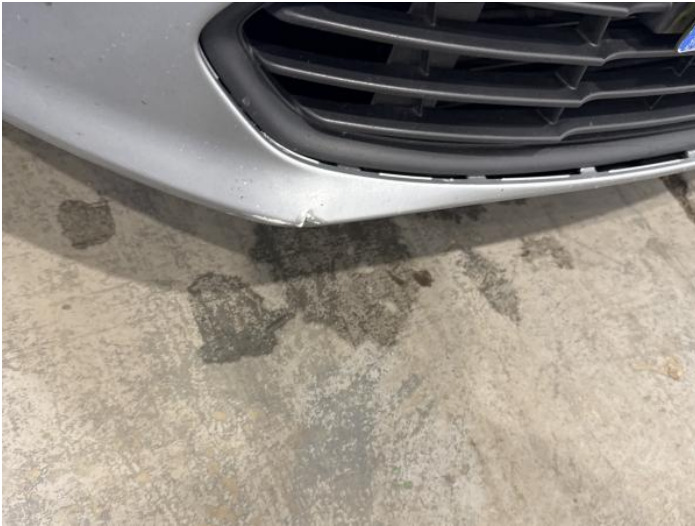
9: Bumper Front
Cracked
UpTo 25mm

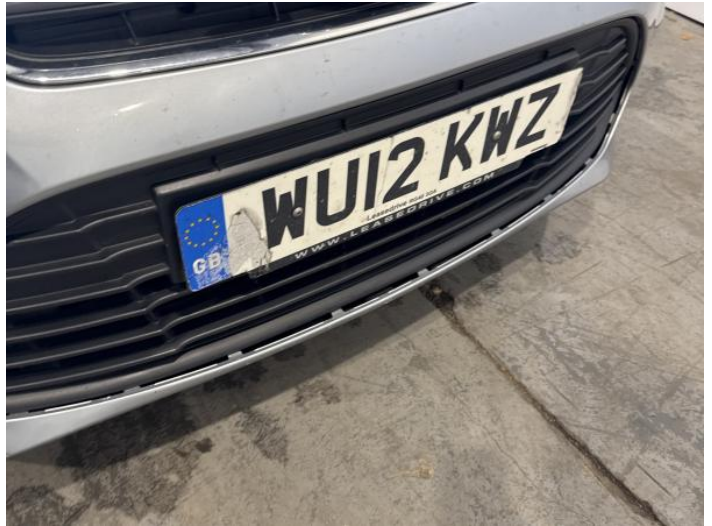
10: Bumper Front Grill
Broken
Replace

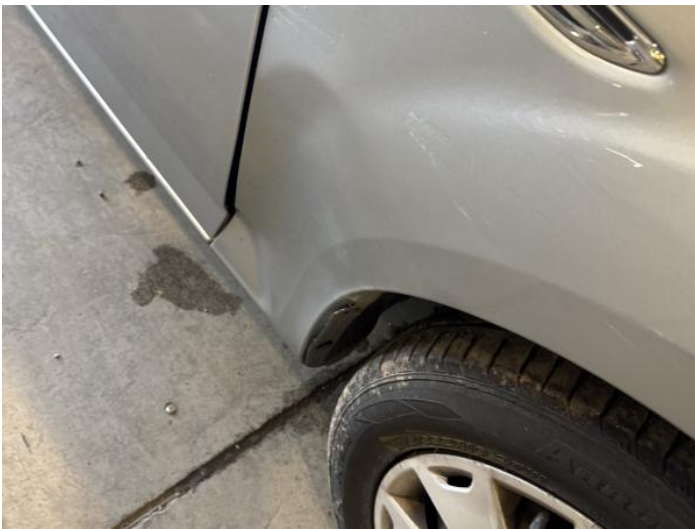
11: Wing osf
Dented
With Paint Damage

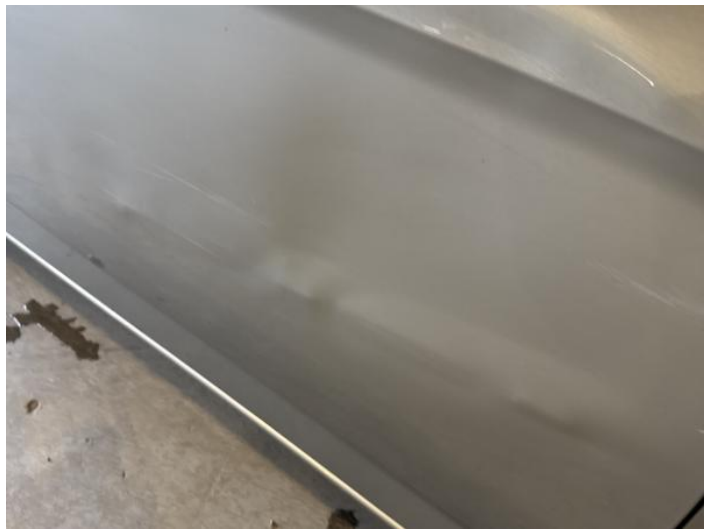
12: Door osf
Dented
With Paint Damage

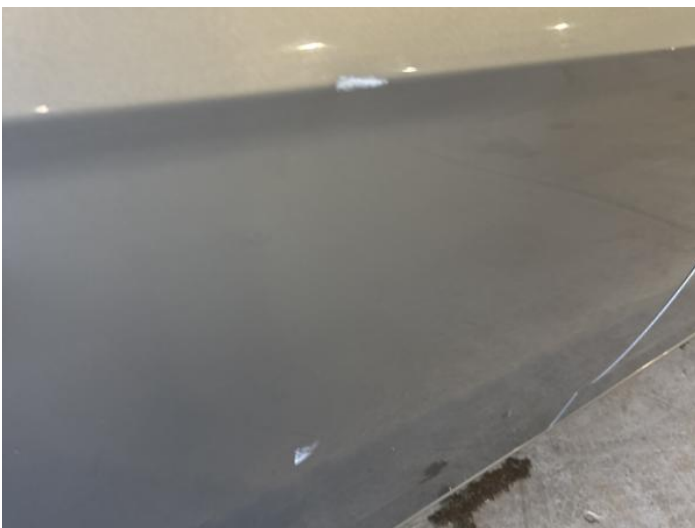
13: Door osr
Dented
With Paint Damage

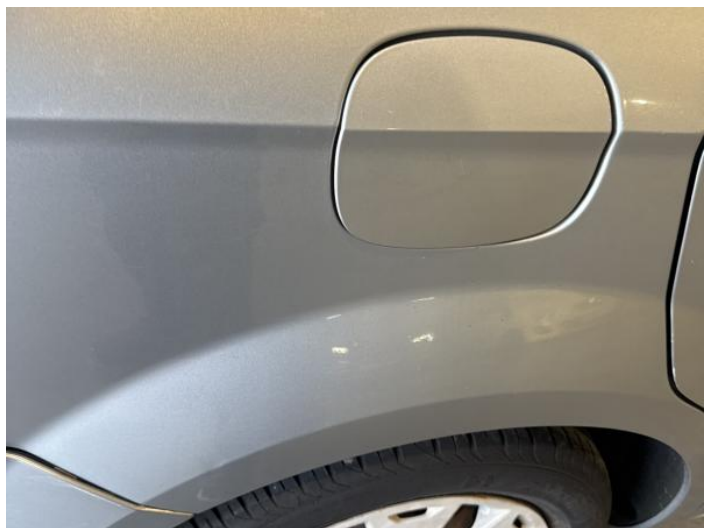
14: Qtr Panel osr
Dented
With Paint Damage

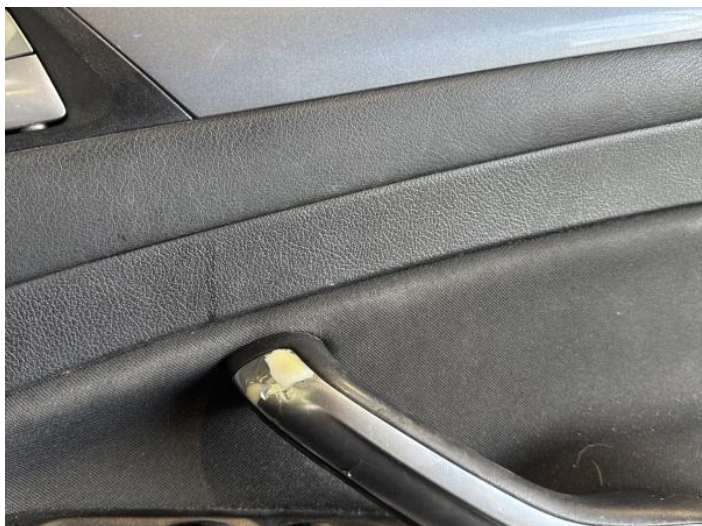
15: Handle Inner osf
Damaged
Replace
