VEHICLE INSPECTION REPORT

RO69KWV

Jeep Compass 1.6 Multijet 120 Limited 5dr [2WD]

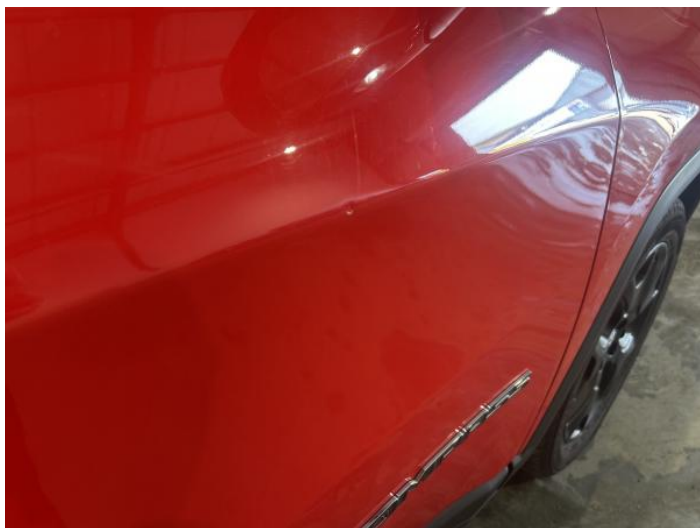
1: Door osf
Dented
2 Or Less UpTo 10mm

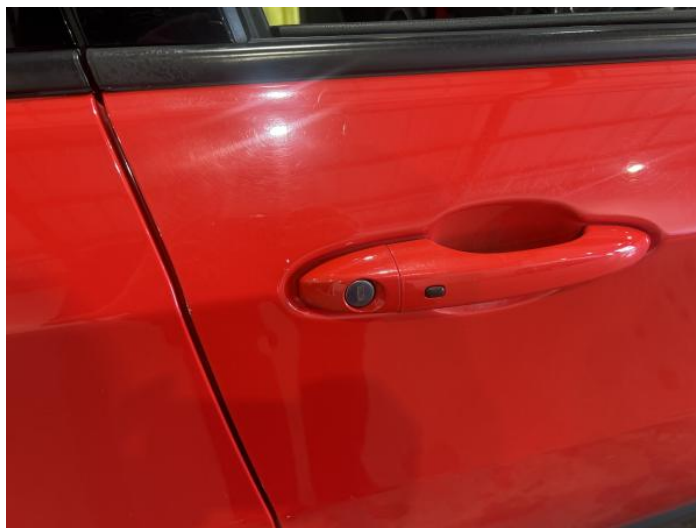
2: Door osf
Chipped
1 To 5

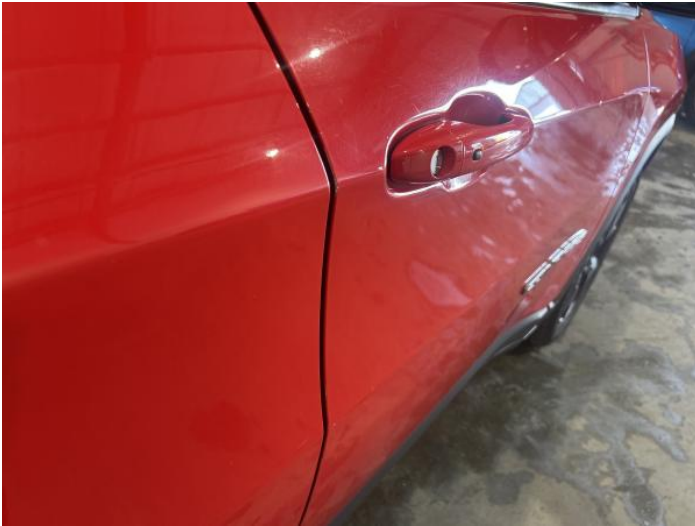
3: Door osf
Chipped
Edge Chip

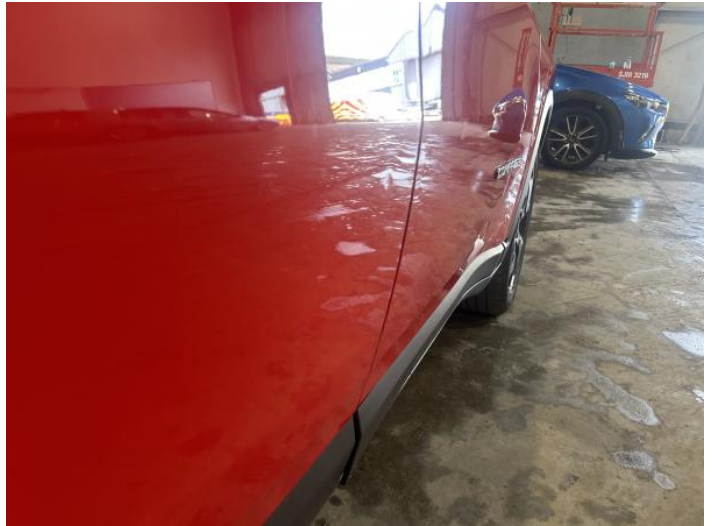
4: Door osr
Dented
Over 2 UpTo 10mm

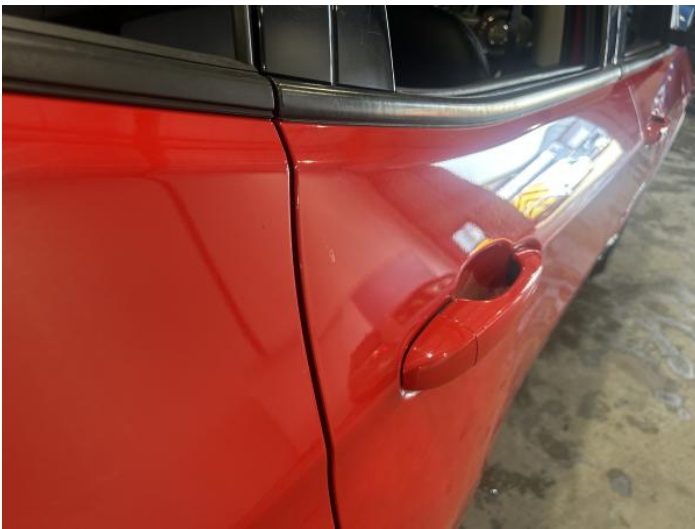
5: Door osr
Chipped
Edge Chip

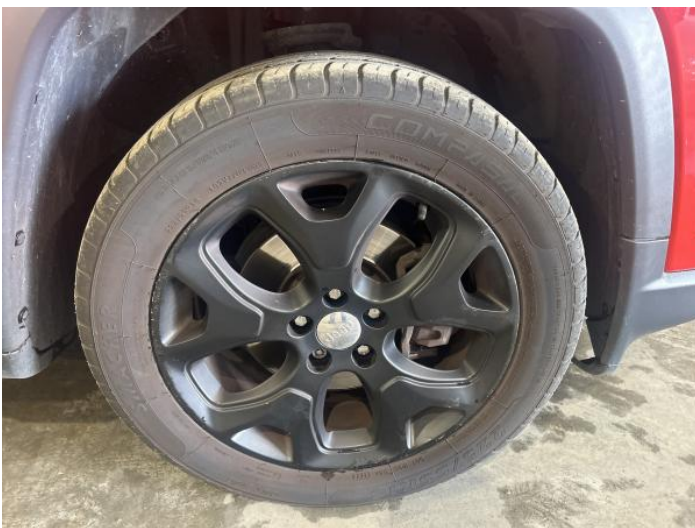
7: Wheel osf
Scratched
Over 50mm

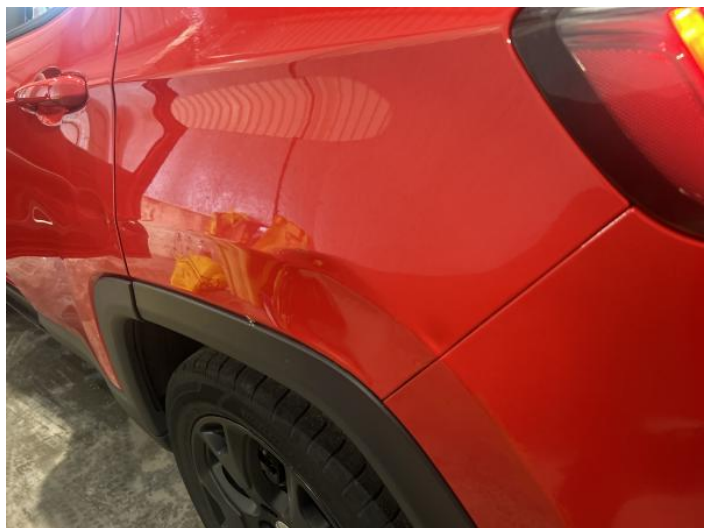
8: Qtr Panel nsr
Dented
Over 30mm

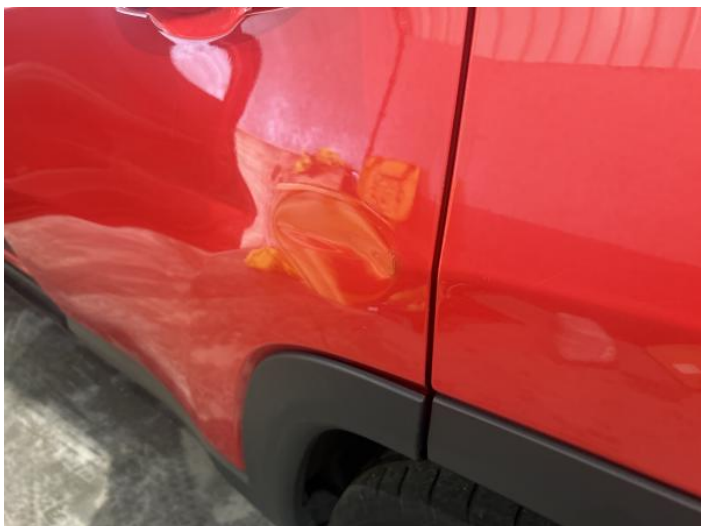
9: Door nsr
Dented
With Paint Damage

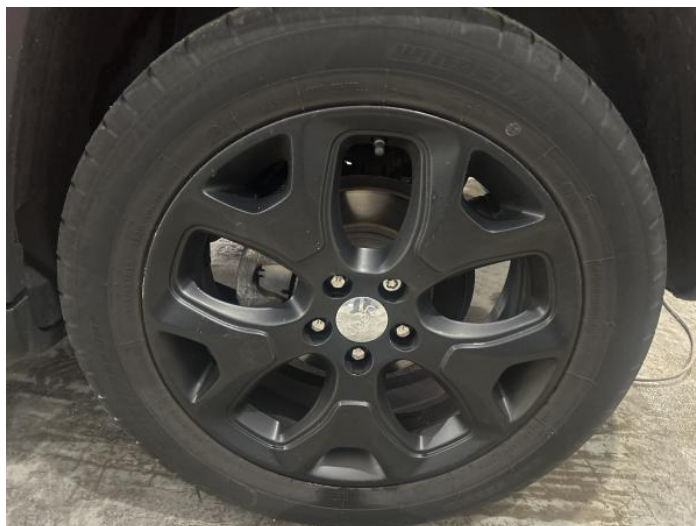
10: Wheel nsr
Scratched
Up To 50mm

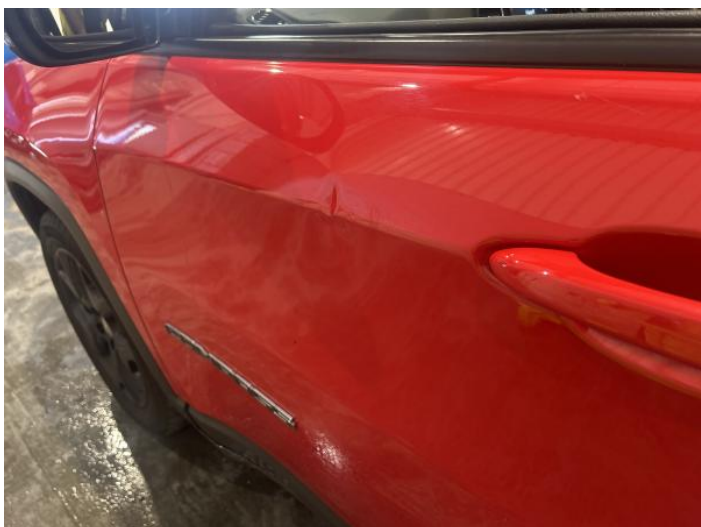
11: Door nsf
Dented
Over 30mm

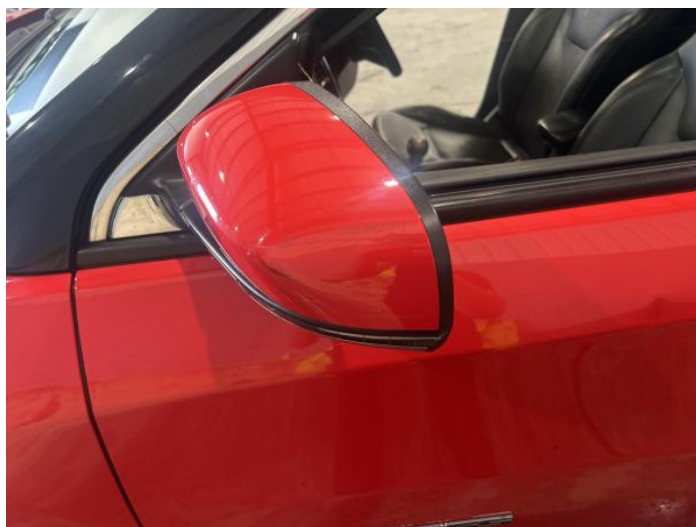
12: Door Mirror Assy nsf
Scratched (Painted)
Over 25mm Not Thru Paint

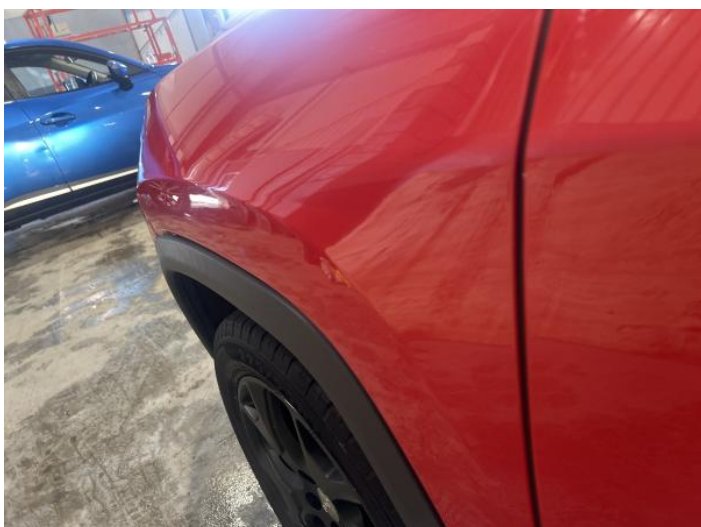
13: Wing nsf
Dented
Over 30mm

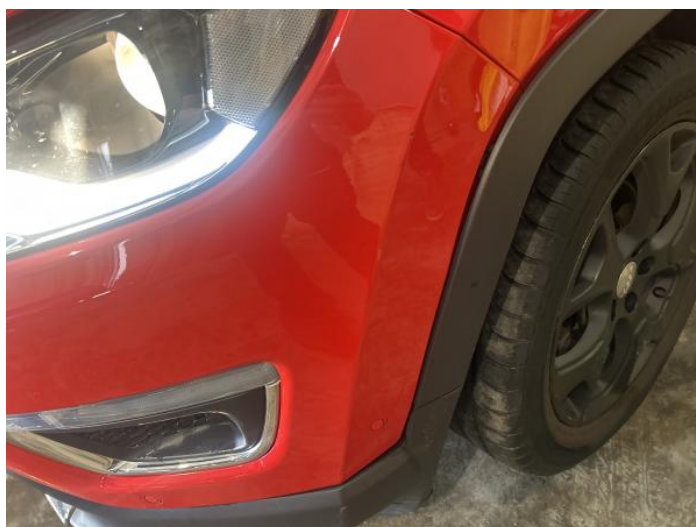
14: Bumper Front
Scratched
25 to 100mm Thru Paint

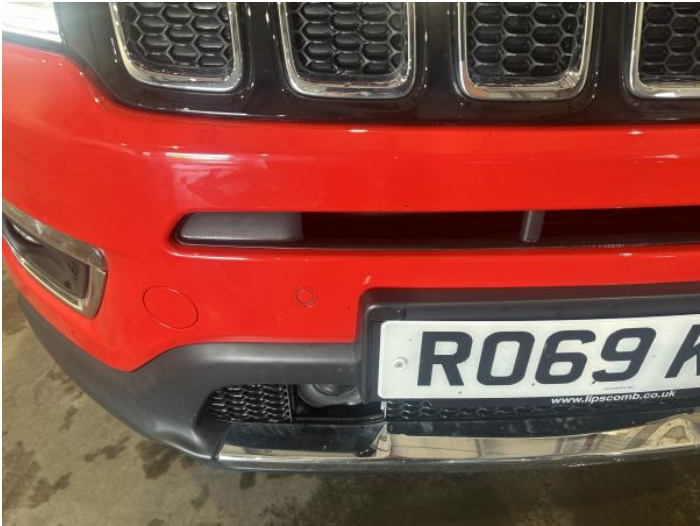
15: Bumper Front
Chipped
Multiple Chips
