VEHICLE INSPECTION REPORT

HY59LFO

Citroen C4 Grand Picasso 1.6HDi 16V VTR Plus 5dr EGS

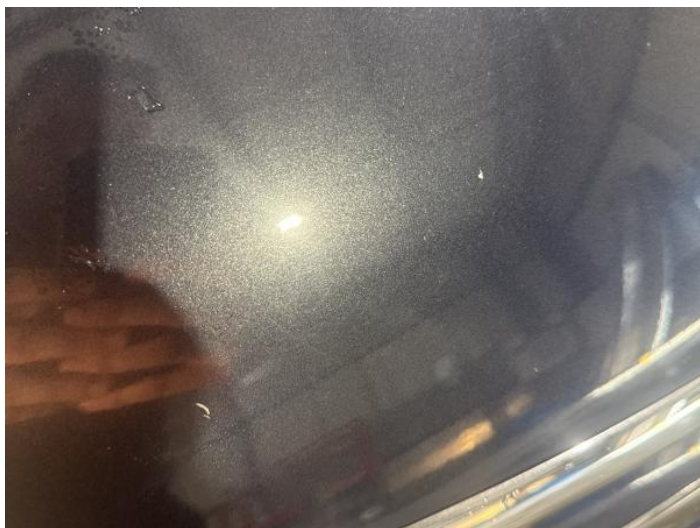
1: Bonnet
Chipped
1 To 5

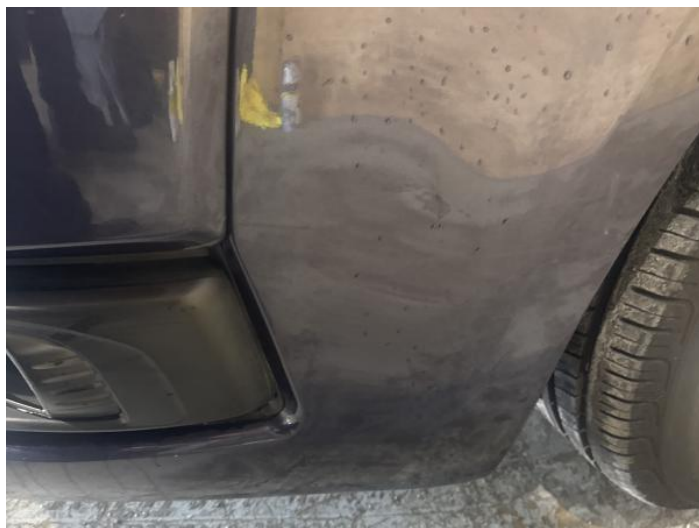
2: Bumper Front
Scratched
25 to 100mm Thru Paint

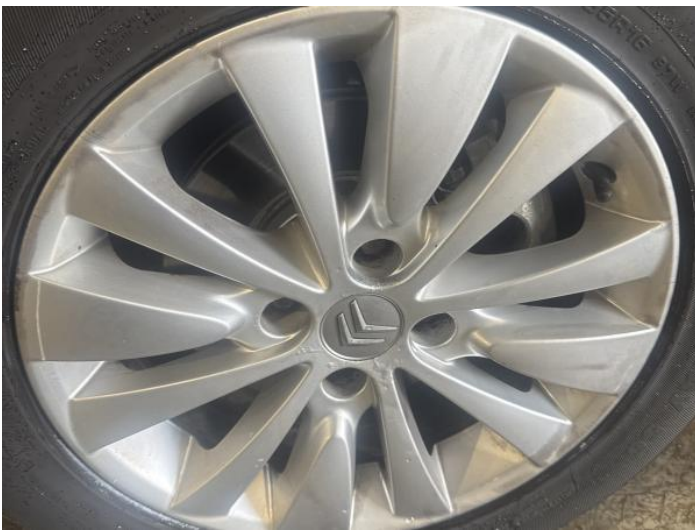
5: Wheel osf
Corroded
Light

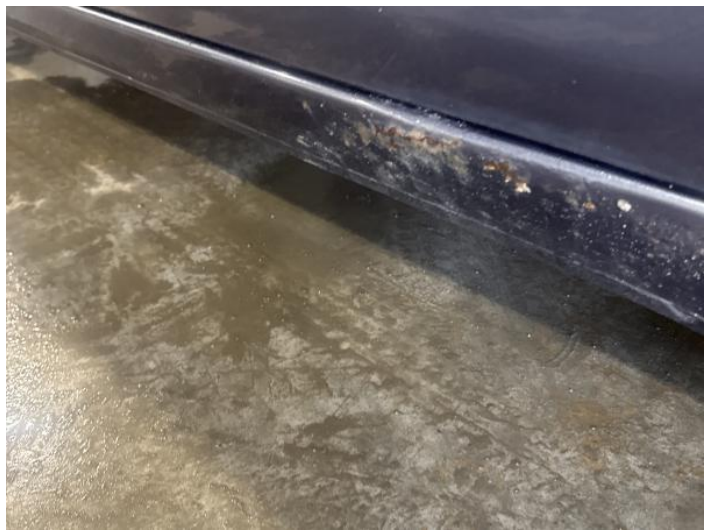
6: Sill os
Rusted
Over 5mm

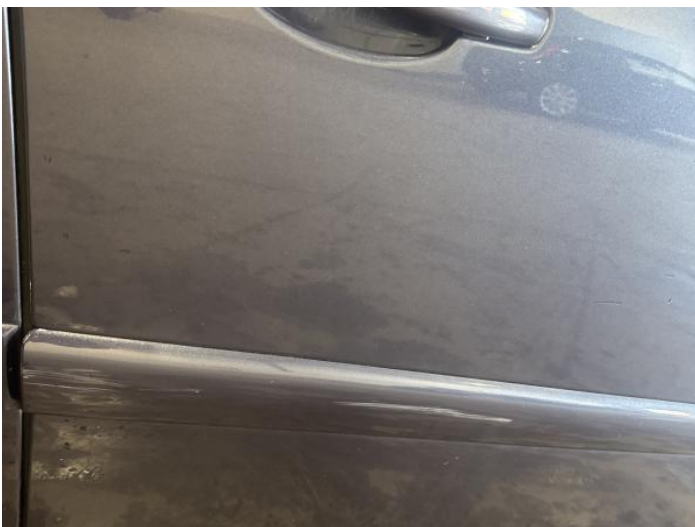
7: Door osf
Scratched
Over 25mm Thru Paint

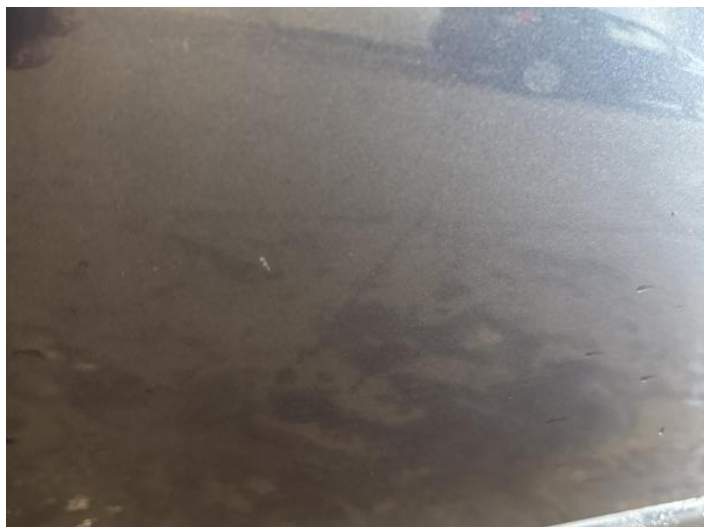
8: Door osr
Chipped
1 To 5

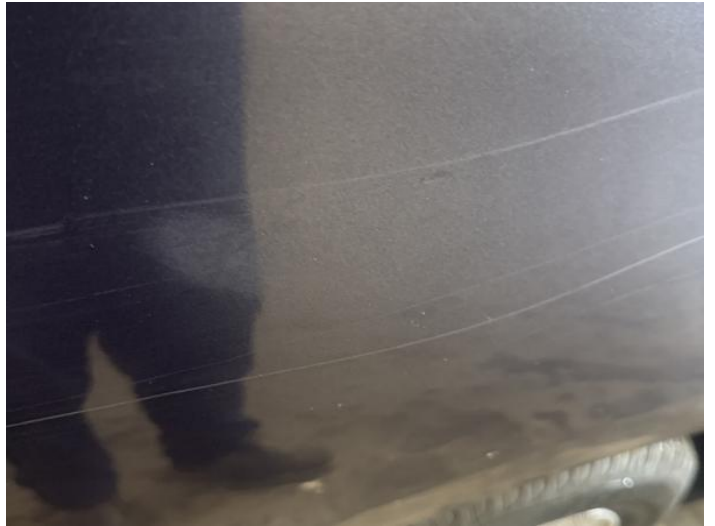
9: Door osr
Scratched
Over 25mm Not Thru Paint

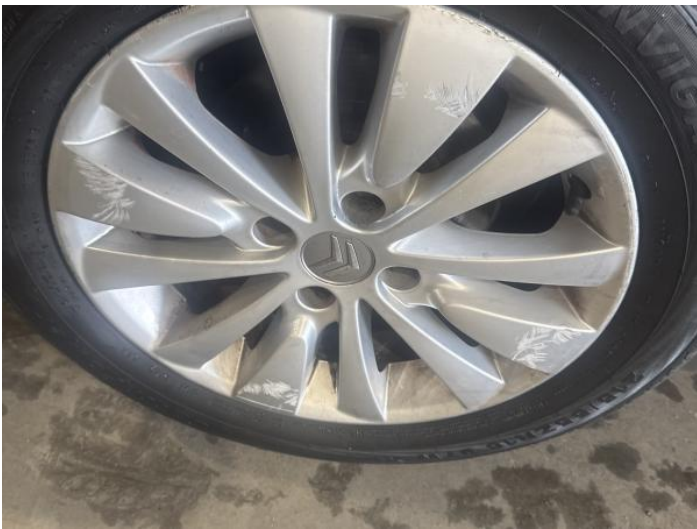
11: Wheel osr
Scratched
Over 50mm

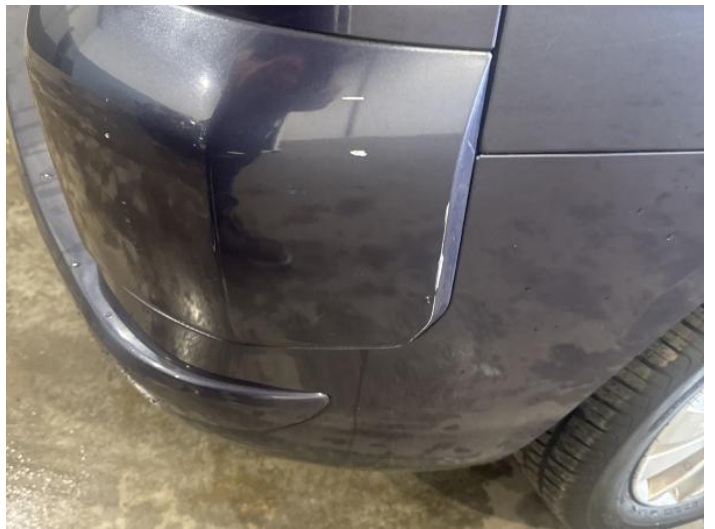
12: Bumper Rear
Scratched
Over 100mm Thru Paint

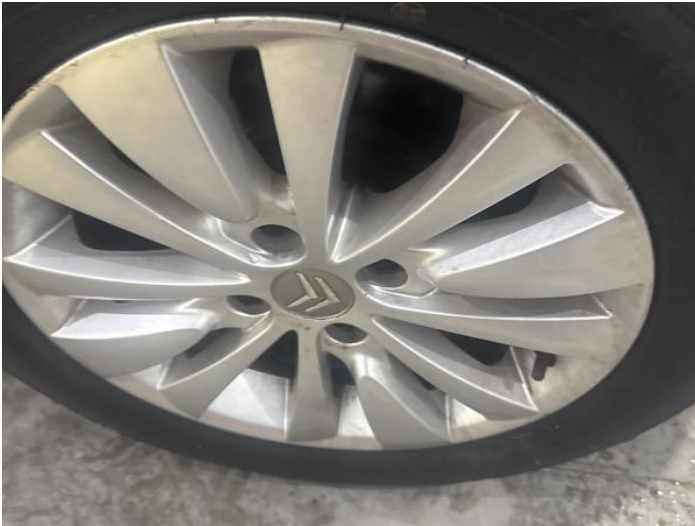
15: Wheel nsr
Scratched
Over 50mm

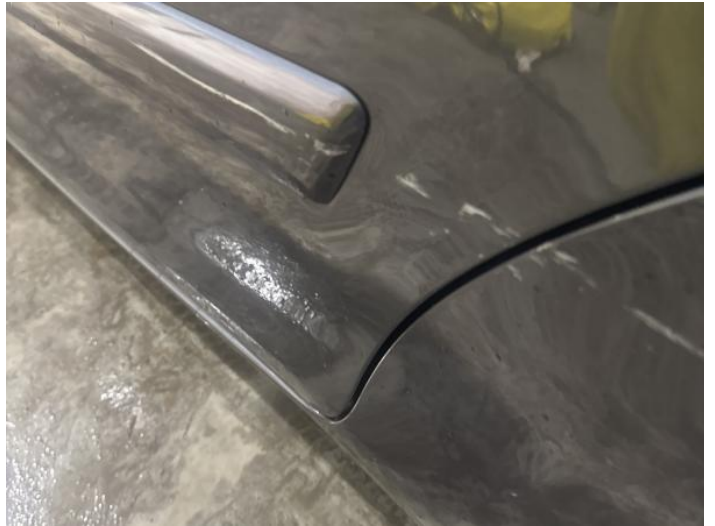
16: Door nsr
Dented
With Paint Damage

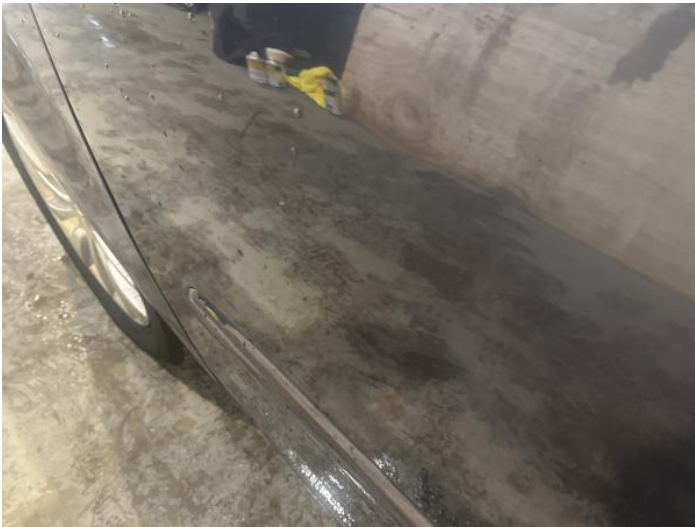
17: Door nsf
Dented
Over 2 UpTo 10mm

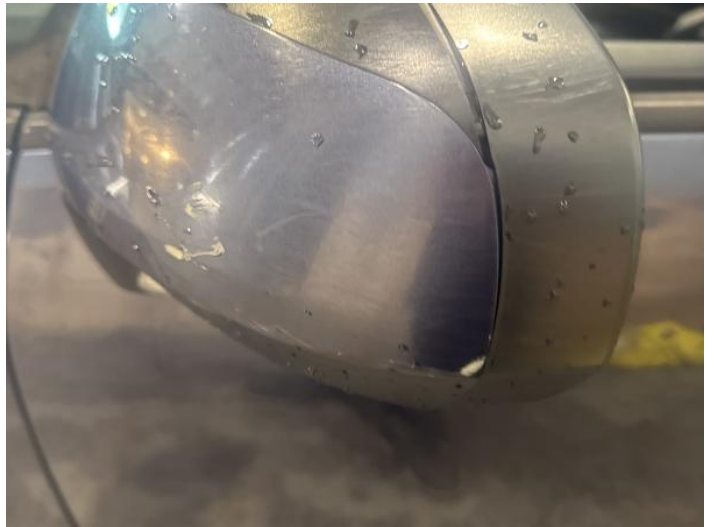
18: Door Mirror Assy nsf
Scratched (Painted)
Over 25mm Thru Paint

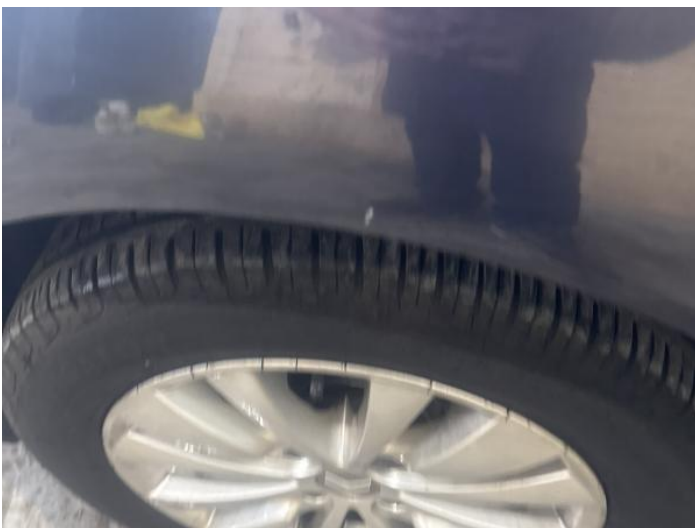
19: Wing nsf
Chipped
1 To 5

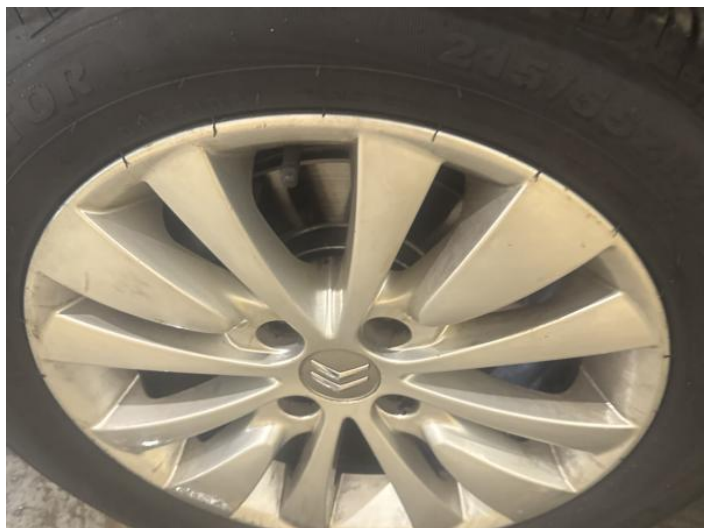
20: Wheel nsf
Scratched
Over 50mm
