VEHICLE INSPECTION REPORT

RJ13PXL

Volkswagen Golf 1.6 TDI 105 SE 5dr

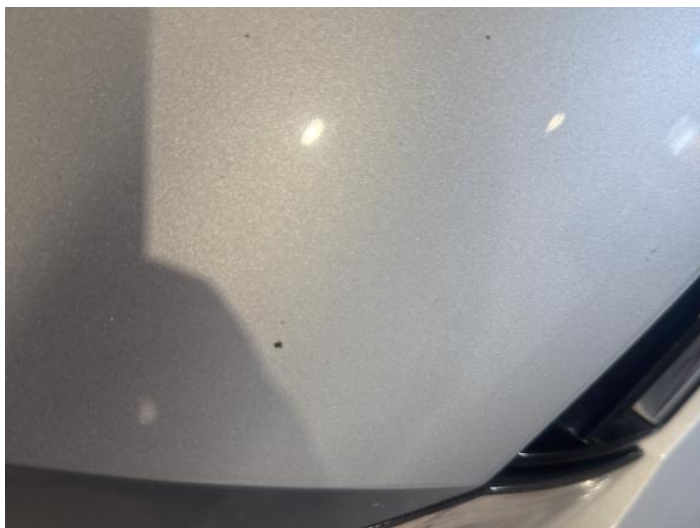
1: Bonnet
Chipped
1 To 5

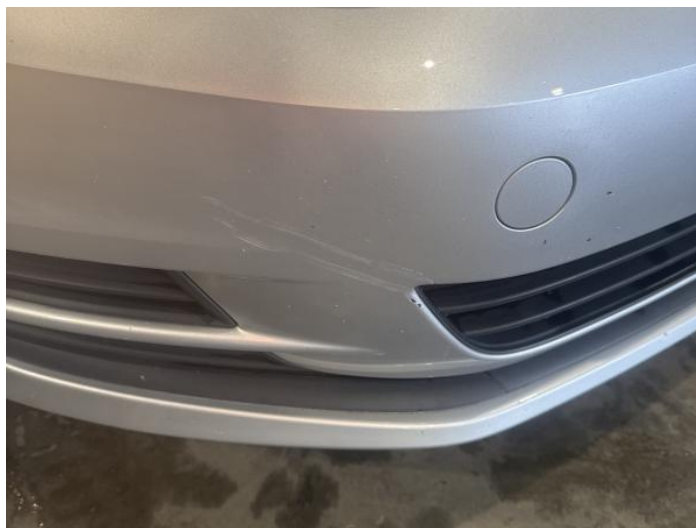
2: Bumper Front
Scratched
Over 100mm Thru Paint

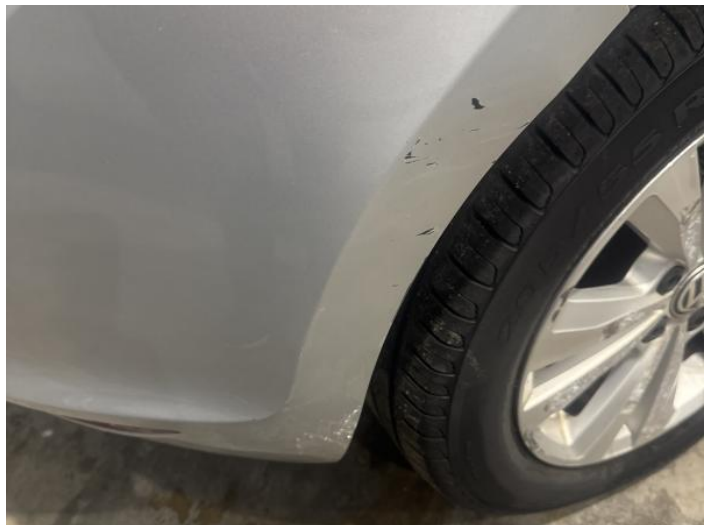
8: Bumper Rear
Scratched
Over 100mm Thru Paint

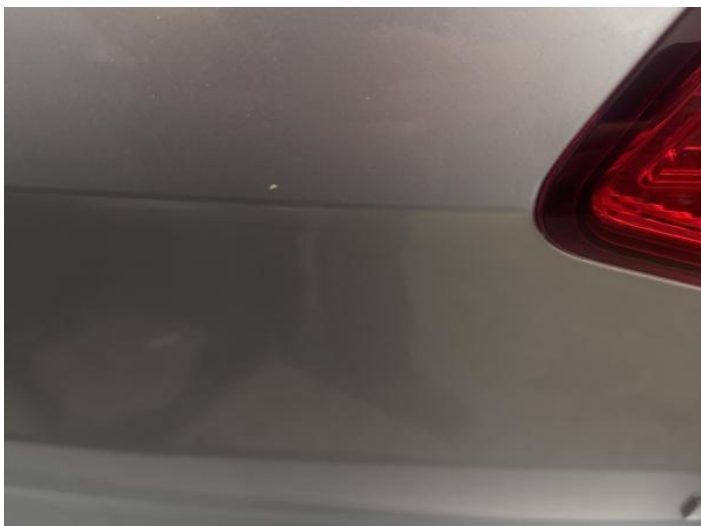
9: Boot Lid
Chipped
1 To 5

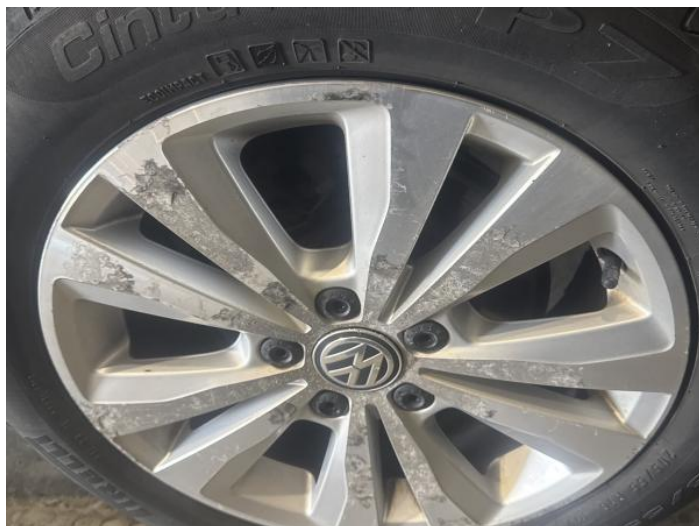
10: Wheel nsr
Scratched
Over 50mm

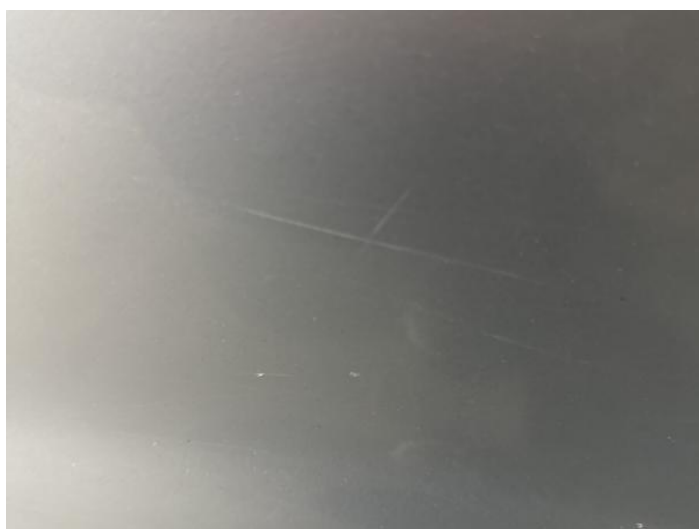
12: Door nsr
Chipped
1 To 5

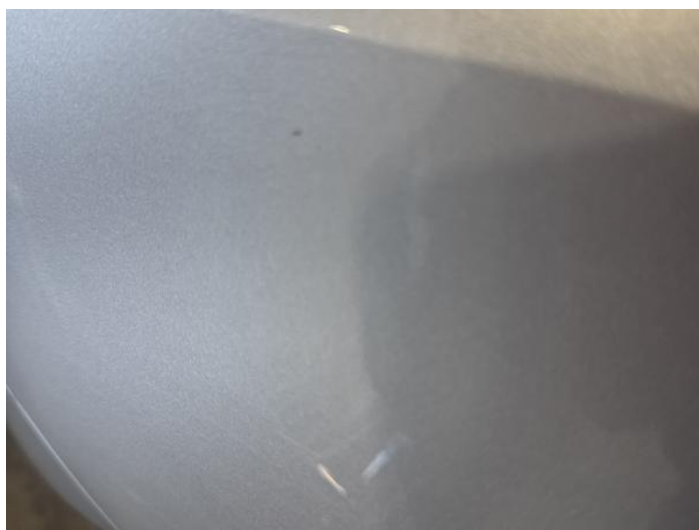
14: Wing nsf
Chipped
1 To 5

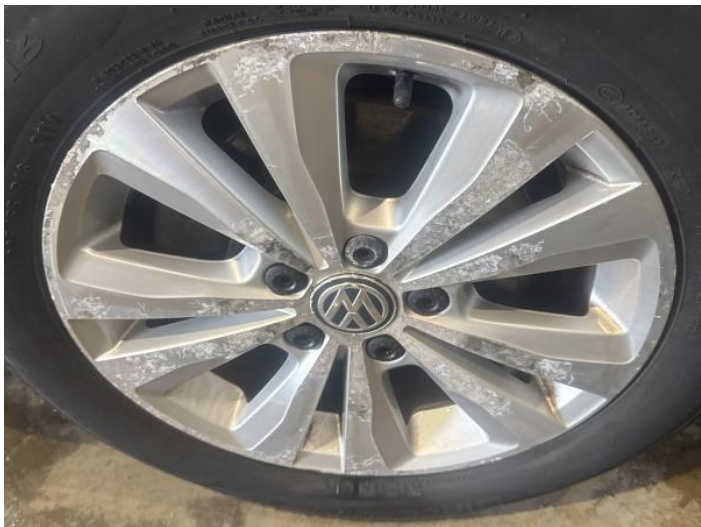
15: Wheel nsf
Scratched
Over 50mm
