VEHICLE INSPECTION REPORT

EN62EVU

Hyundai I30 1.6 CRDi Blue Drive Active 5dr

nama
GRADE
3

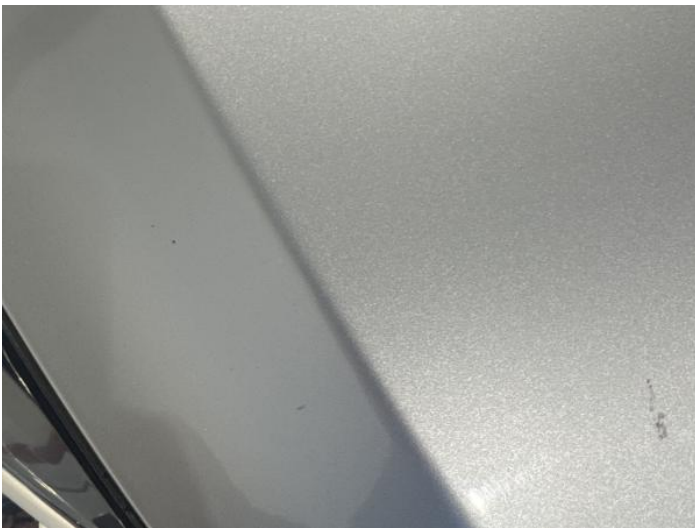
1: Bonnet
Chipped
1 To 5

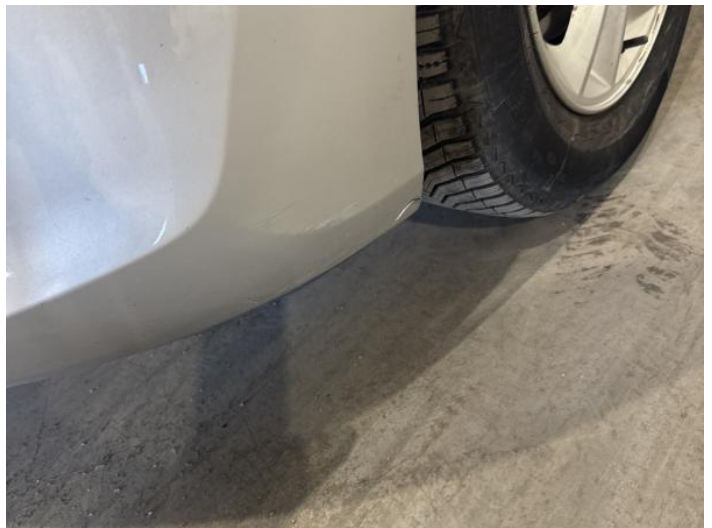
2: Bumper Front
Cracked
UpTo 25mm

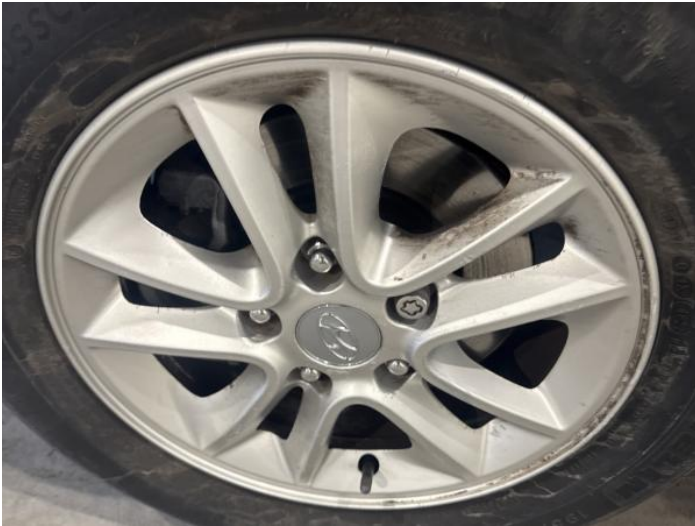
3: Wheel nsf
Scratched
Up To 50mm

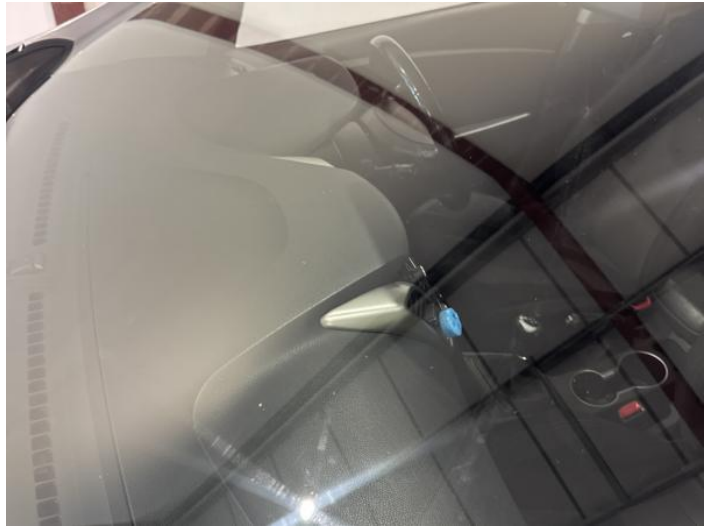
4: Screen Front
Chipped
UpTo 10mm

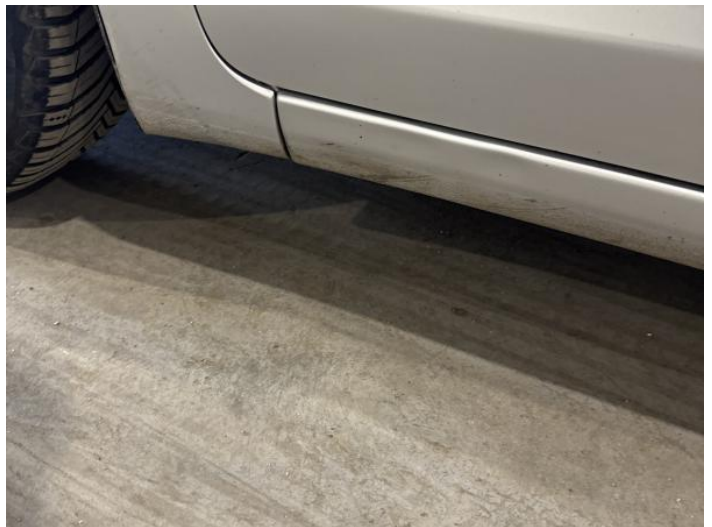
6: Sill ns
Dented
Over 30mm

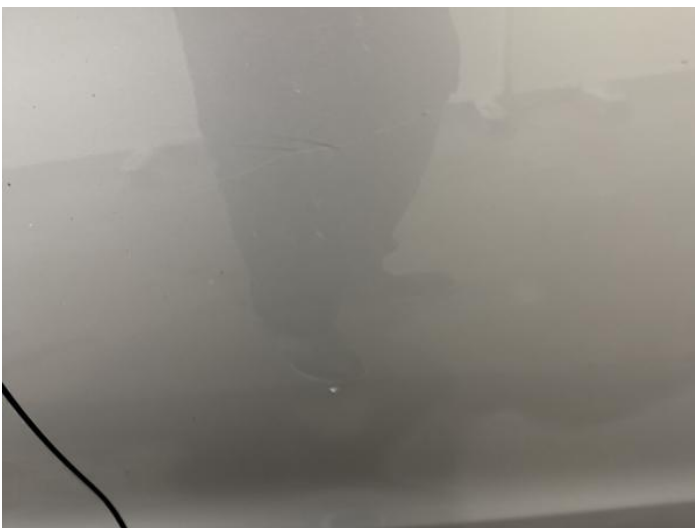
7: Door nsr
Chipped
1 To 5

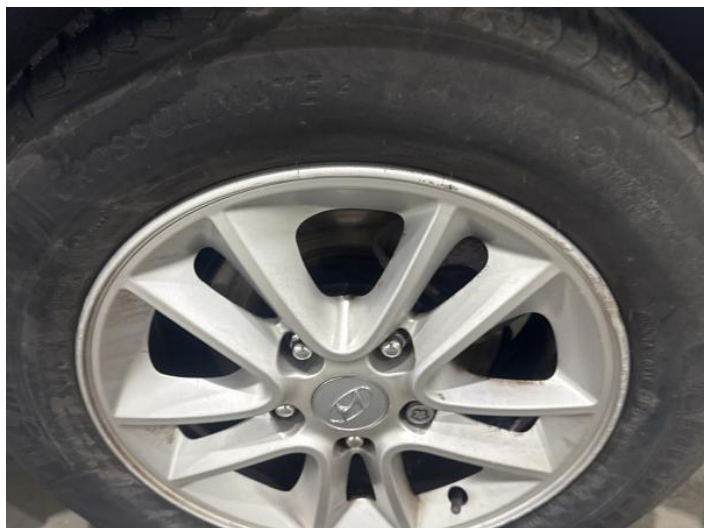
8: Wheel nsr
Scratched
Over 50mm

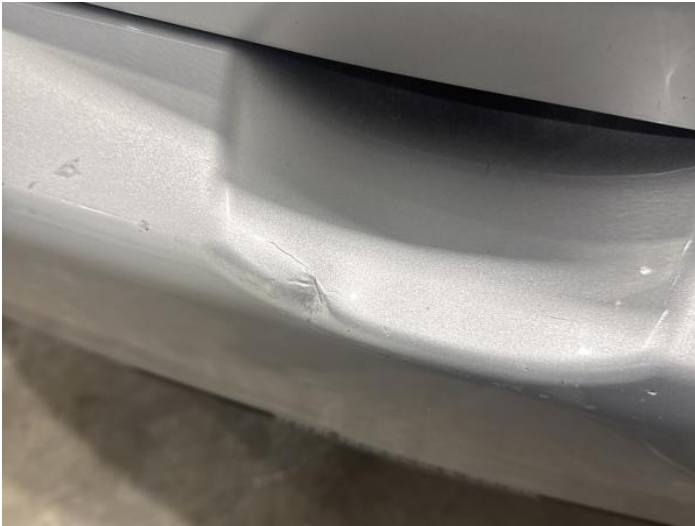
9: Bumper Rear
Dented
With Paint Damage

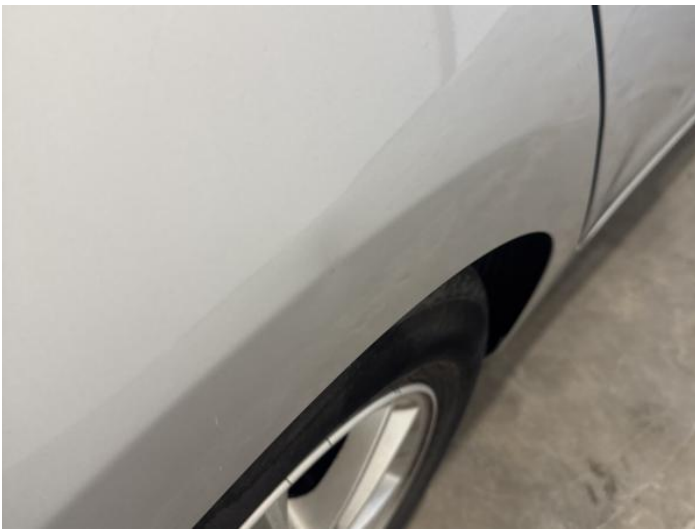
11: Qtr Panel osr
Dented
Between 10mm + 30mm

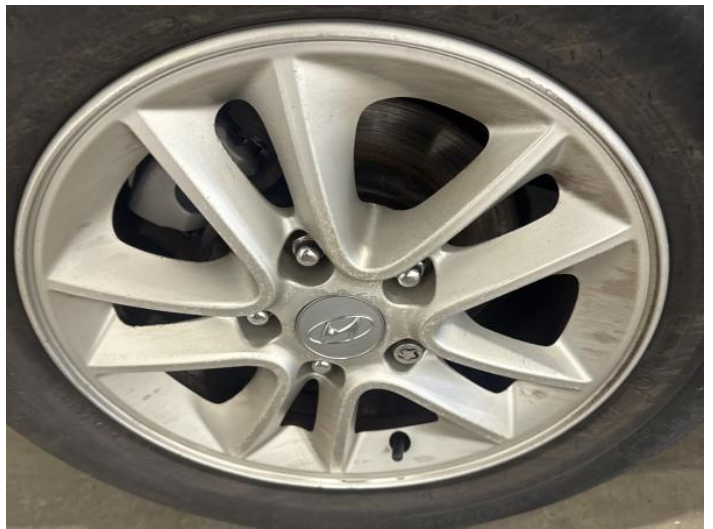
12: Wheel osr
Scratched
Over 50mm

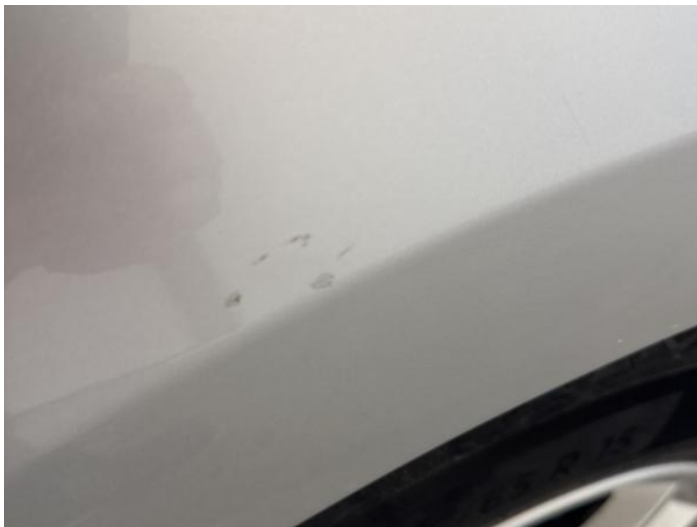
15: Wing osf
Chipped
1 To 5

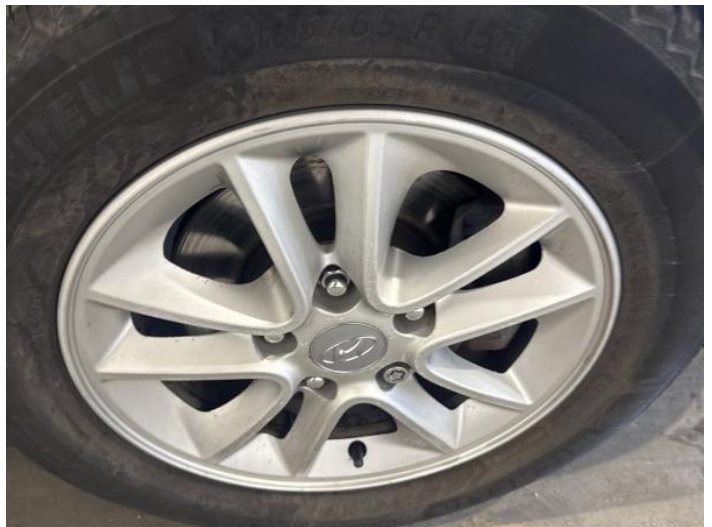
16: Wheel osf
Scratched
Over 50mm
