# VEHICLE INSPECTION REPORT

**GF17AGU**

## Vauxhall Mokka X 1.4T Active 5dr

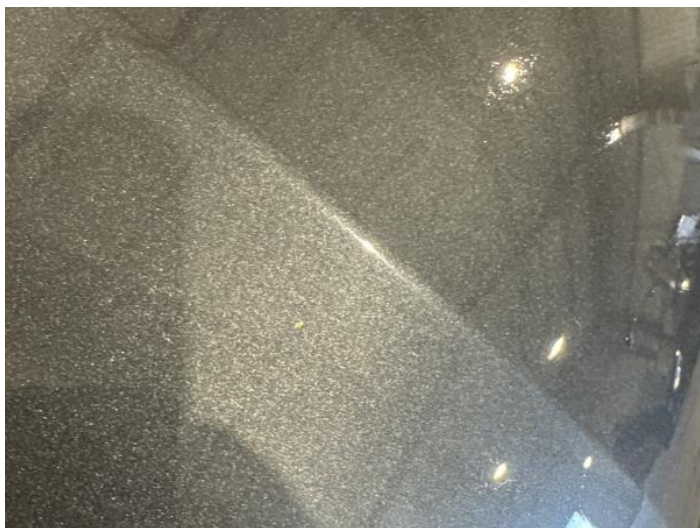
1: Bonnet  
Chipped  
1 To 5

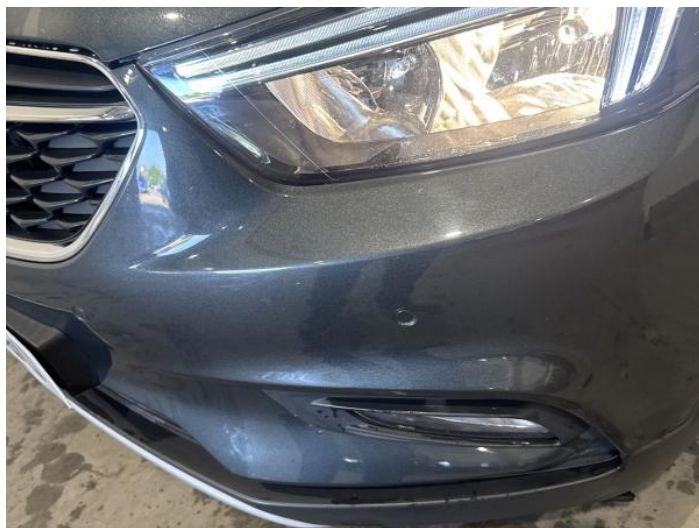
2: Bumper Front  
Chipped  
Multiple Chips

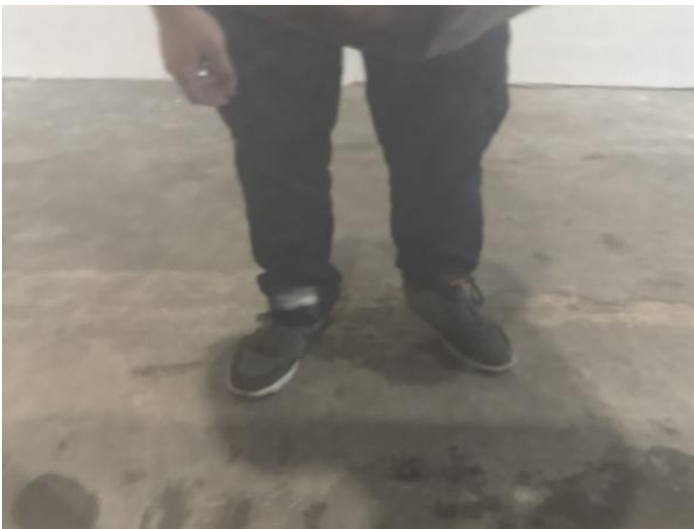
5: Door osr  
Chipped  
1 To 5

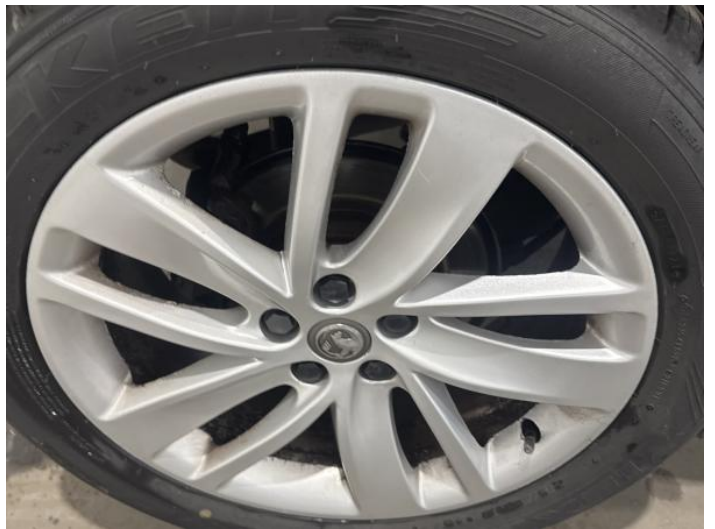
6: Wheel osr  
Corroded  
Light

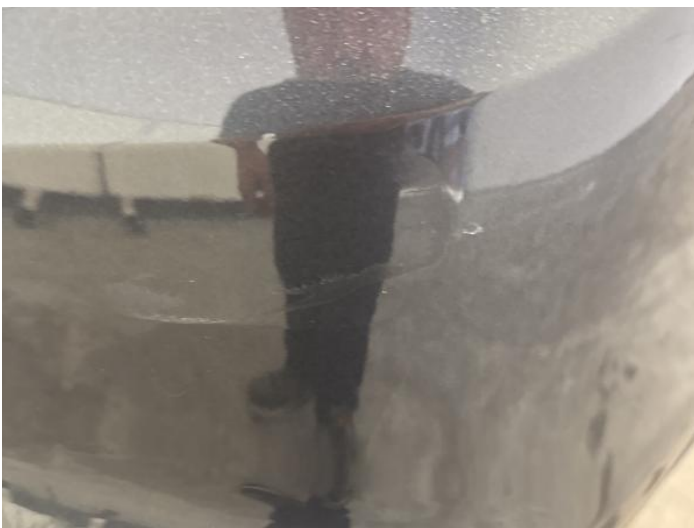
7: Bumper Rear  
Scratched  
25 to 100mm Thru Paint

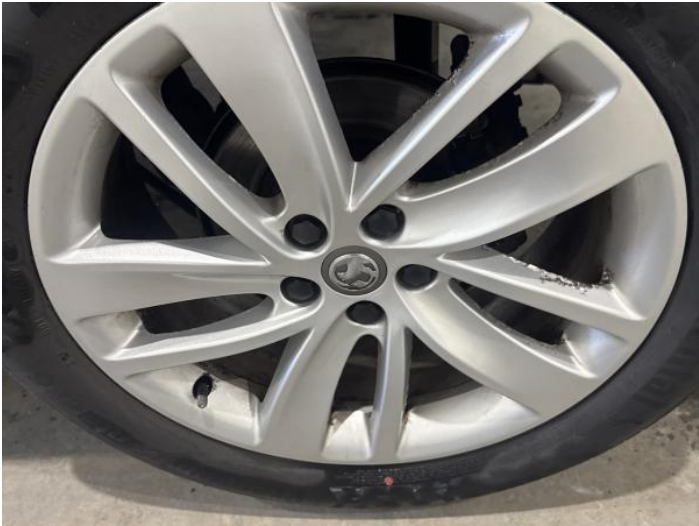
9: Wheel nsr  
Corroded  
Light

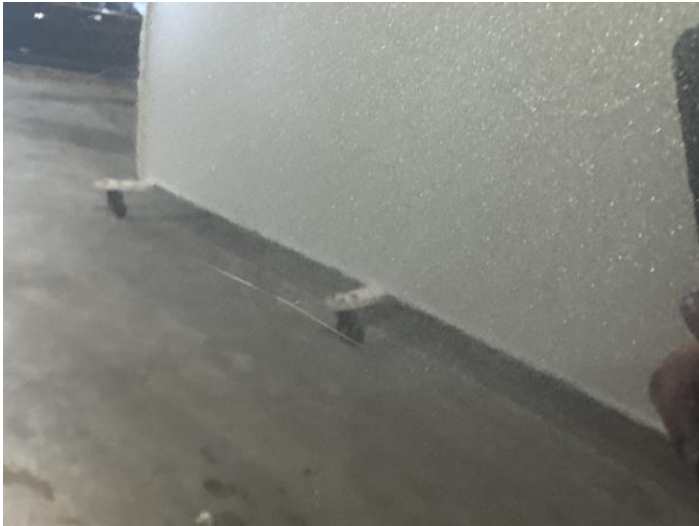
10: Door nsr  
Scratched  
Over 25mm Not Thru Paint

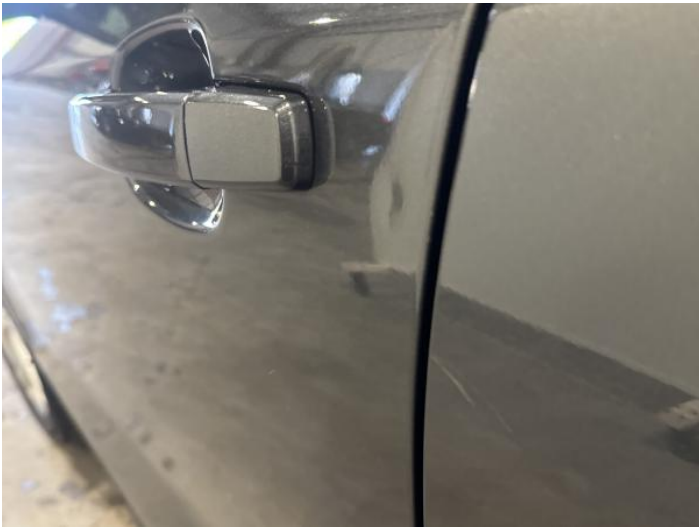
11: Door nsf  
Dented  
Over 2 UpTo 10mm
