VEHICLE INSPECTION REPORT

GD17FXH

Kia Venga 1.6 4 5dr Auto [6]

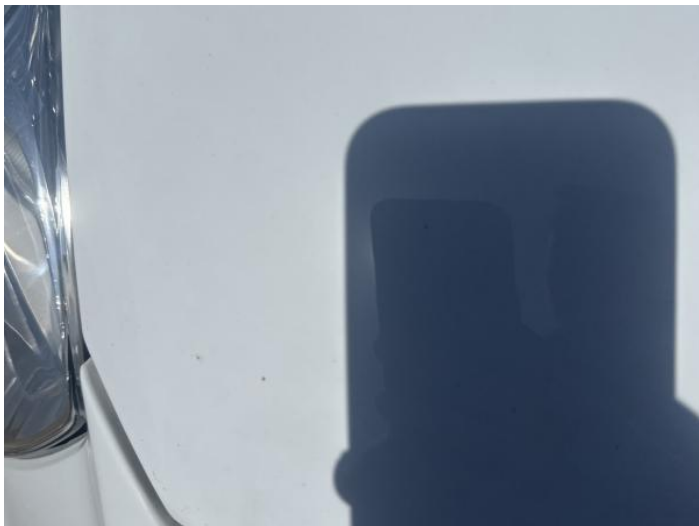
1: Bonnet
Chipped
1 To 5

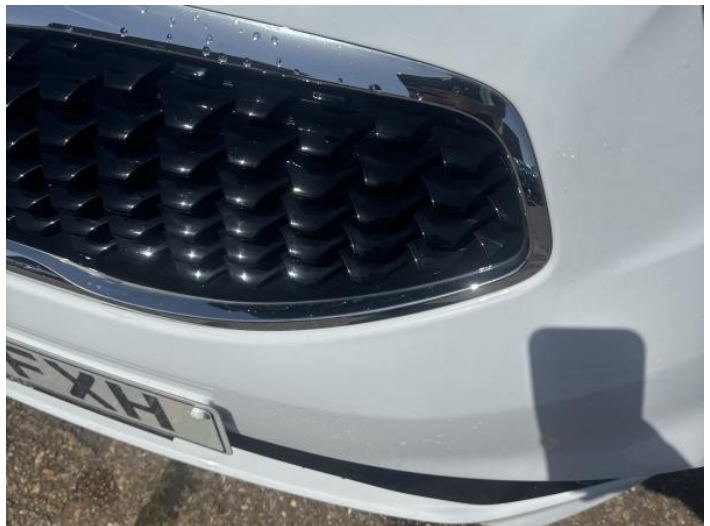
2: Bumper Front
Chipped
Multiple Chips

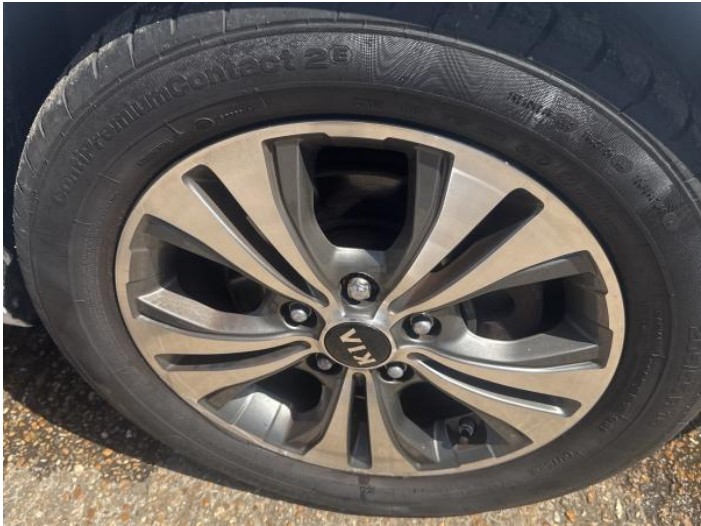
4: Wheel osf
Scratched
Over 50mm

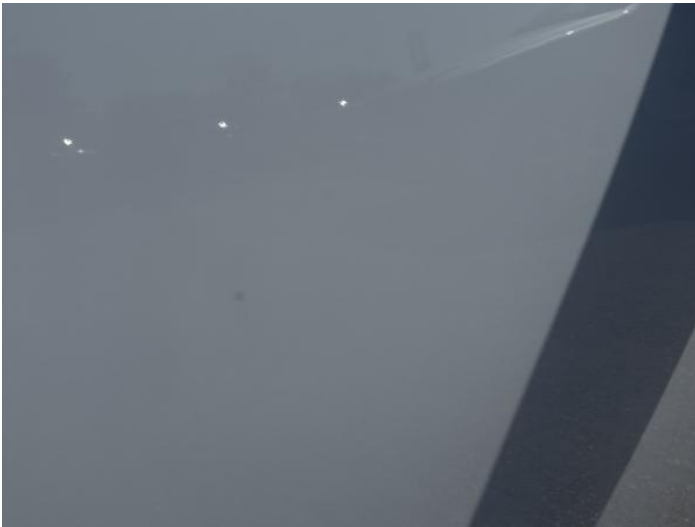
5: Door osf
Chipped
1 To 5

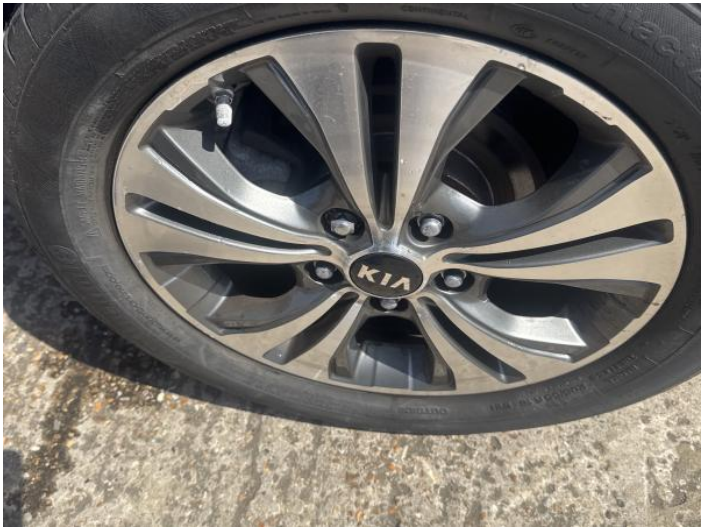
6: Wheel osr
Scratched
Over 50mm

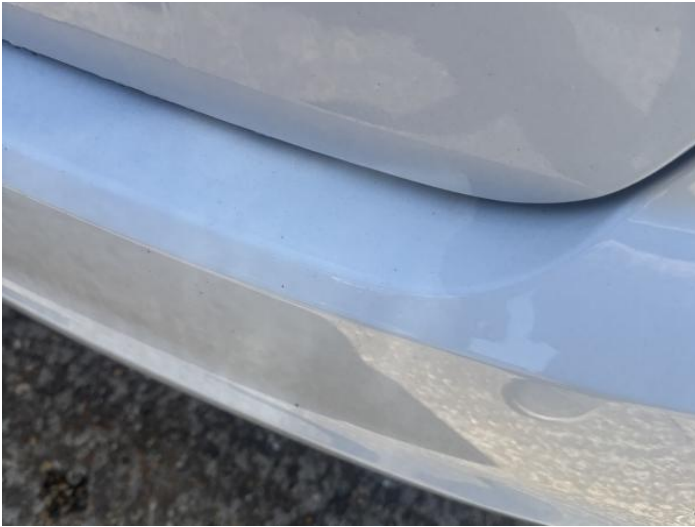
7: Bumper Rear
Chipped
Multiple Chips

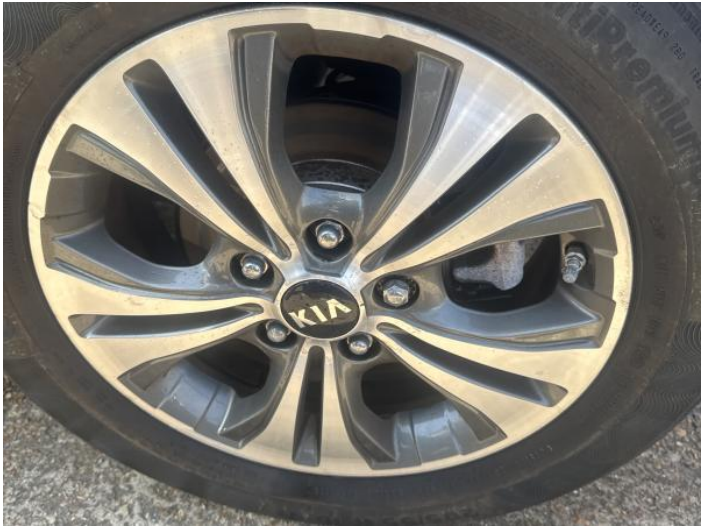
8: Wheel nsr
Scratched
Over 50mm

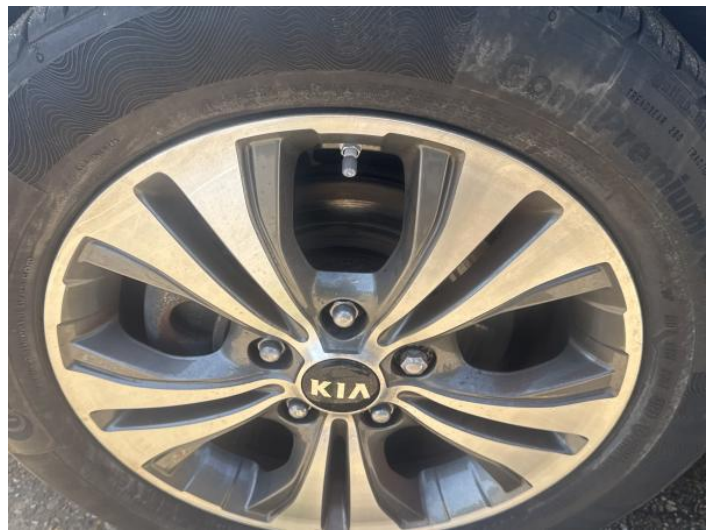
12: Wheel nsf
Scratched
Up To 50mm
