## **VEHICLE INSPECTION REPORT**

**GY66DKO**

## Toyota Verso 1.6 D-4D Icon TSS 5dr

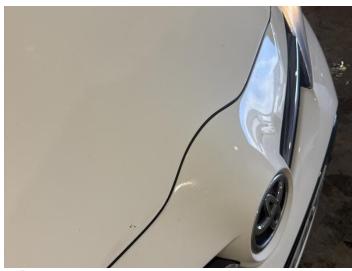
1: Bonnet Chipped 1 To 5

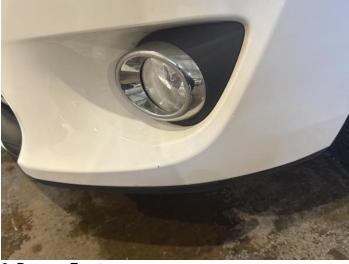
2: Bumper Front Scratched UpTo 25mm Thru Paint

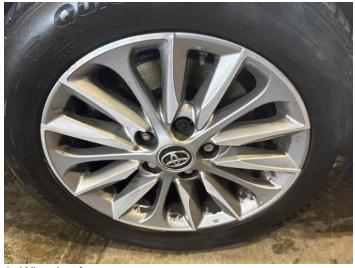
3: Wheel nsf Scratched Over 50mm

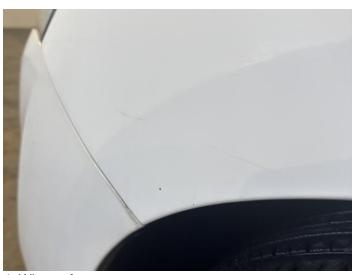
4: Wing nsf Scratched UpTo 25mm Thru Paint

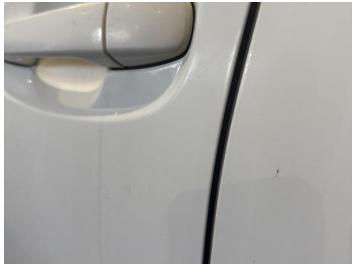
5: Door nsf Scratched UpTo 25mm Thru Paint

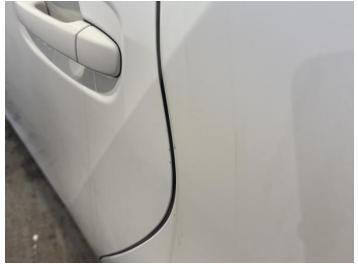
6: Door nsr Chipped Edge Chip

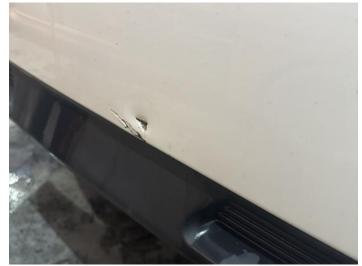
7: Bumper Rear Cracked UpTo 25mm

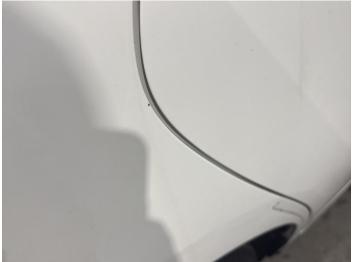
8: Qtr Panel osr Chipped 1 To 5

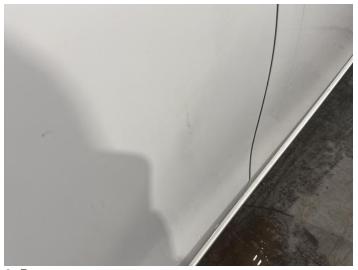
9: Door osr Scratched Over 25mm Thru Paint

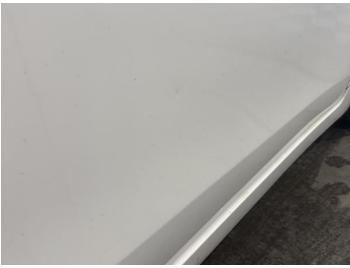
10: Door osf Dented Between 10mm + 30mm

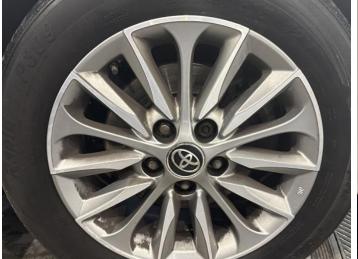
11: Wheel osf Scratched Up To 50mm

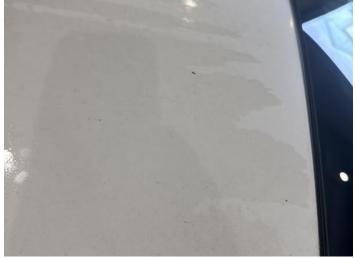
13: Roof Chipped 1 To 5

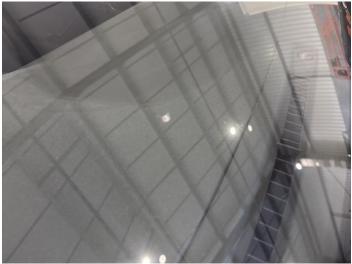
14: Screen Front Chipped UpTo 10mm
