VEHICLE INSPECTION REPORT

GU14NZW

Ford Fiesta 1.0 EcoBoost Zetec 5dr

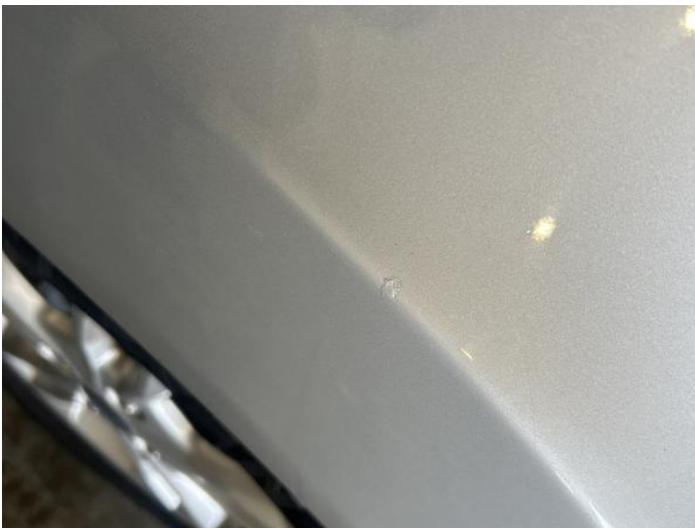
1: Wing osf
Chipped
1 To 5

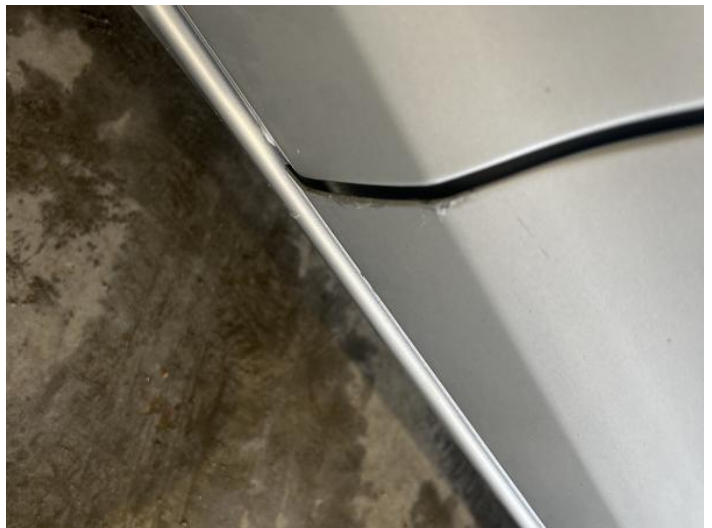
2: Door osf
Chipped
Edge Chip

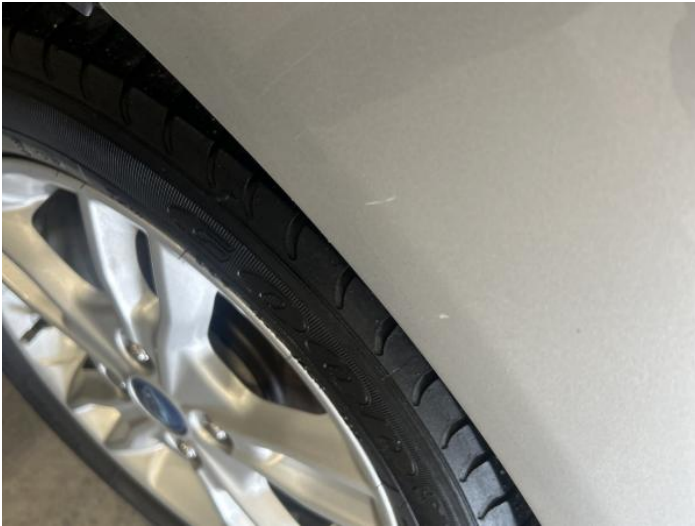
3: Qtr Panel osr
Chipped
1 To 5

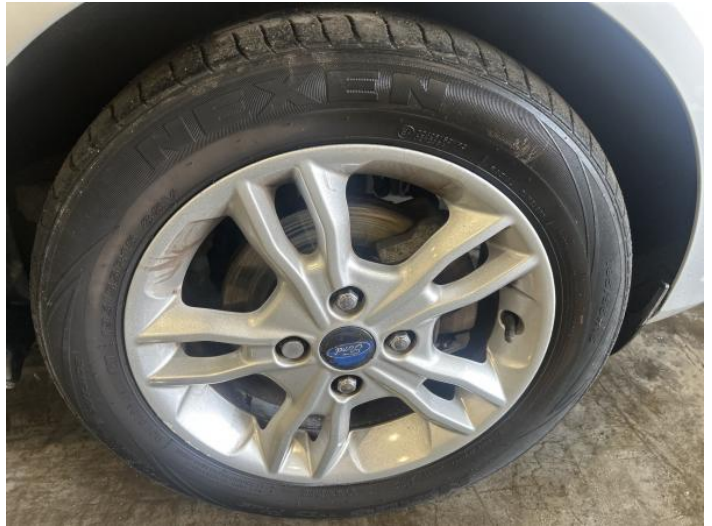
4: Wheel osf
Scratched
Over 50mm

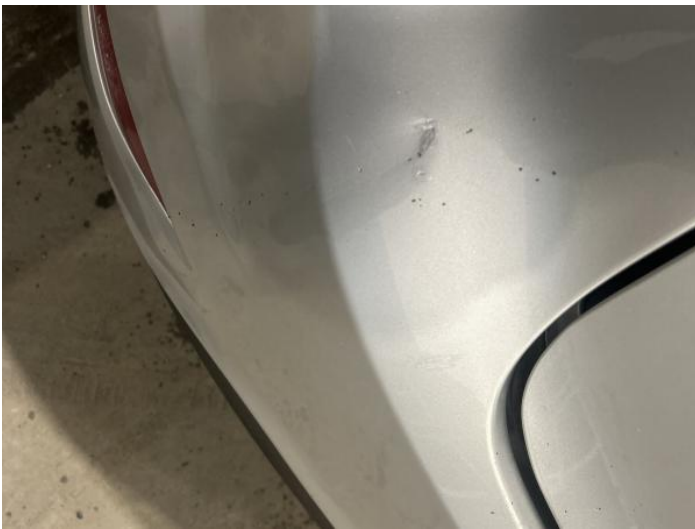
5: Bumper Rear
Scratched
25 to 100mm Thru Paint

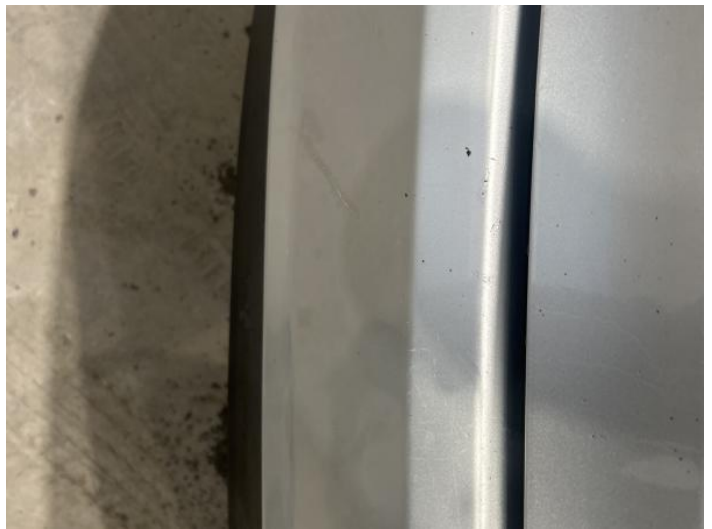
6: Bumper Rear
Chipped
Multiple Chips

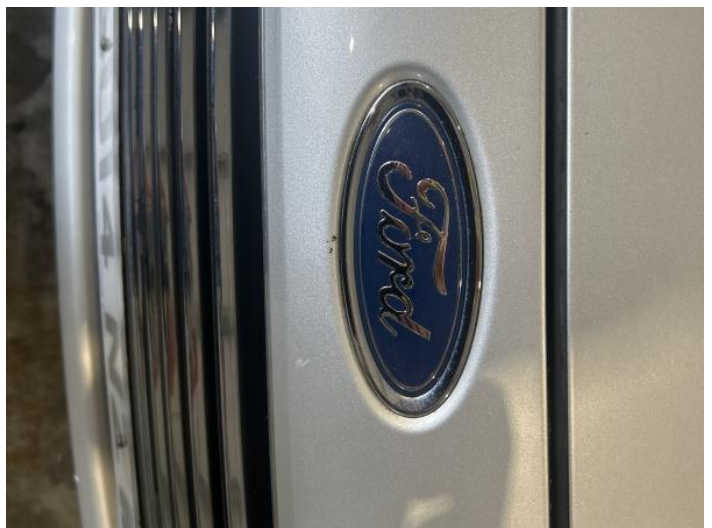
8: Bumper Front
Chipped
Multiple Chips

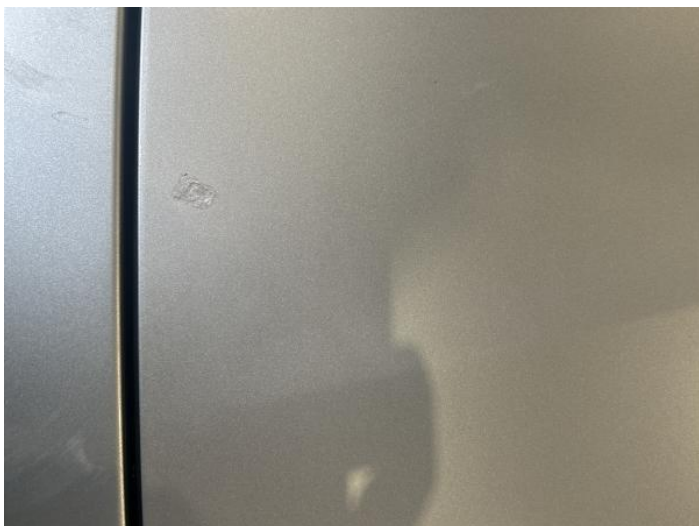
9: Bonnet
Chipped
1 To 5

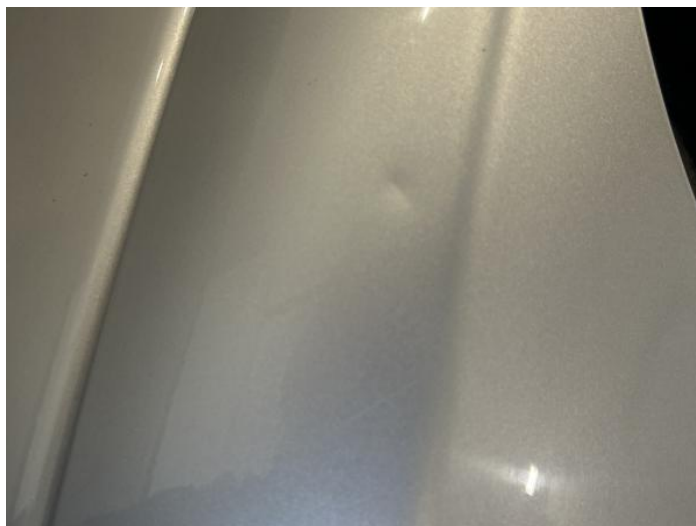
10: Bonnet
Dented
2 Or Less UpTo 10mm

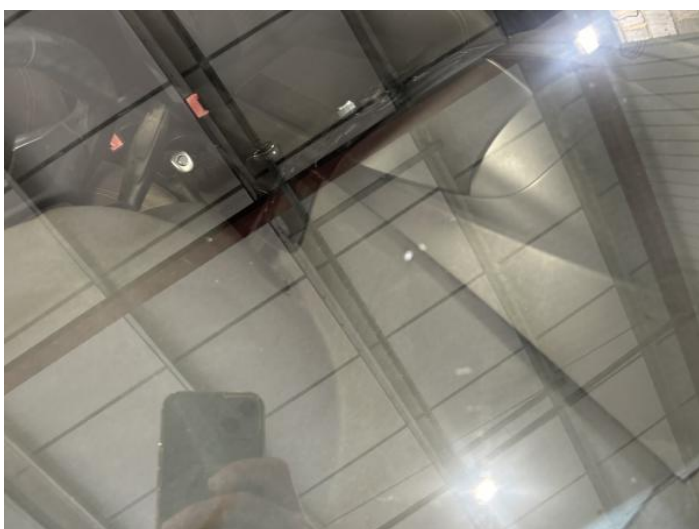
11: Screen Front
Chipped
UpTo 10mm
