# VEHICLE INSPECTION REPORT

**YS11KYK**

## Audi A5 2.0T FSI 180 Black Edition 2dr [Start Stop]

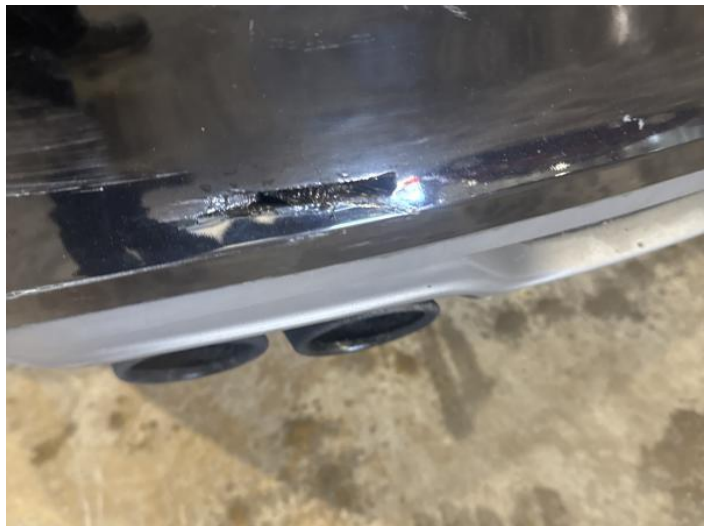
2: Bumper Rear  
Hole  
Over 25mm

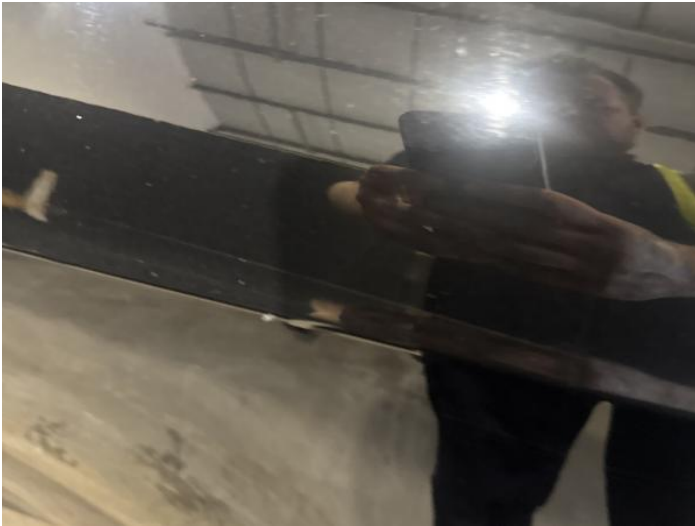
3: Qtr Panel nsr  
Chipped  
1 To 5

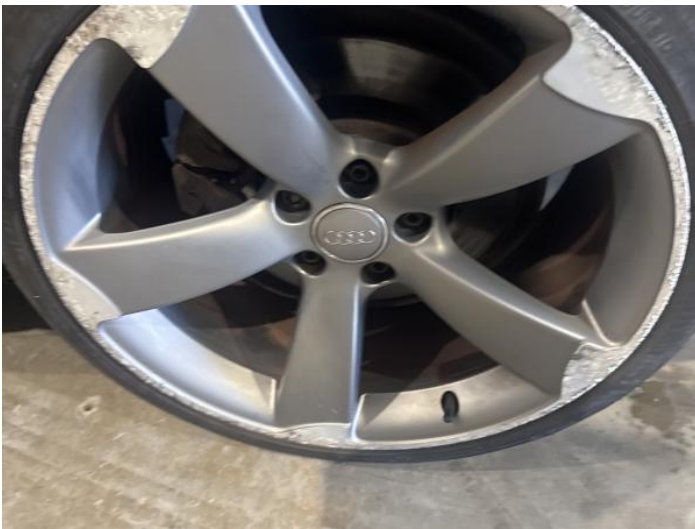
5: Wheel nsr  
Scratched  
Over 50mm

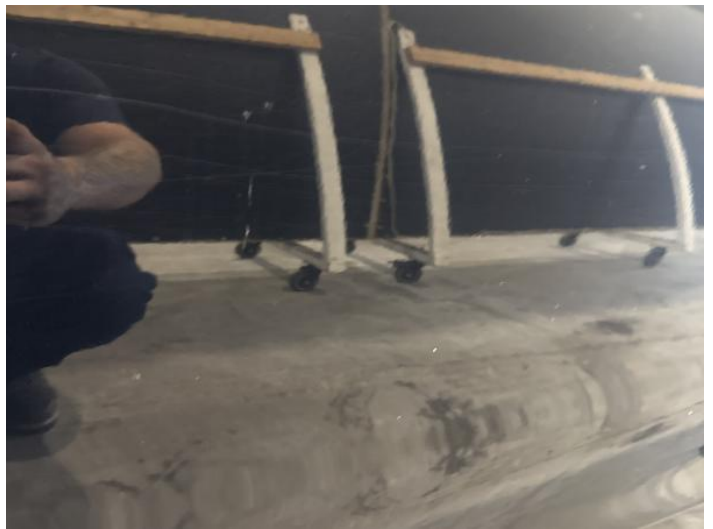
6: Door nsf  
Chipped  
Multiple Chips

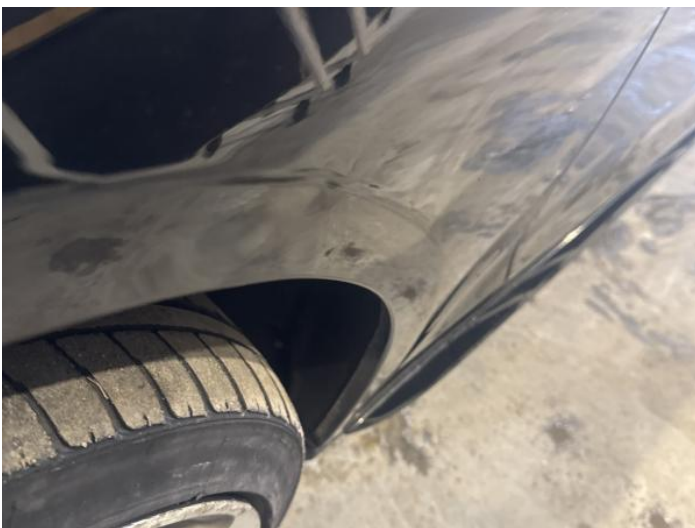
7: Wing nsf  
Dented  
Over 30mm

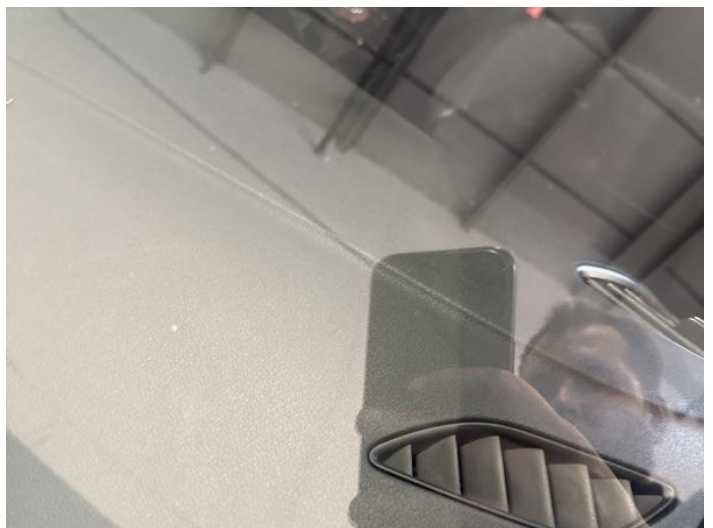
8: Screen Front  
Chipped  
UpTo 10mm

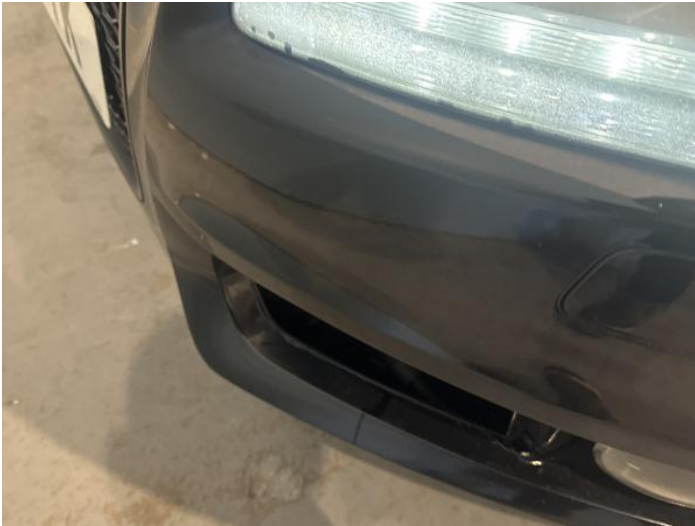
9: Bumper Front  
Poor Previous Repair  
Paint Flake

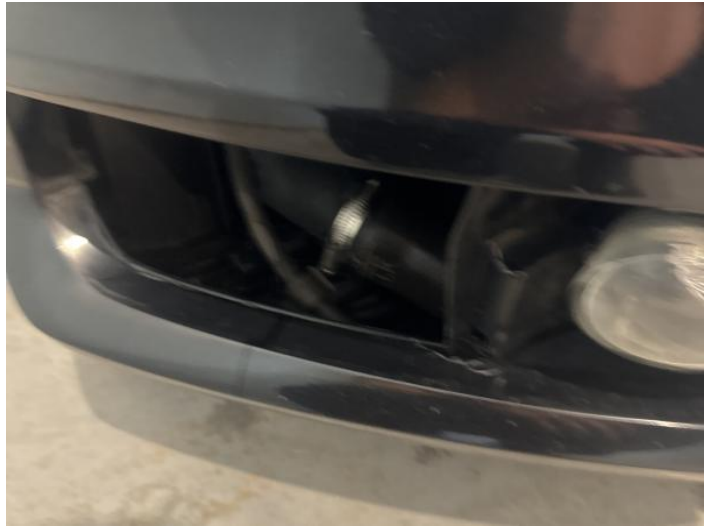
10: Bumper Front Moulding  
Broken  
Replace

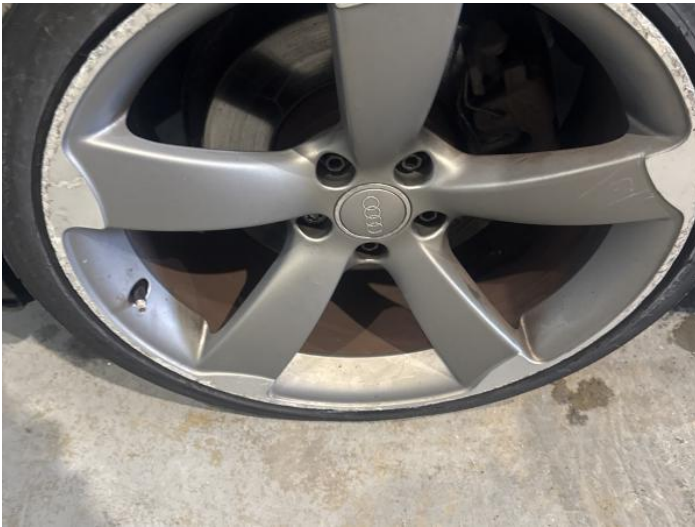
11: Wheel nsf  
Scratched  
Over 50mm

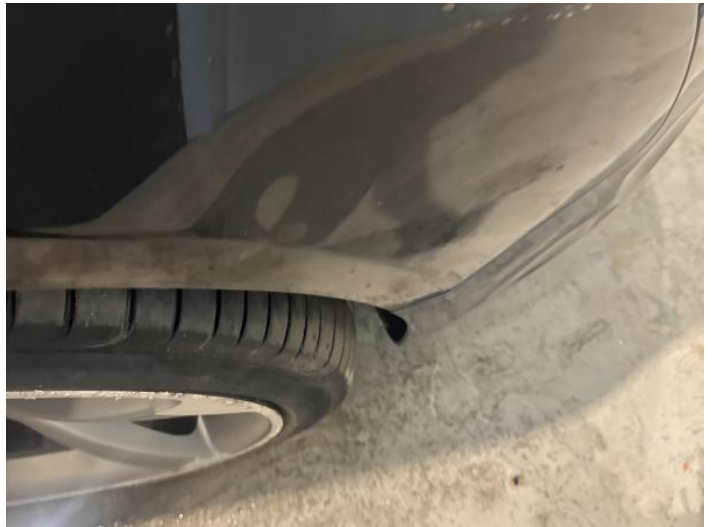
12: Wing osf  
Dented  
Over 30mm

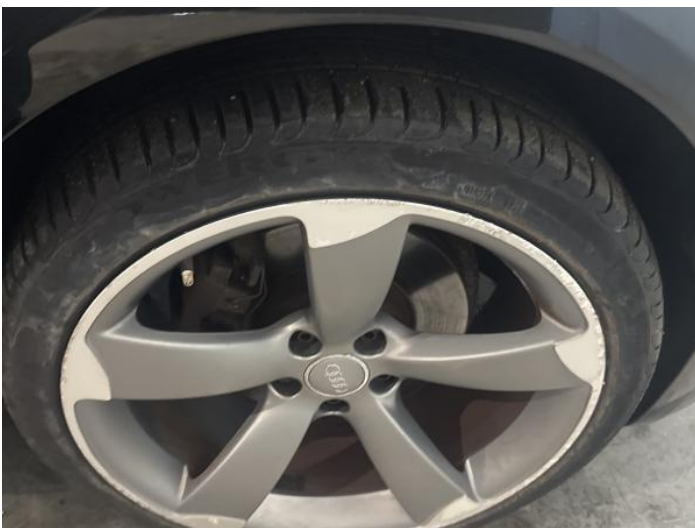
13: Wheel osf  
Scratched  
Over 50mm

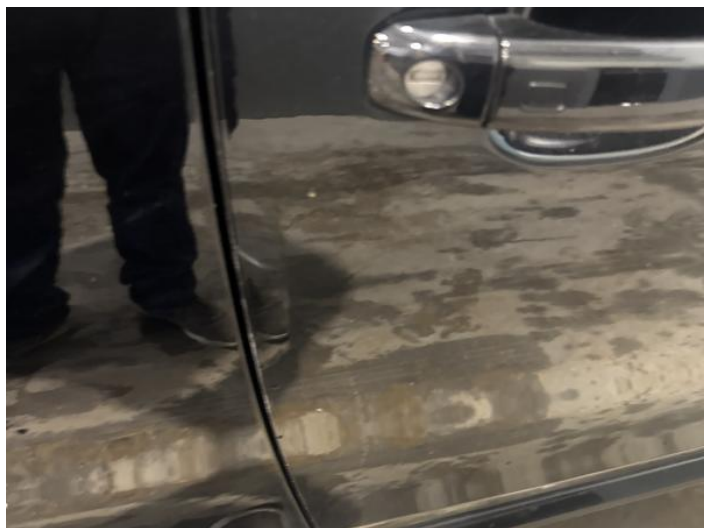
14: Door osf  
Dented  
Over 30mm

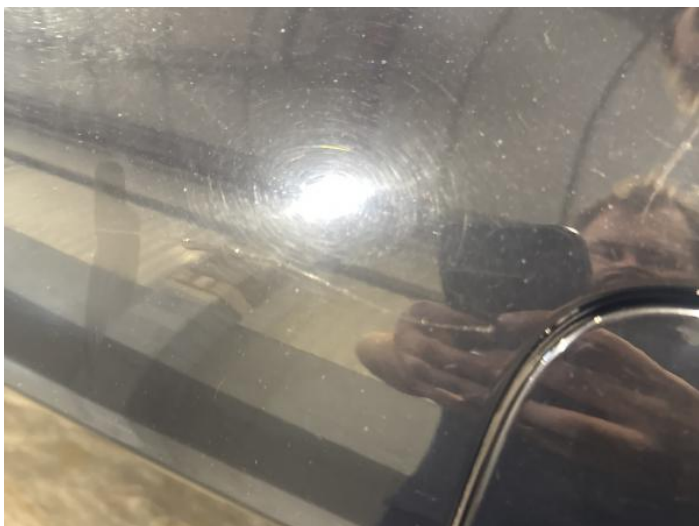
15: Qtr Panel osr  
Scratched  
Over 25mm Thru Paint
