VEHICLE INSPECTION REPORT

VE67CWP

Ford Focus 1.5 EcoBoost Titanium 5dr Auto

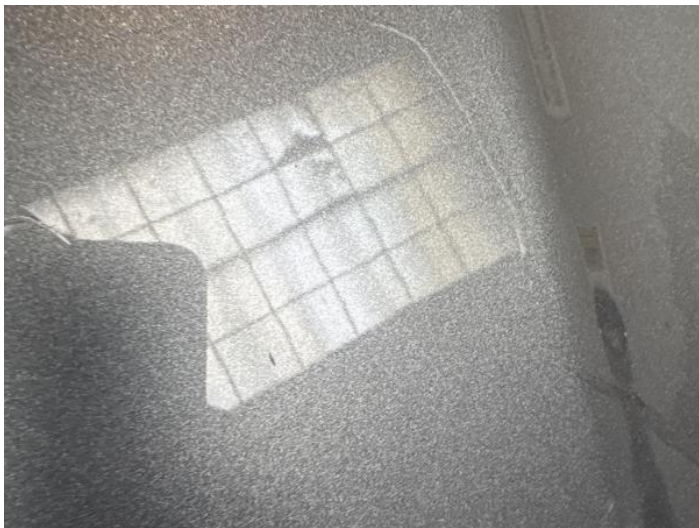
1: Bonnet
Chipped
1 To 5

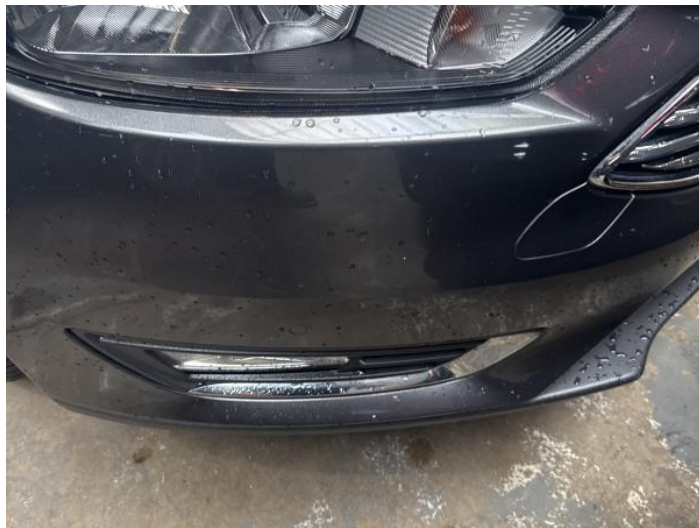
2: Bumper Front
Chipped
Multiple Chips

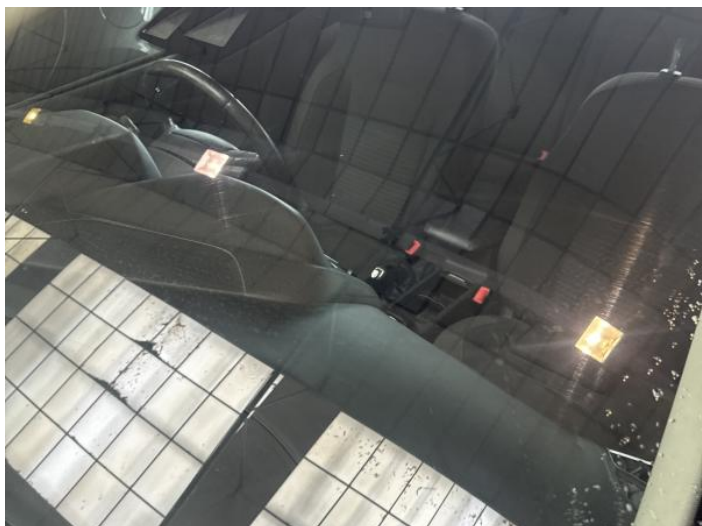
3: Screen Front
Chipped
UpTo 10mm

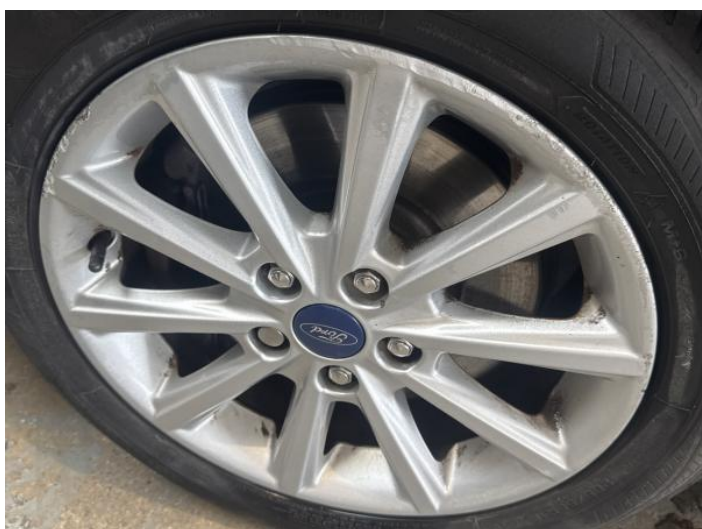
5: Wheel nsf
Scratched
Over 50mm

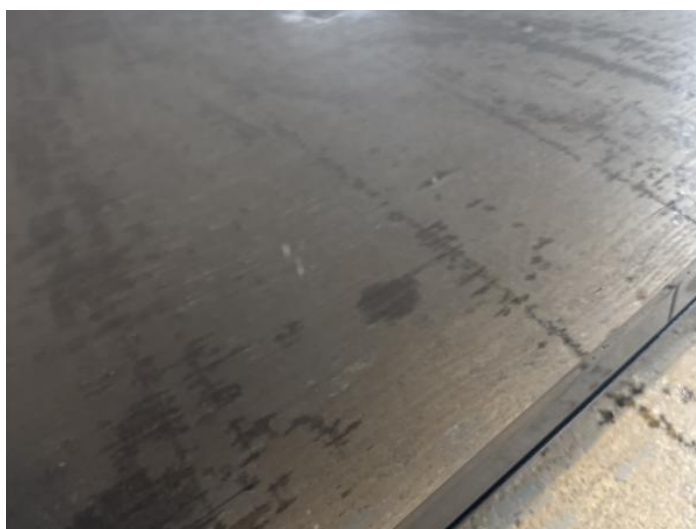
6: Door nsf
Dented
Over 2 UpTo 10mm

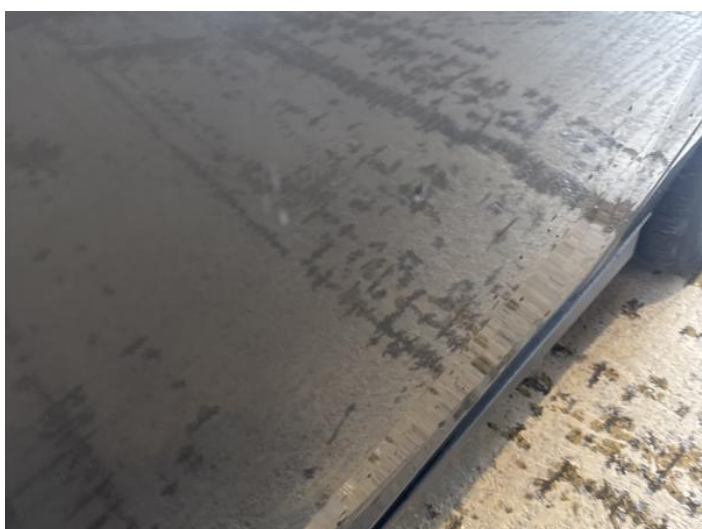
7: Door nsr
Chipped
1 To 5

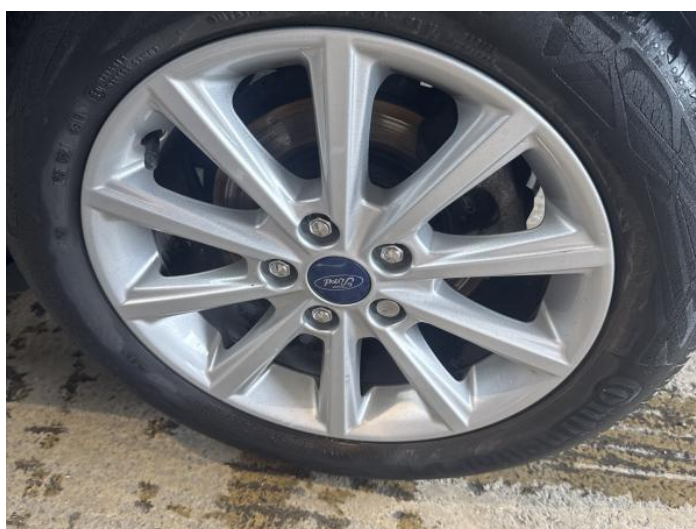
8: Wheel nsr
Scratched
Up To 50mm

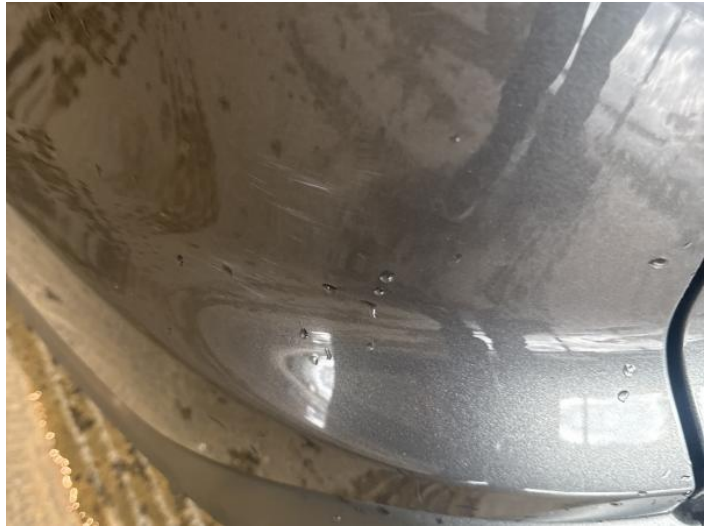
9: Qtr Panel nsr
Scratched
Over 25mm Not Thru Paint

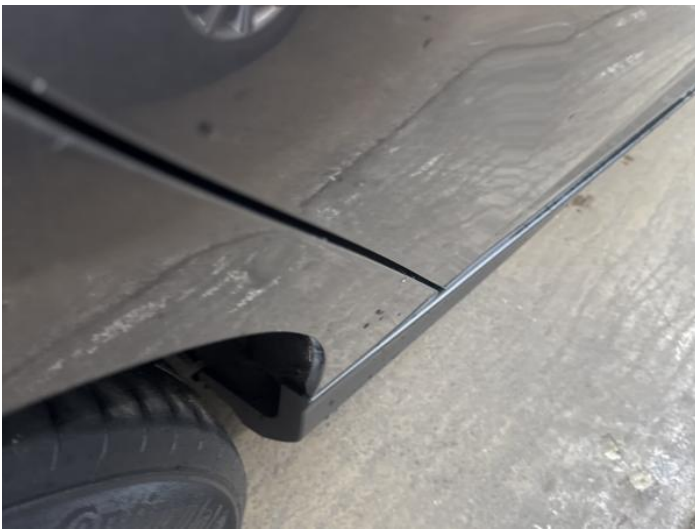
11: Qtr Panel osr
Dented
2 Or Less UpTo 10mm

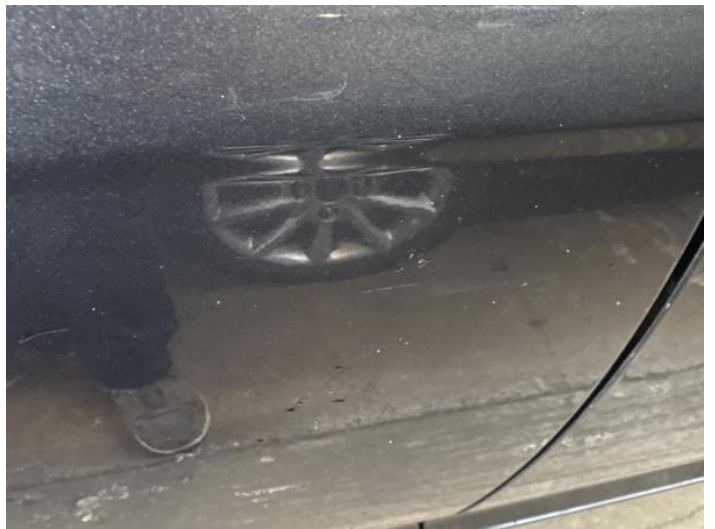
12: Door osr
Scratched
UpTo 25mm Thru Paint

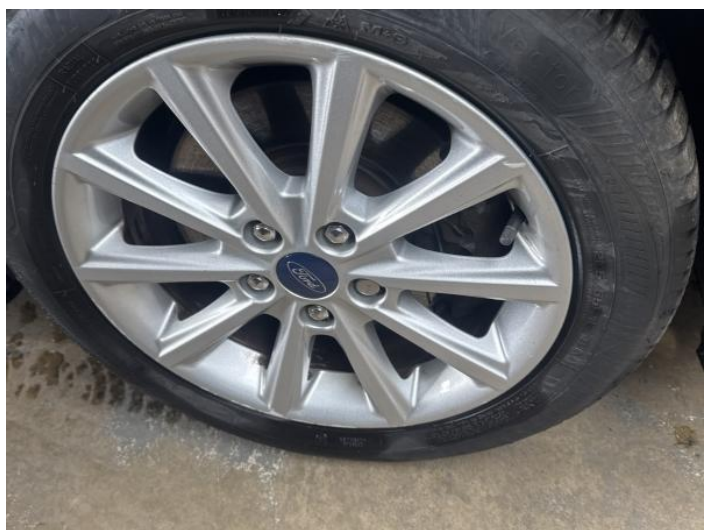
14: Wheel osf
Scratched
Up To 50mm

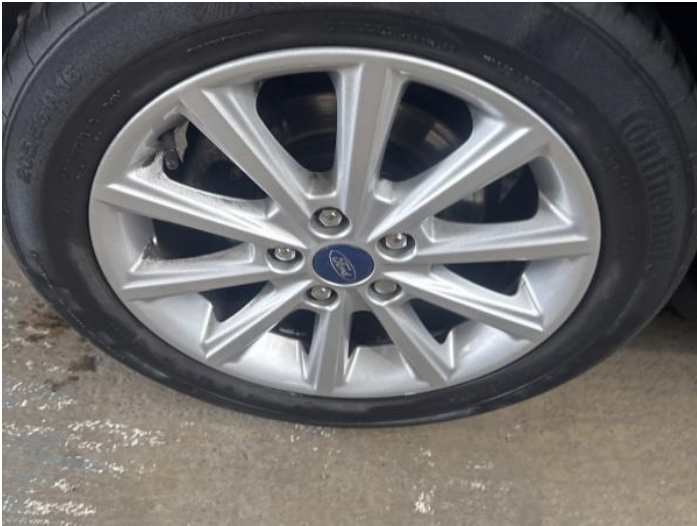
15: Wheel osr
Scratched
Up To 50mm
