# VEHICLE INSPECTION REPORT

**ML08SSK**

## Mitsubishi Lancer 1.6 Equippe 4dr Auto

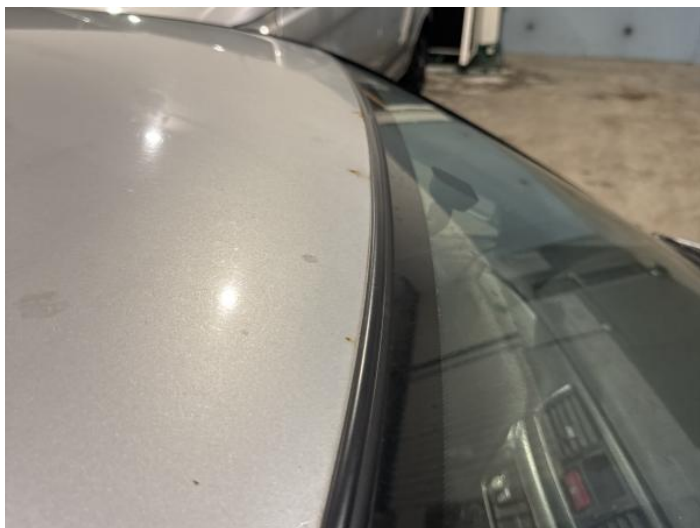
1: Roof  
Rusted  
Over 5mm

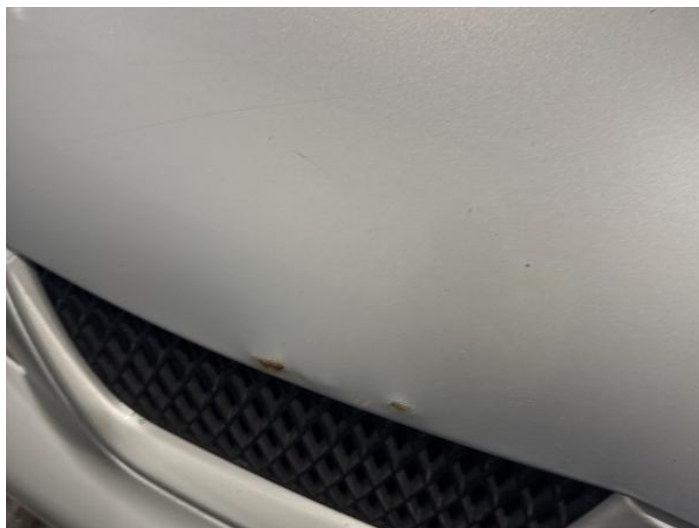
2: Bonnet  
Dented  
With Paint Damage

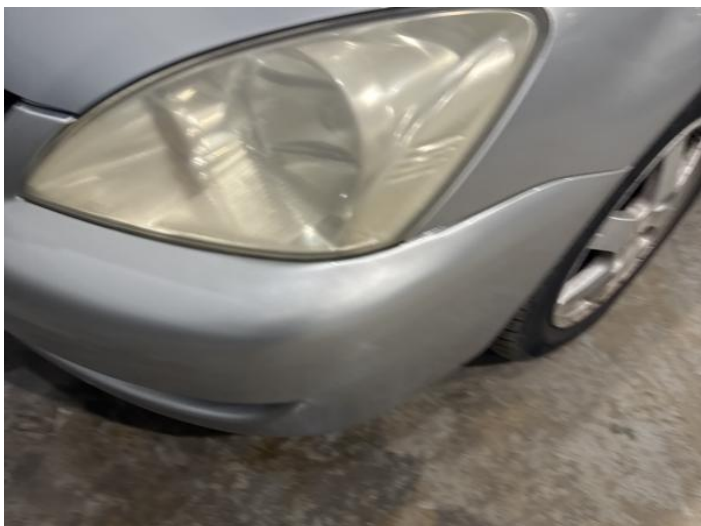
3: Bumper Front  
Poor Previous Repair  
Poor Paint

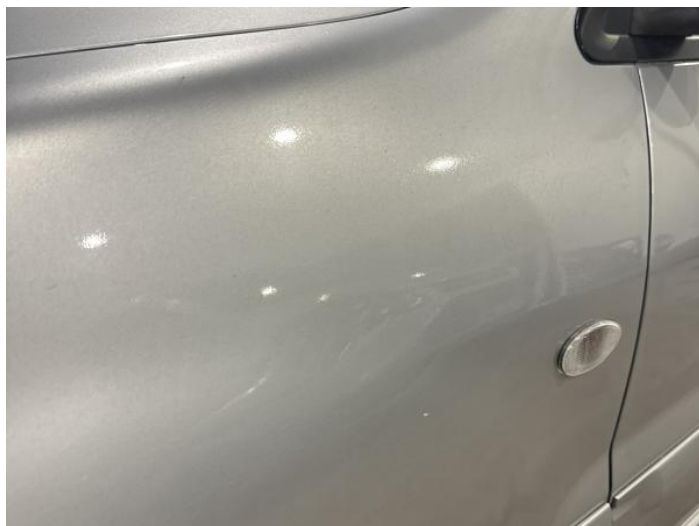
4: Wing nsf  
Poor Previous Repair  
Poor Paint

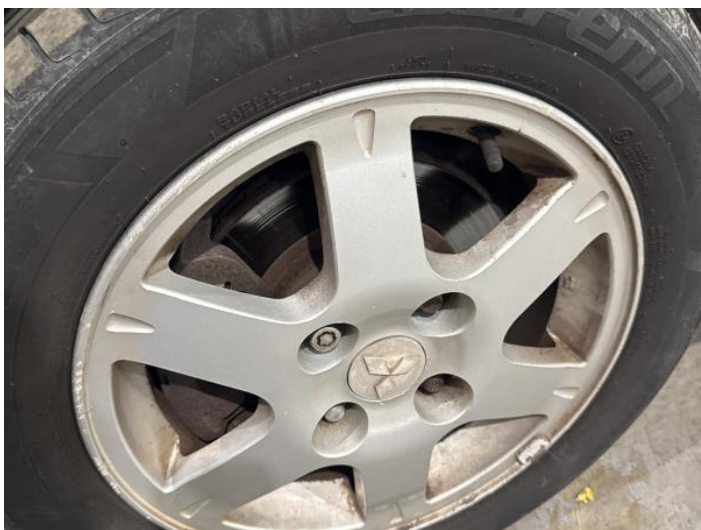
5: Wheel nsf  
Scratched  
Over 50mm

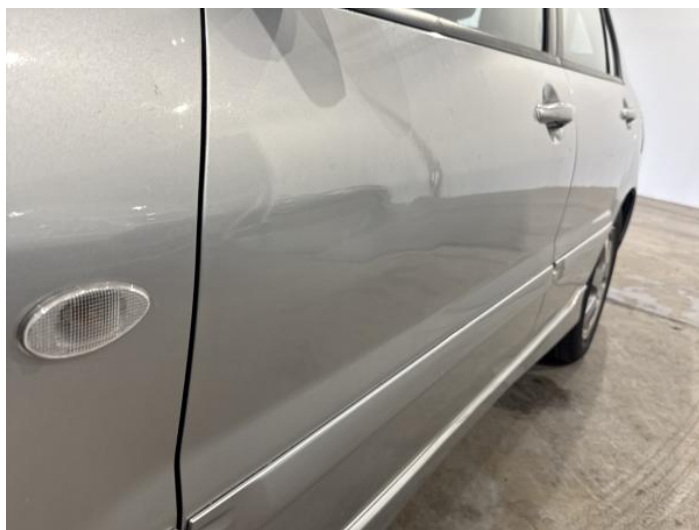
6: Door nsf  
Dented  
Over 30mm

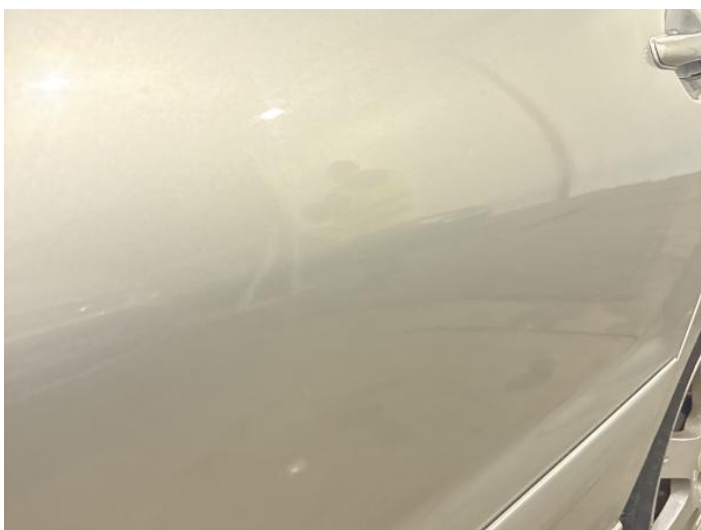
7: Door nsr  
Poor Previous Repair  
Poor Paint

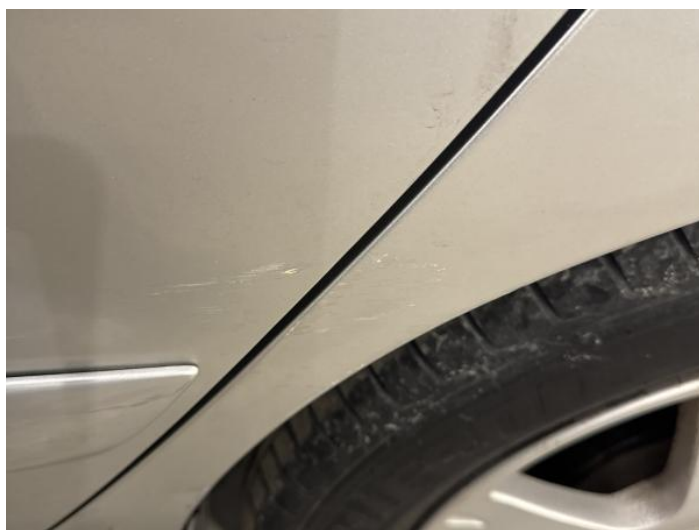
8: Qtr Panel nsr  
Scratched  
Over 25mm Thru Paint

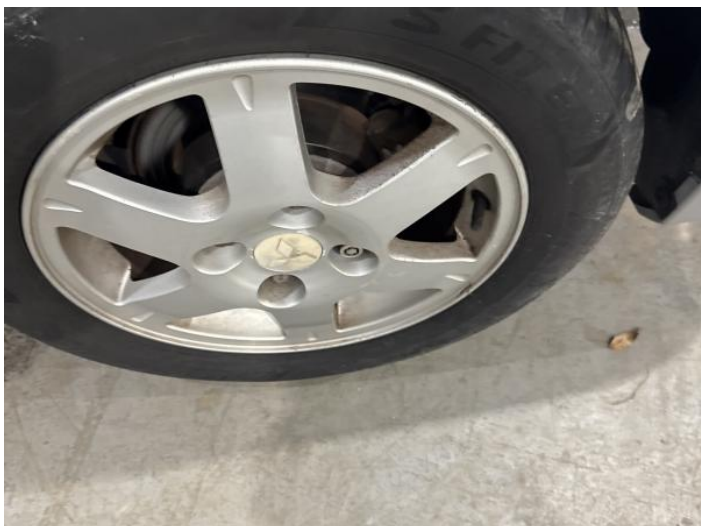
9: Wheel nsr  
Scratched  
Over 50mm

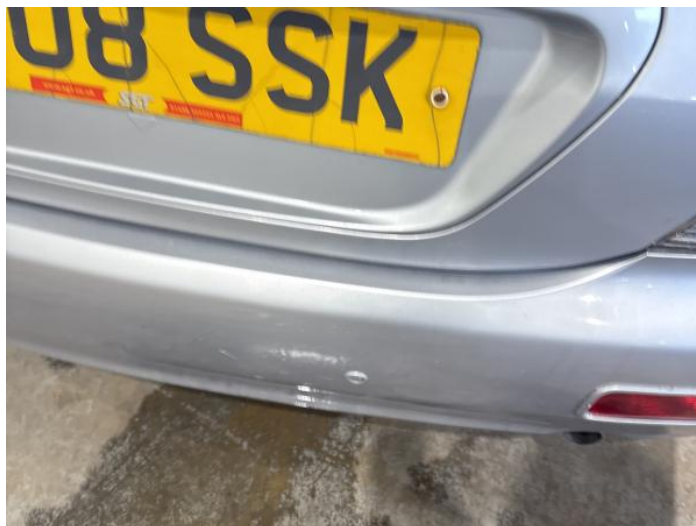
10: Bumper Rear  
Poor Previous Repair  
Poor Paint

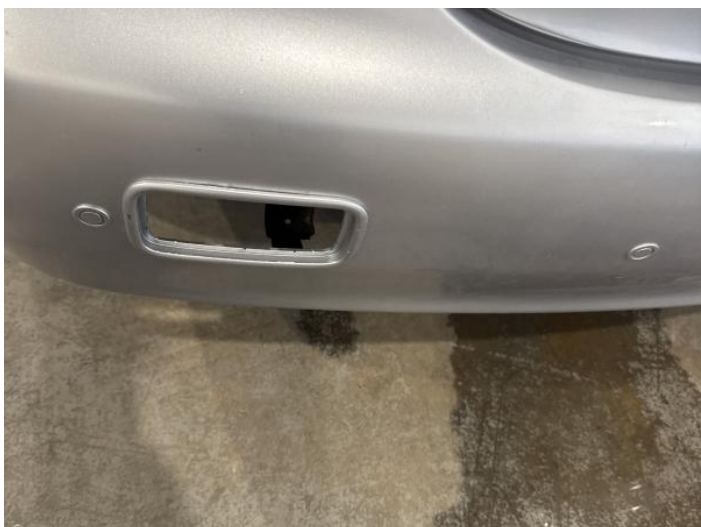
11: Reflector nsr  
Missing  
Replace

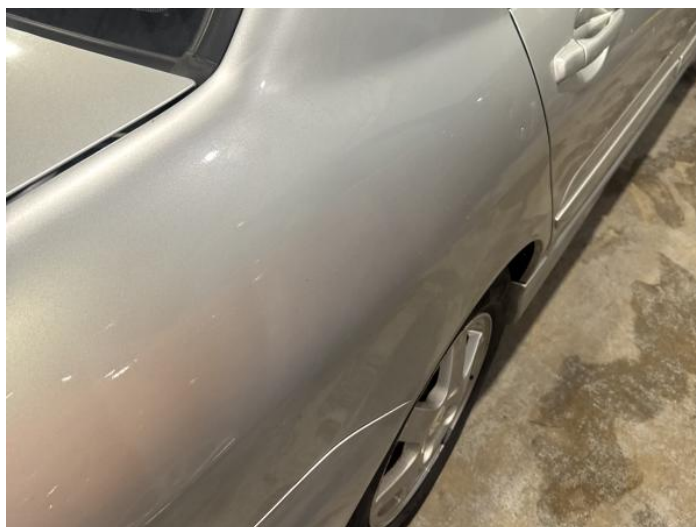
12: Qtr Panel osr  
Dented  
With Paint Damage

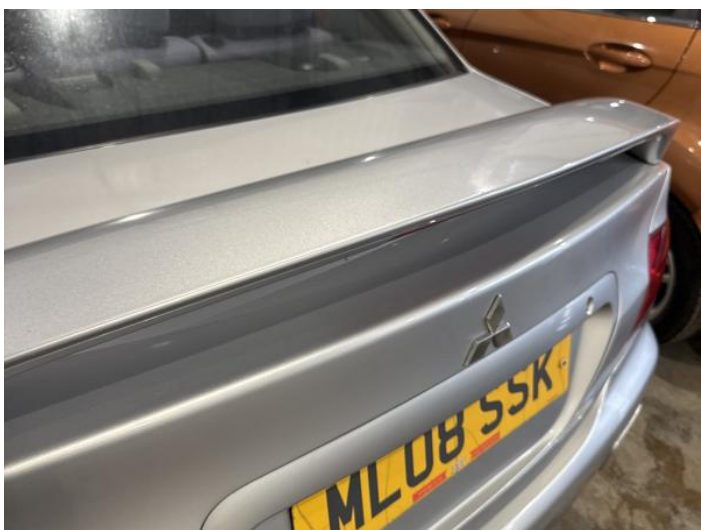
13: Boot Lid  
Chipped  
1 To 5

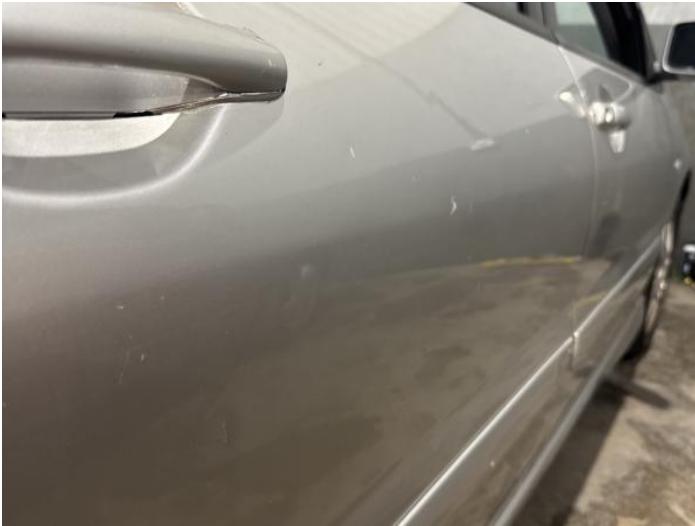
15: Door osr  
Dented  
With Paint Damage

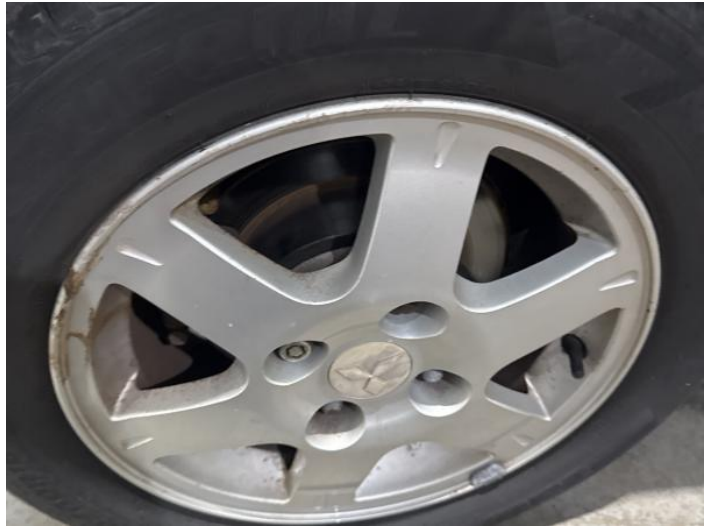
16: Wheel osr  
Scratched  
Over 50mm

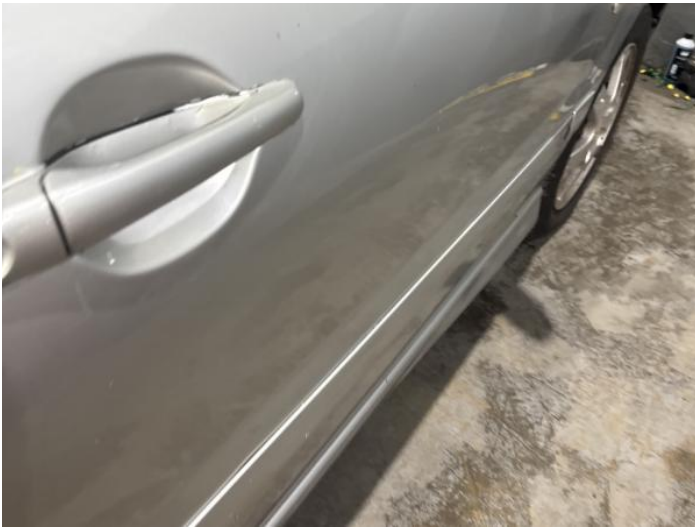
17: Door osf  
Dented  
With Paint Damage

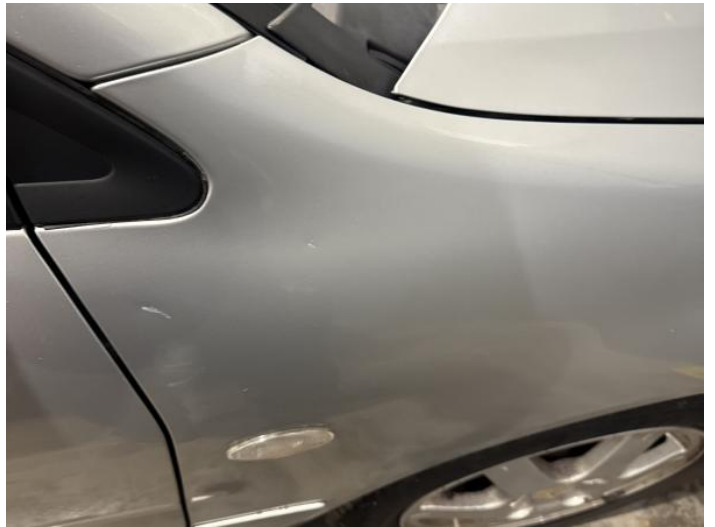
18: Wing osf  
Dented  
With Paint Damage

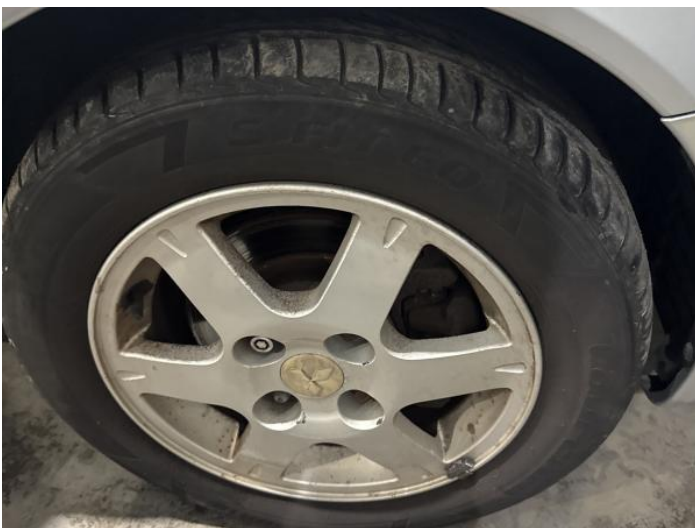
19: Wheel osf  
Scratched  
Over 50mm
