# VEHICLE INSPECTION REPORT

LO16NVZ

## Volkswagen Golf 1.6 TDI 110 Match Edition 5dr

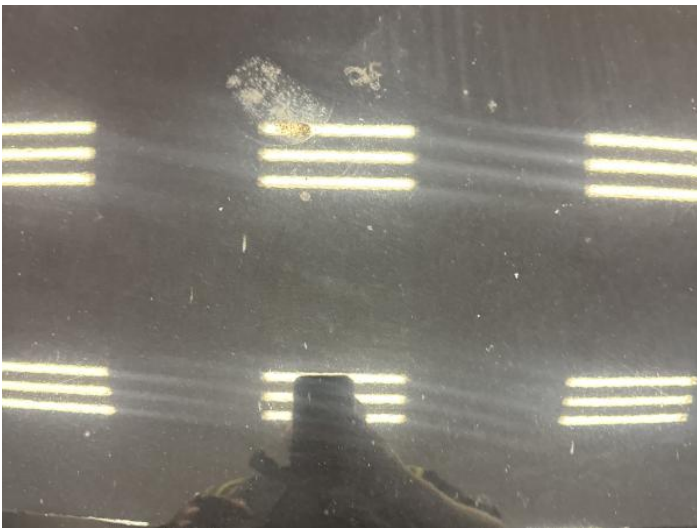
1: Bonnet  
Chipped  
Multiple Chips

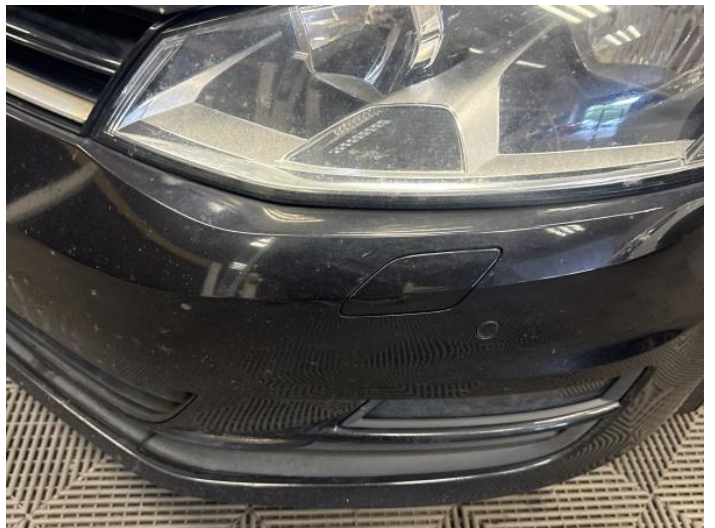
2: Bumper Front  
Poor Previous Repair  
Poor Paint

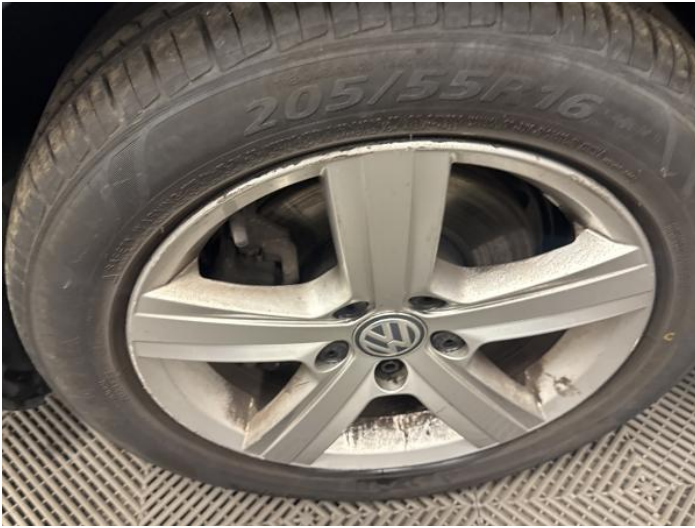
3: Wheel nsf  
Scratched  
Over 50mm

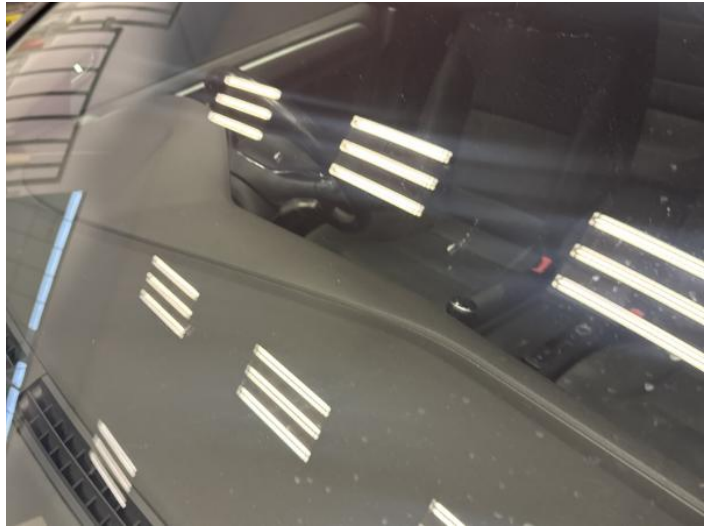
4: Screen Front  
Chipped  
UpTo 10mm

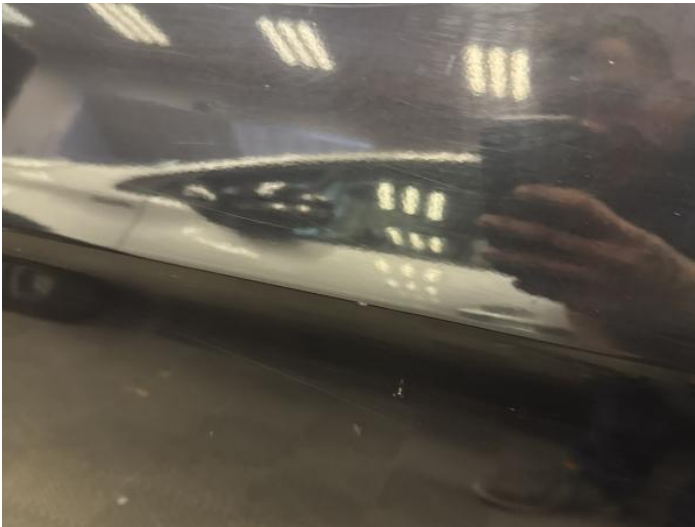
5: Door nsf  
Poor Previous Repair  
Poor Paint

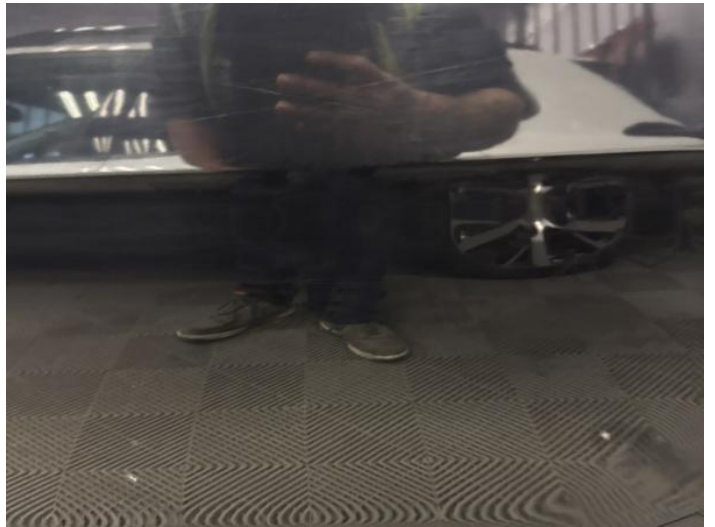
6: Door nsr  
Poor Previous Repair  
Poor Paint

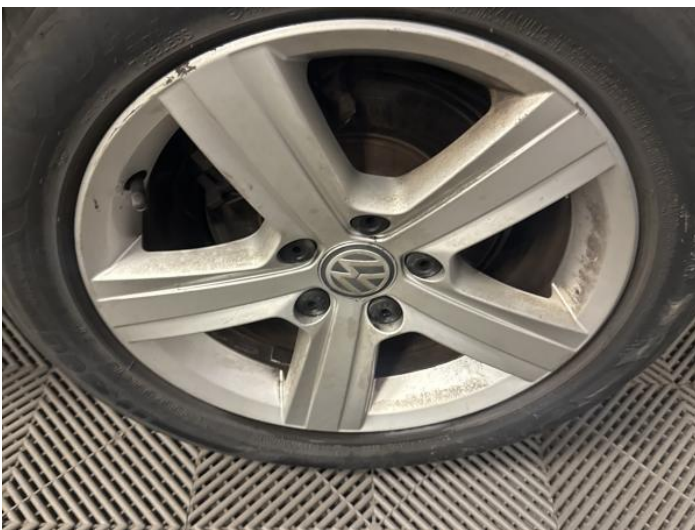
7: Wheel nsr  
Scratched  
Over 50mm

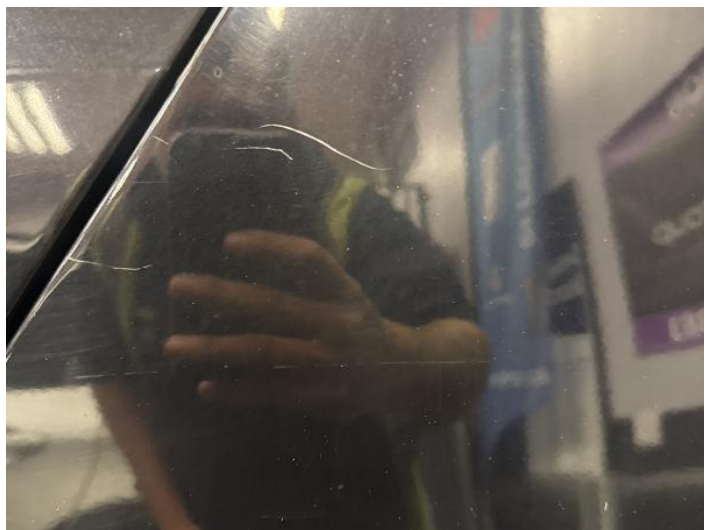
8: Qtr Panel nsr  
Scratched  
Over 25mm Thru Paint

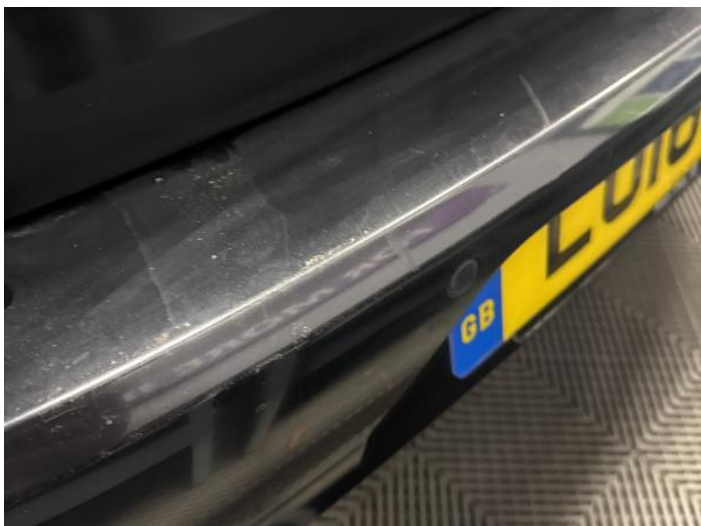
9: Bumper Rear  
Poor Previous Repair  
Poor Paint

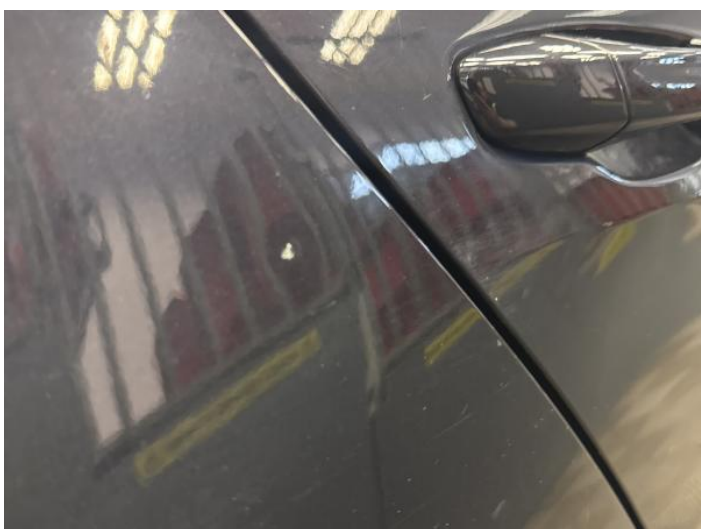
11: Qtr Panel osr  
Dented  
2 Or Less UpTo 10mm

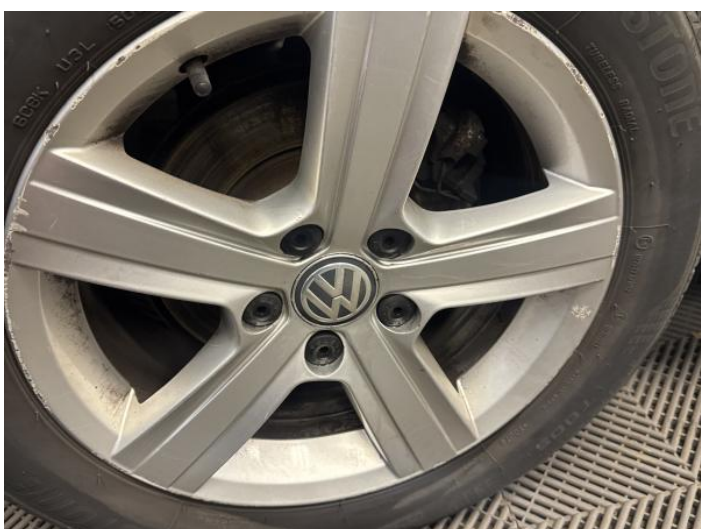
13: Wheel osr  
Scratched  
Over 50mm

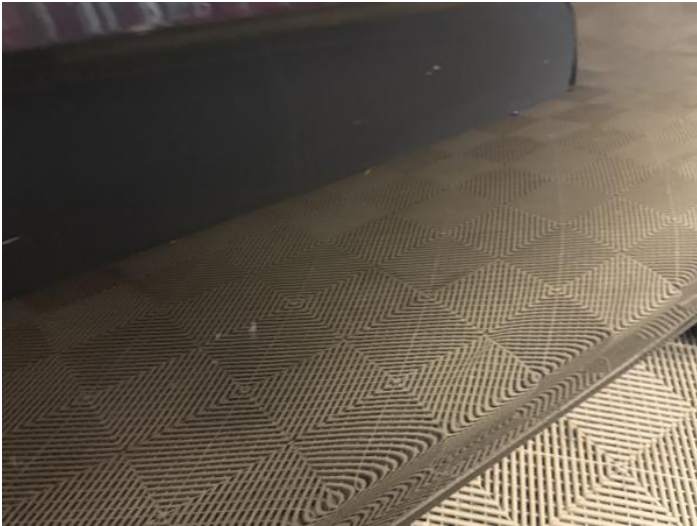
15: Door osf  
Chipped  
1 To 5

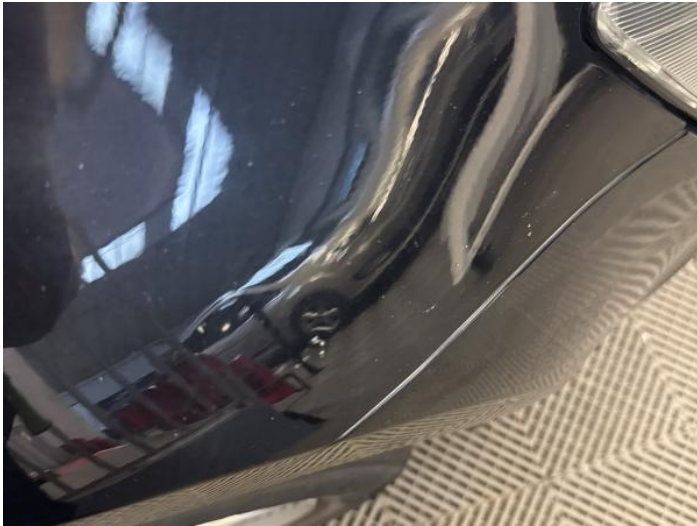
16: Wing osf  
Chipped  
Multiple Chips

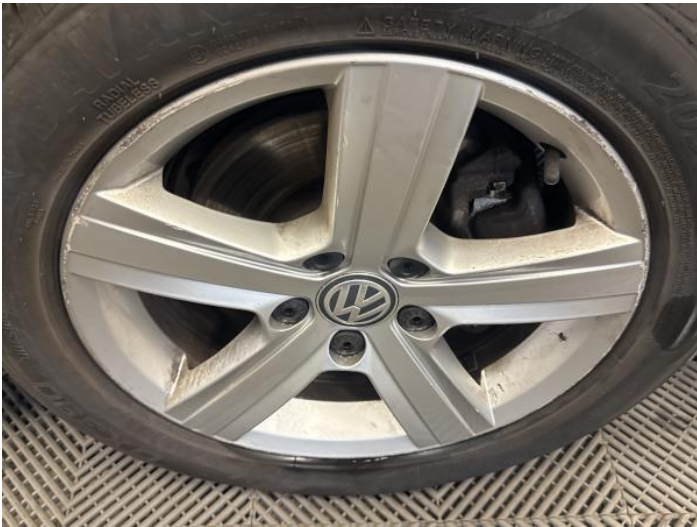
17: Wheel osf  
Scratched  
Over 50mm
