VEHICLE INSPECTION REPORT

HN14XZJ

Ford Fiesta 1.25 82 Zetec 5dr

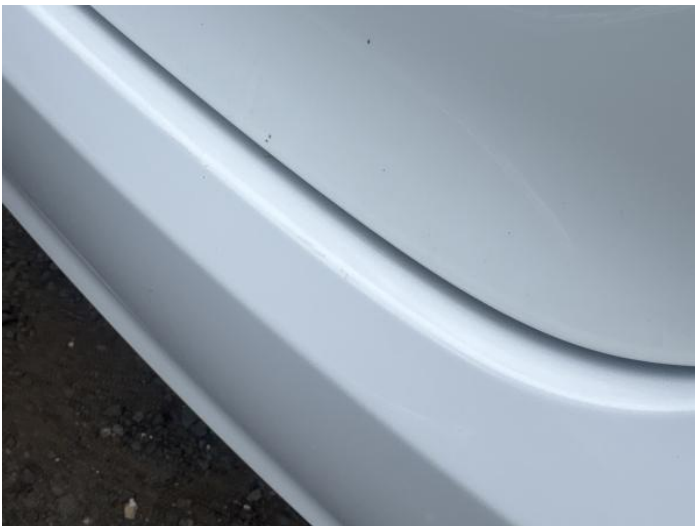
1: Bumper Rear
Chipped
Multiple Chips

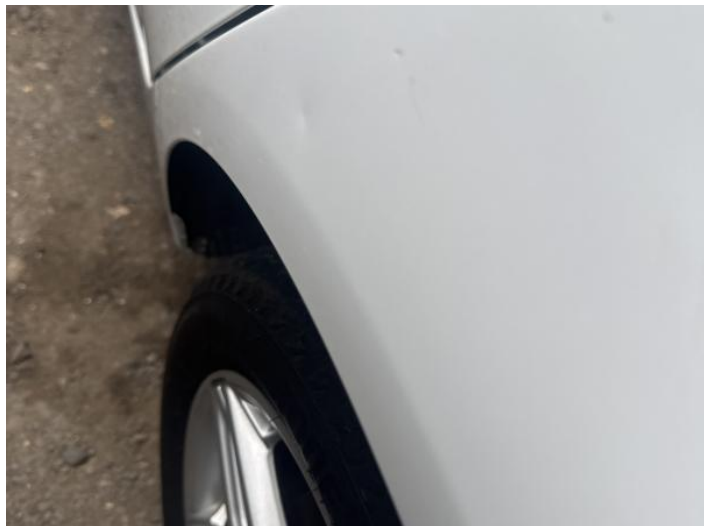
2: Qtr Panel nsr
Dented
Over 2 UpTo 10mm

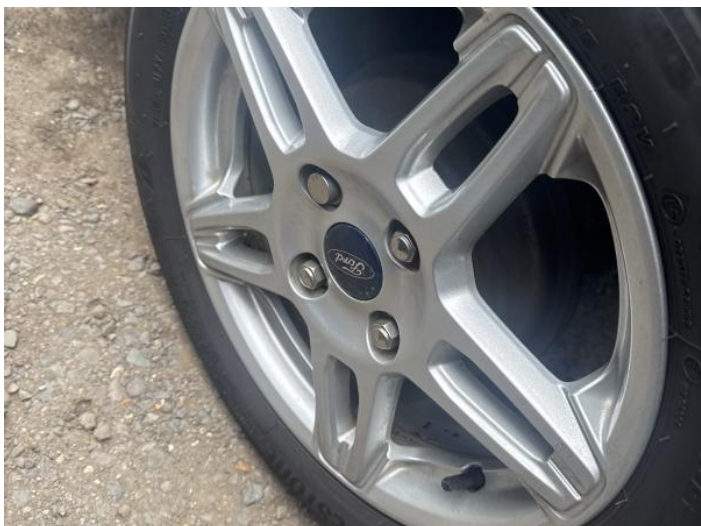
3: Wheel nsr
Scratched
Over 50mm

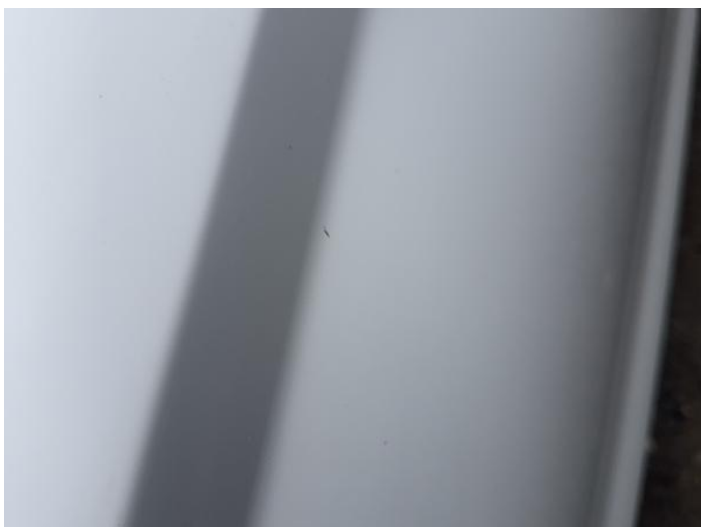
5: Door nsf
Chipped
1 To 5

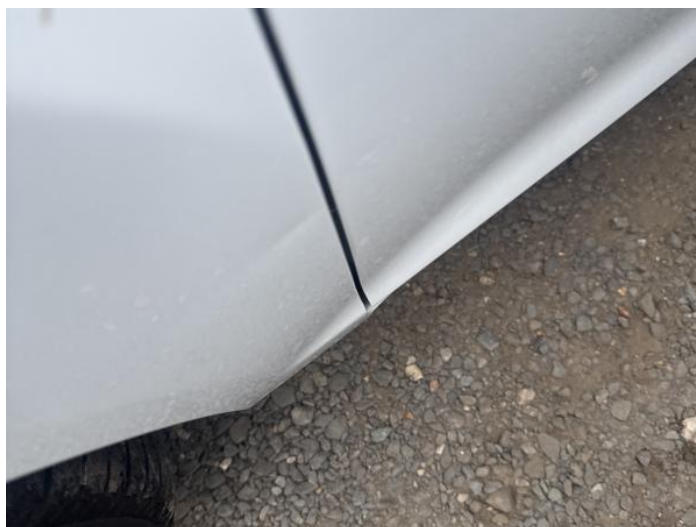
6: Wing nsf
Dented
Between 10mm + 30mm

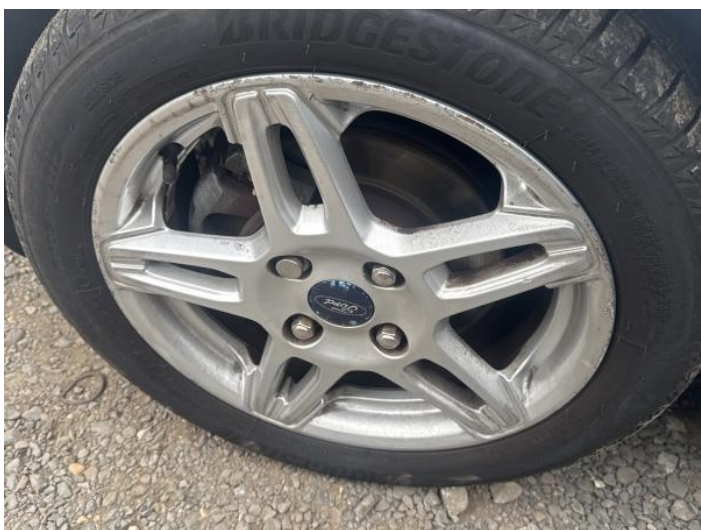
7: Wheel nsf
Scratched
Over 50mm

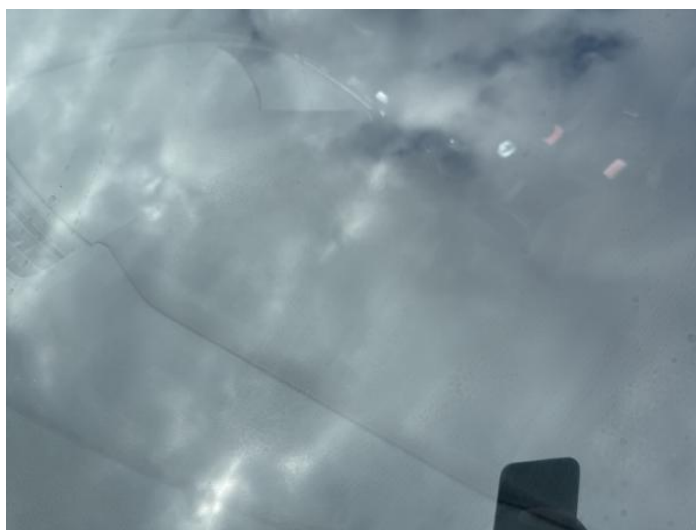
8: Screen Front
Chipped
UpTo 10mm

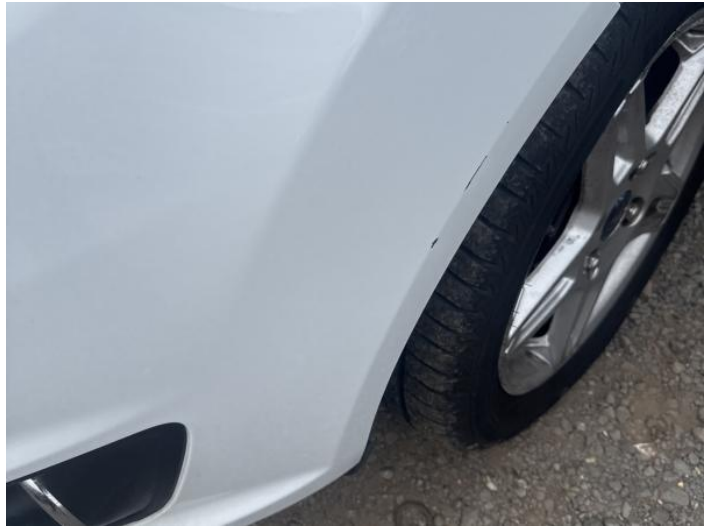
10: Bumper Front
Scratched
25 to 100mm Thru Paint

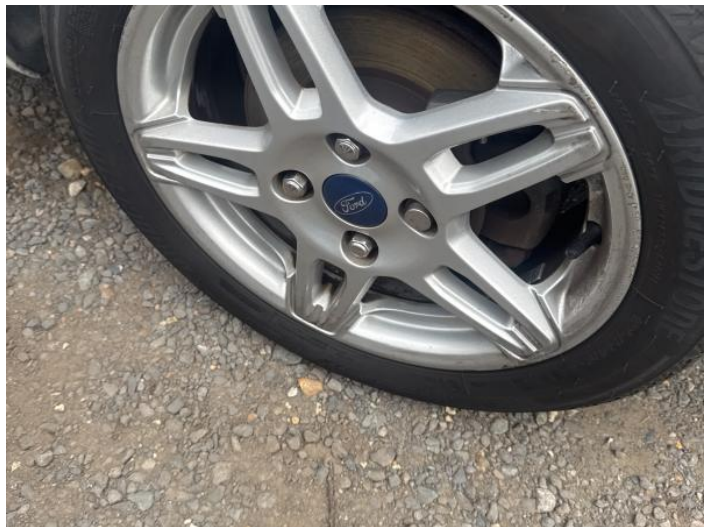
12: Wheel osf
Scratched
Over 50mm

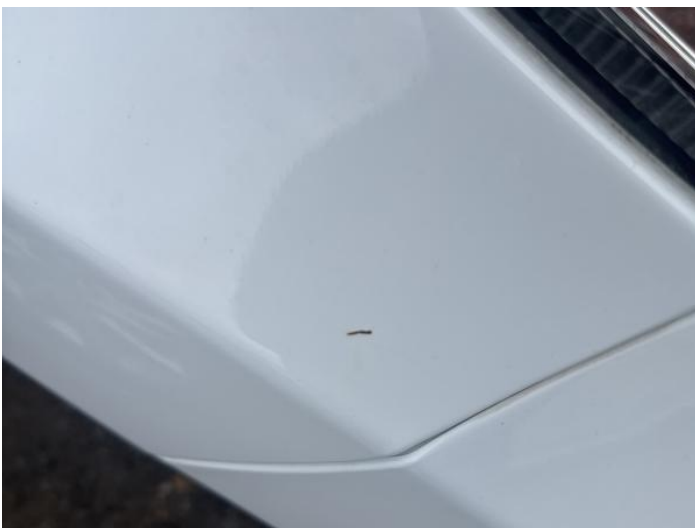
13: Wing osf
Chipped
1 To 5

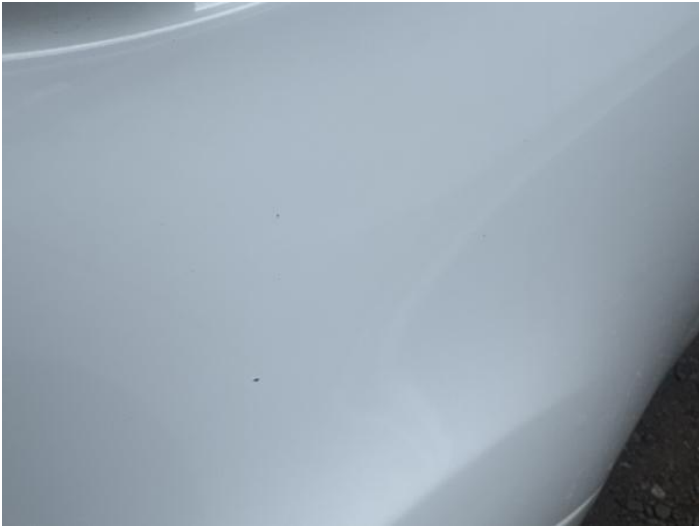
15: Door osr
Chipped
1 To 5

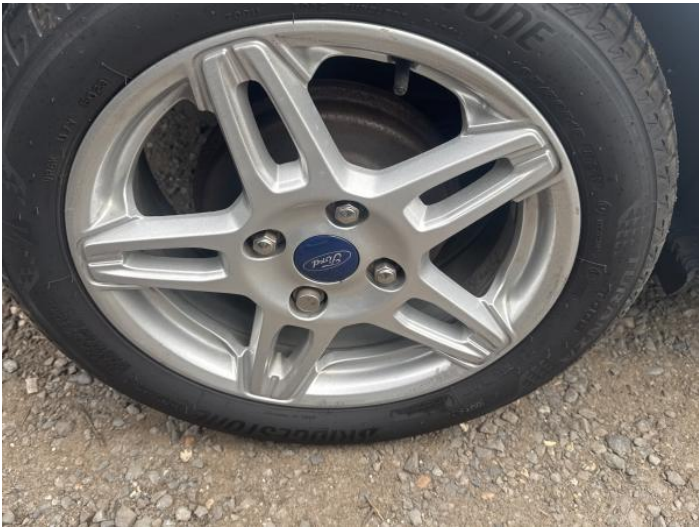
17: Wheel osr
Scratched
Up To 50mm
