VEHICLE INSPECTION REPORT

EO66JRV

Ford Focus 1.0 EcoBoost 125 Titanium 5dr

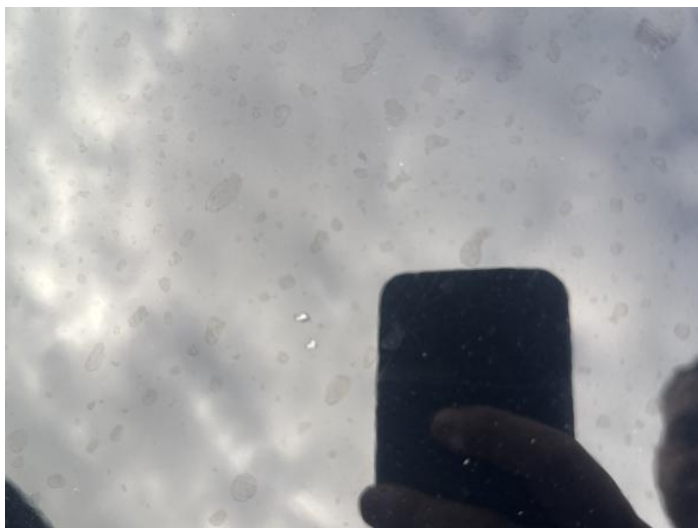
1: Bonnet
Chipped
1 To 5

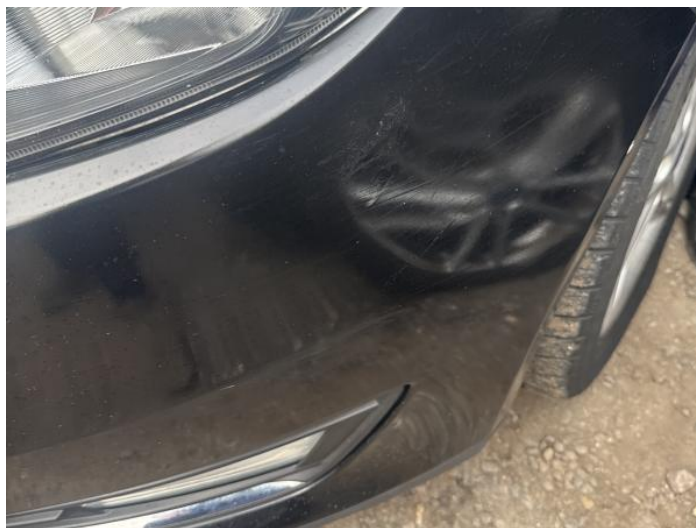
2: Bumper Front
Poor Previous Repair
Poor Paint

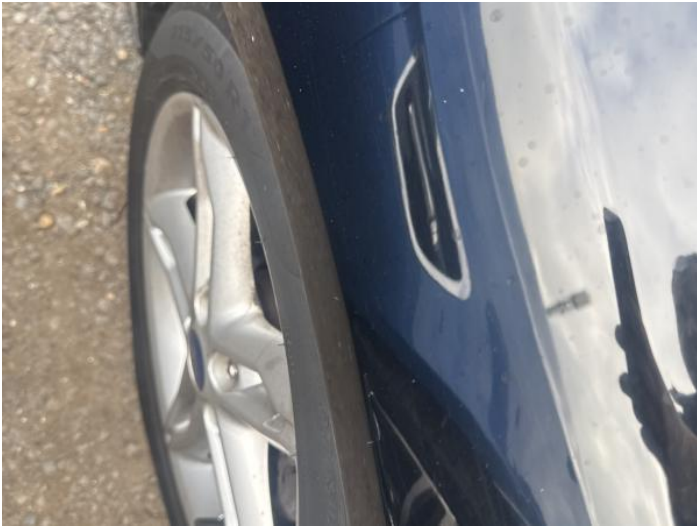
3: Wing osf
Chipped
Multiple Chips

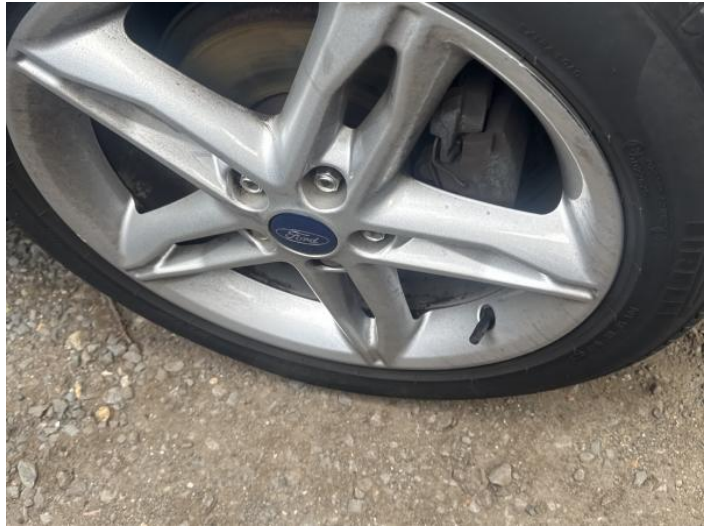
4: Wheel osf
Scratched
Over 50mm

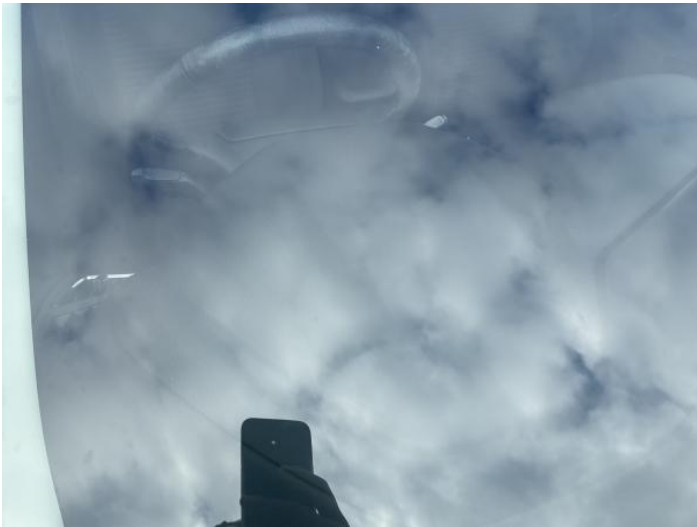
5: Screen Front
Chipped
UpTo 10mm

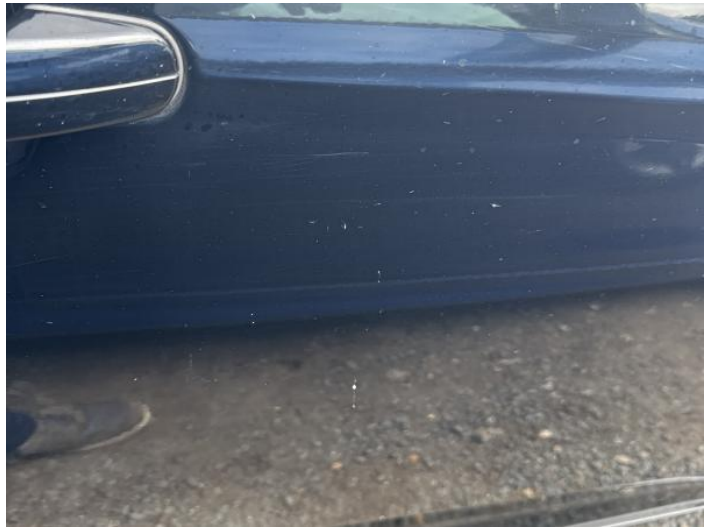
6: Door osf
Chipped
Multiple Chips

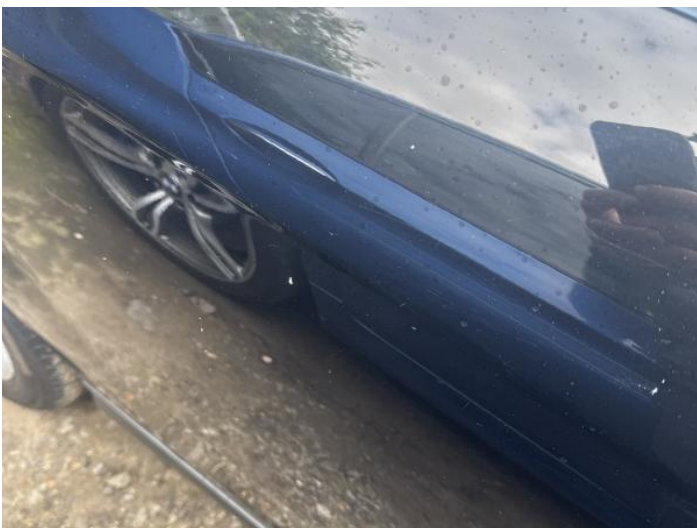
7: Door osr
Chipped
Multiple Chips

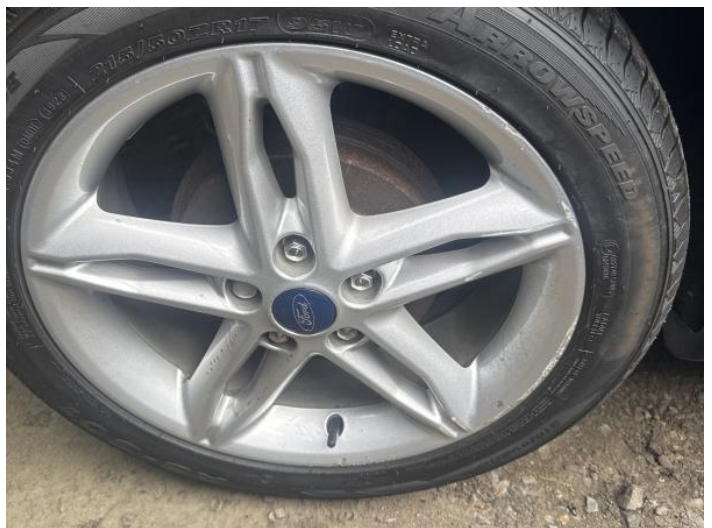
8: Wheel osr
Scratched
Over 50mm

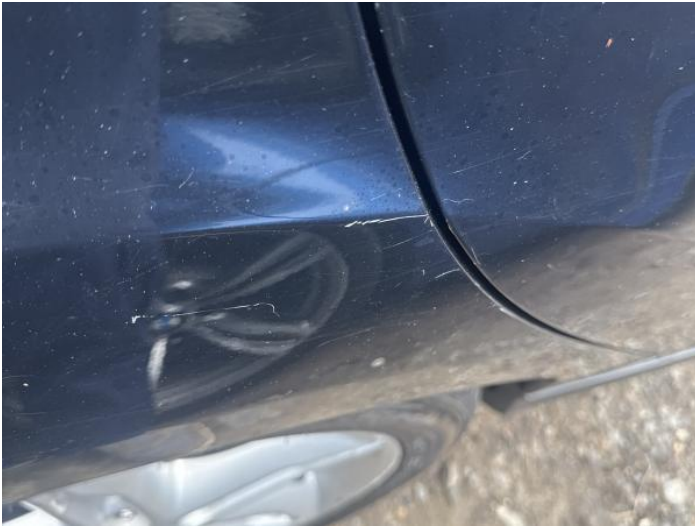
9: Qtr Panel osr
Chipped
1 To 5

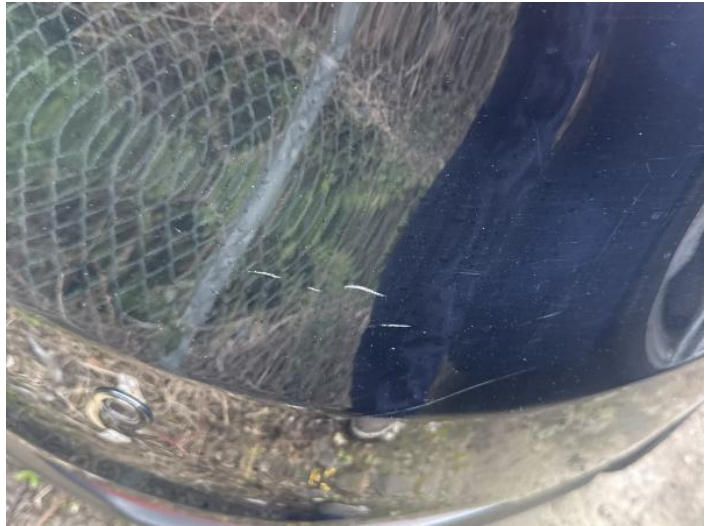
10: Bumper Rear
Scratched
25 to 100mm Thru Paint

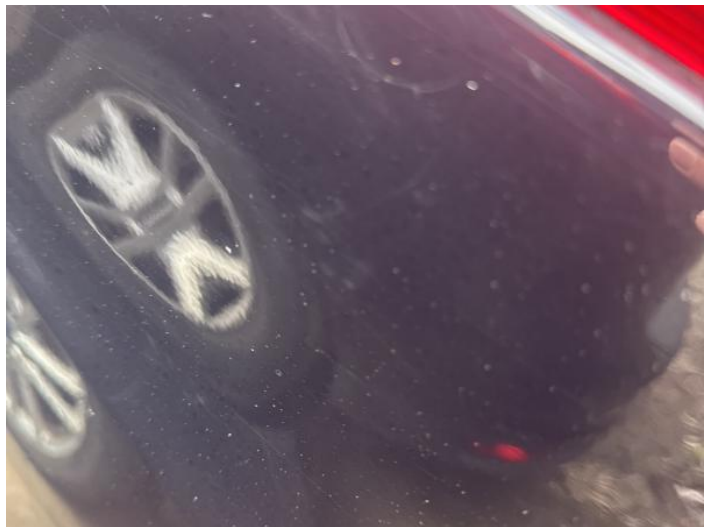
12: Qtr Panel nsr
Chipped
1 To 5

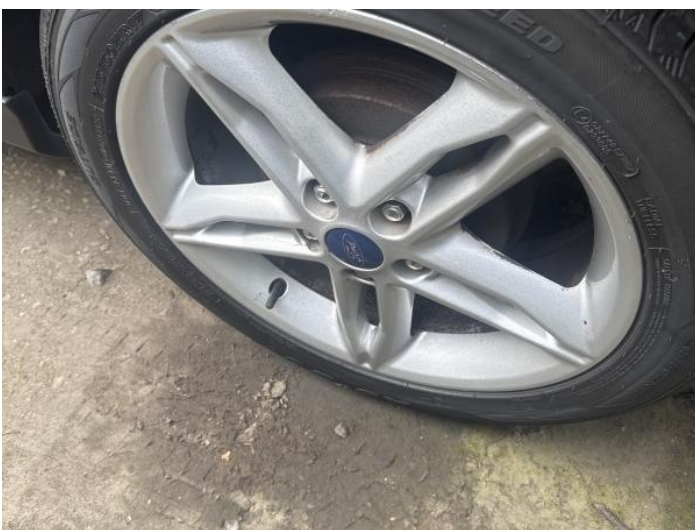
13: Wheel nsr
Scratched
Over 50mm

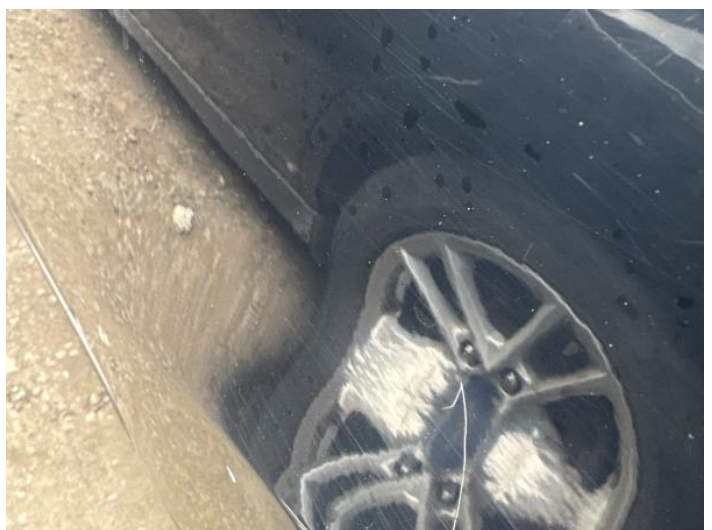
14: Door nsr
Scratched
Over 25mm Thru Paint

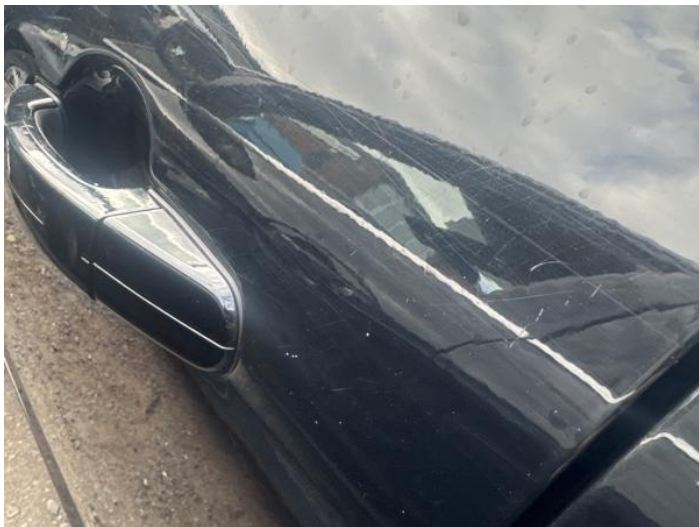
15: Door nsf
Chipped
1 To 5

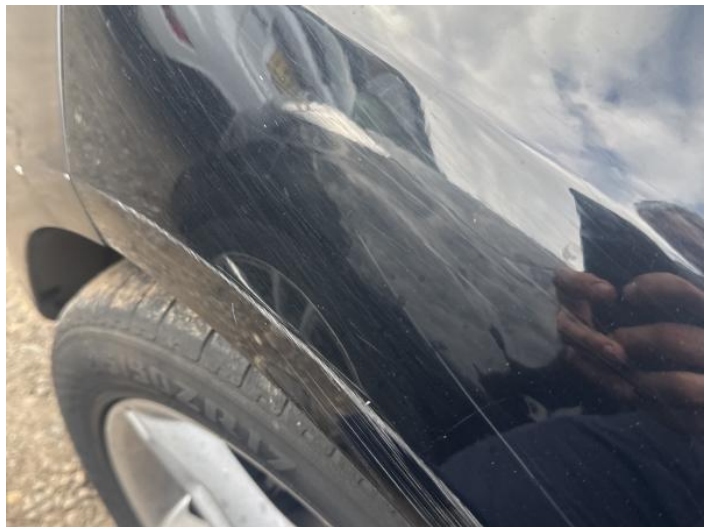
16: Wing nsf
Scratched
Over 25mm Thru Paint

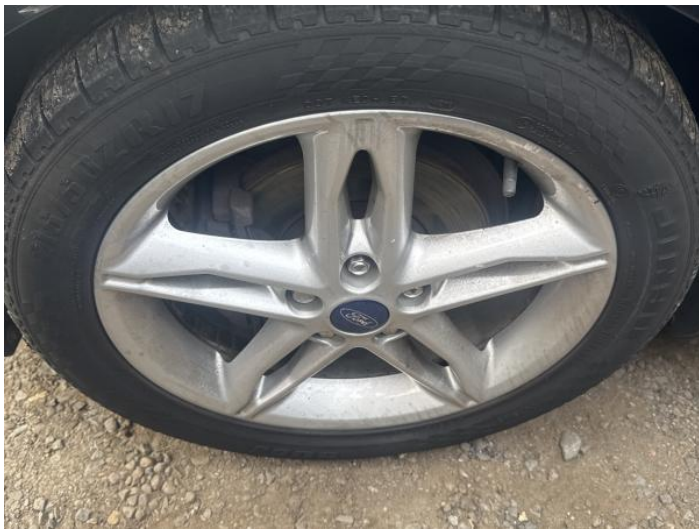
17: Wheel nsf
Scratched
Over 50mm
