VEHICLE INSPECTION REPORT

NA18KFX

Ford C-Max 1.0 EcoBoost Zetec 5dr

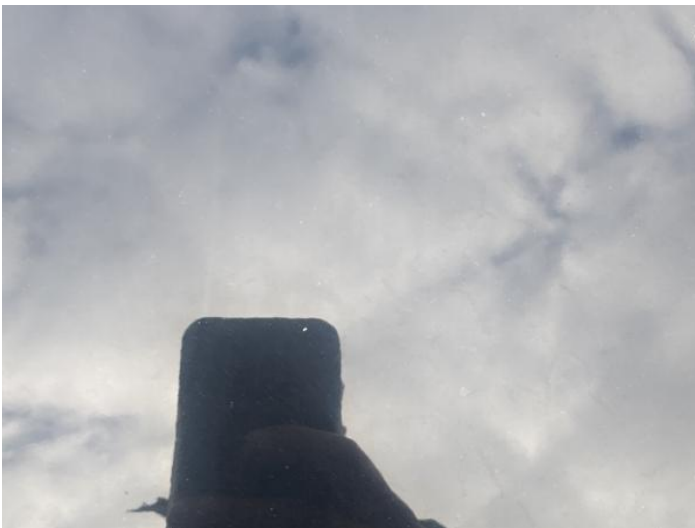
1: Bonnet
Chipped
1 To 5

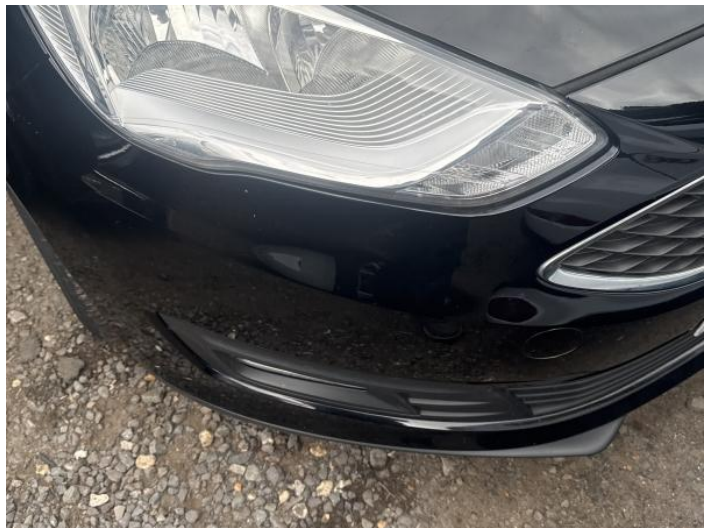
2: Bumper Front
Chipped
Multiple Chips

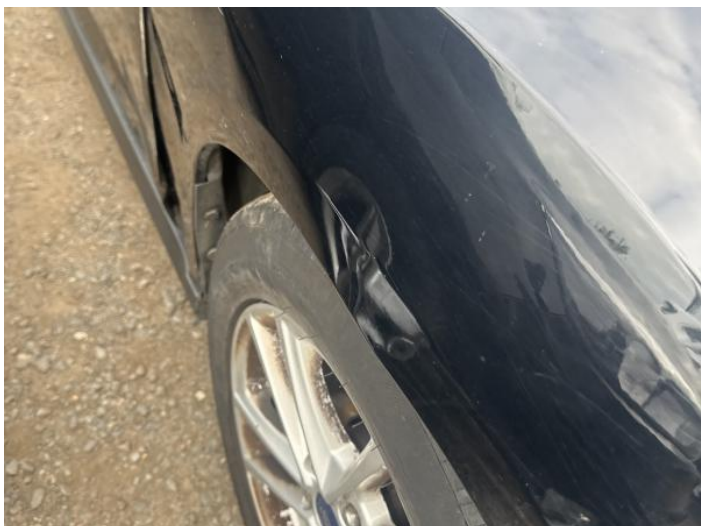
3: Wing osf
Dented
Over 30% Of Panel

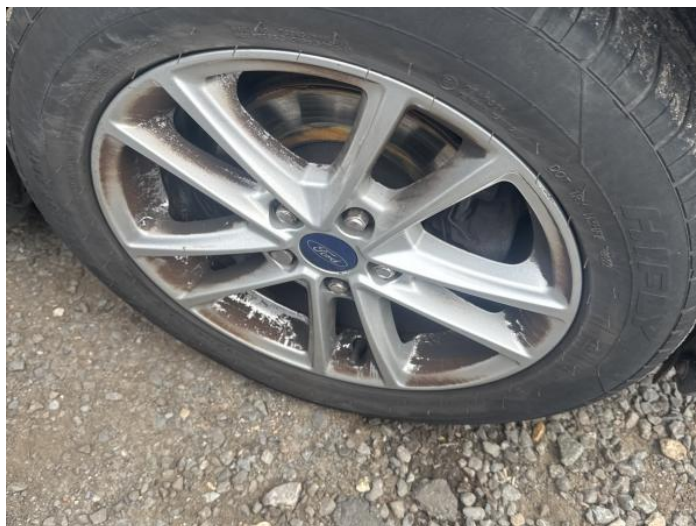
4: Wheel osf
Scratched
Over 50mm

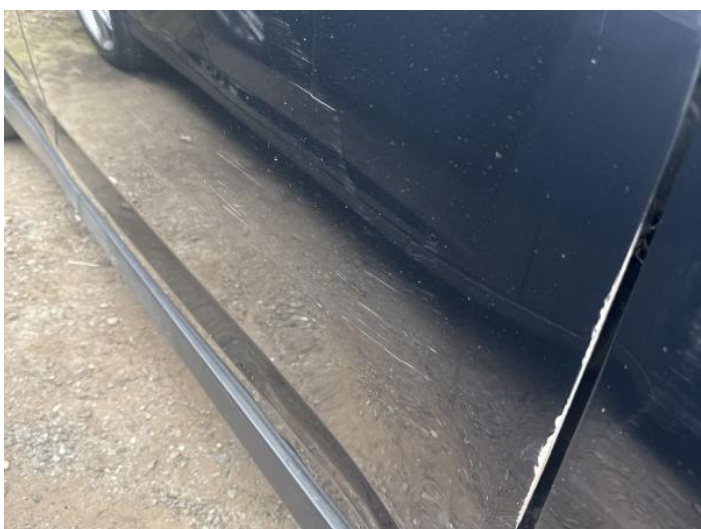
5: Door osf
Dented
Over 30% Of Panel

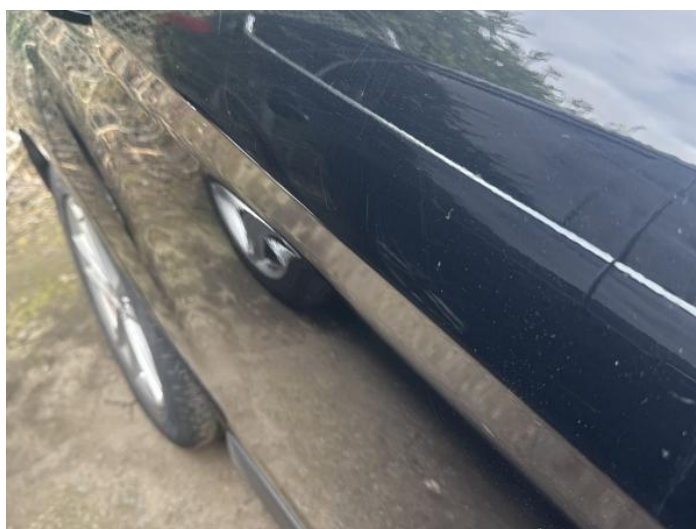
6: Door osr
Chipped
Multiple Chips

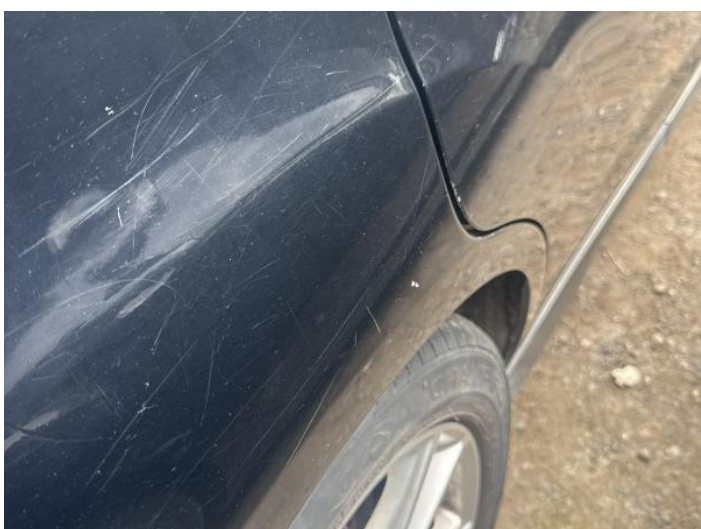
7: Qtr Panel osr
Dented
With Paint Damage

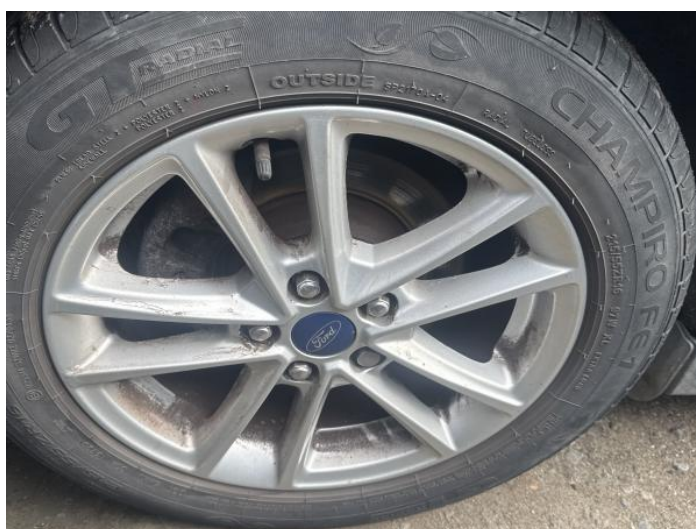
8: Wheel osr
Scratched
Over 50mm

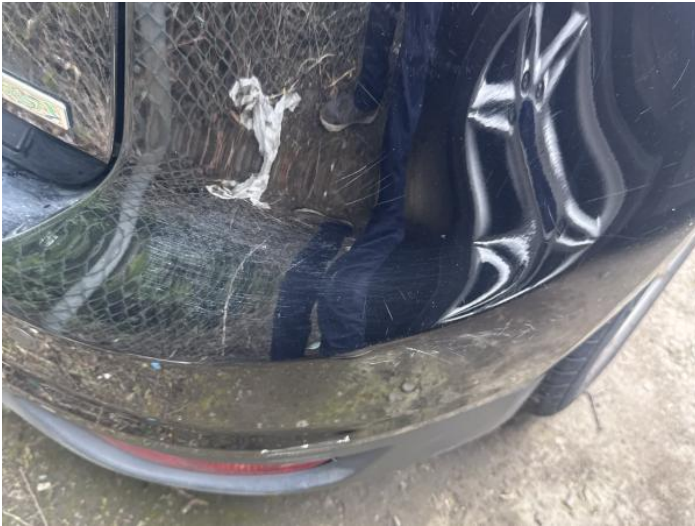
9: Bumper Rear
 Scratched
 Over 100mm Thru Paint

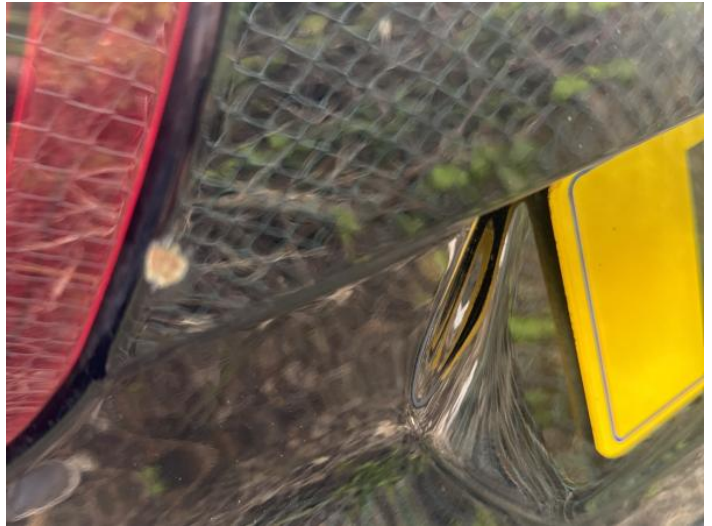
10: Boot Lid
 Rusted
 Over 5mm

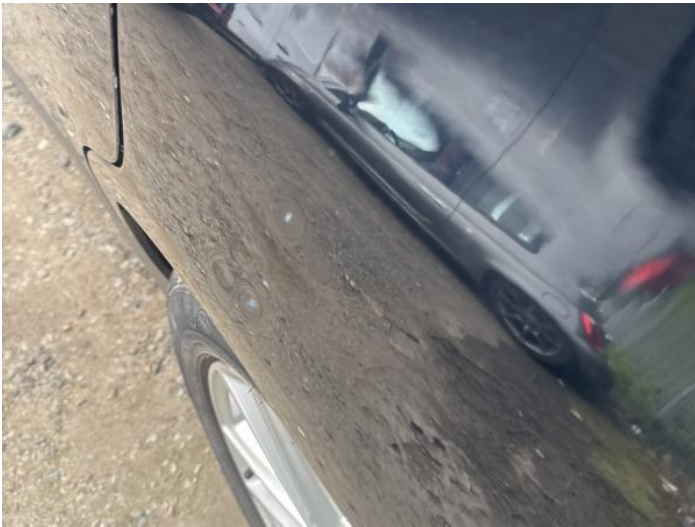
11: Qtr Panel nsr
 Dented
 With Paint Damage

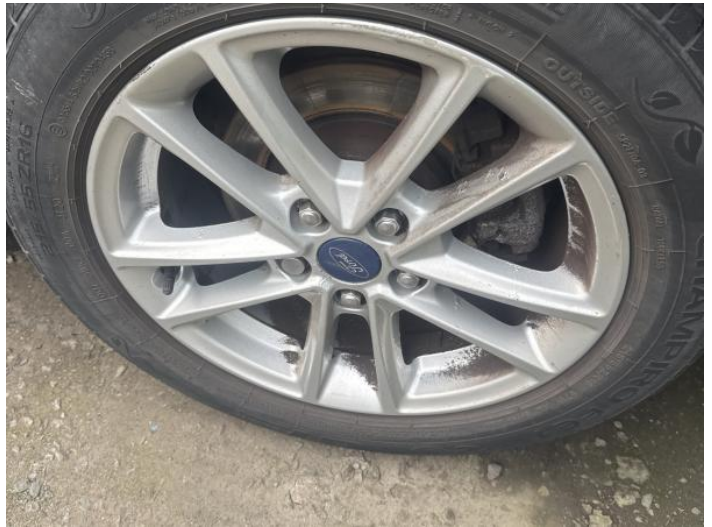
12: Wheel nsr
 Corroded
 Light

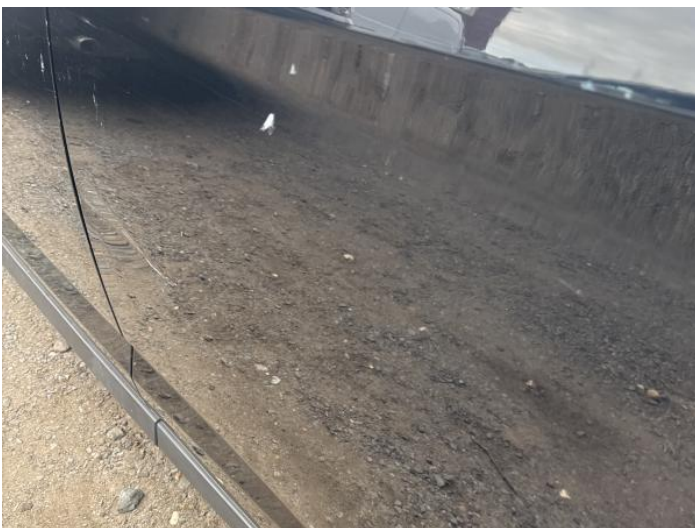
13: Door nsr
 Dented
 With Paint Damage

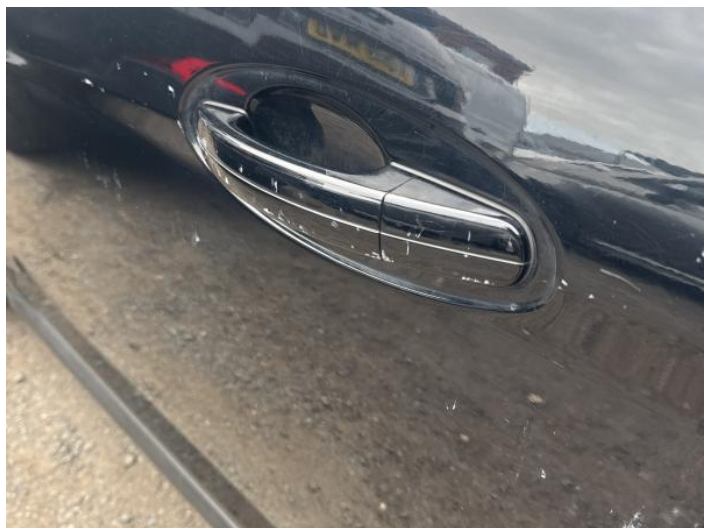
14: Door nsr
 Dented
 With Paint Damage

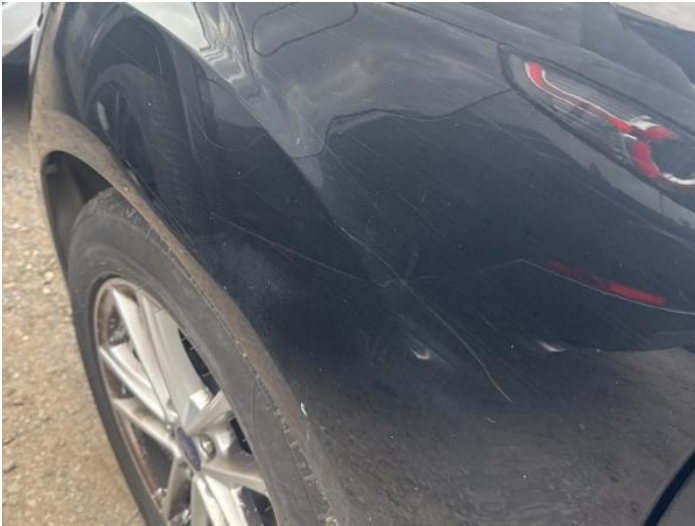
15: Wing nsf
Dented
With Paint Damage

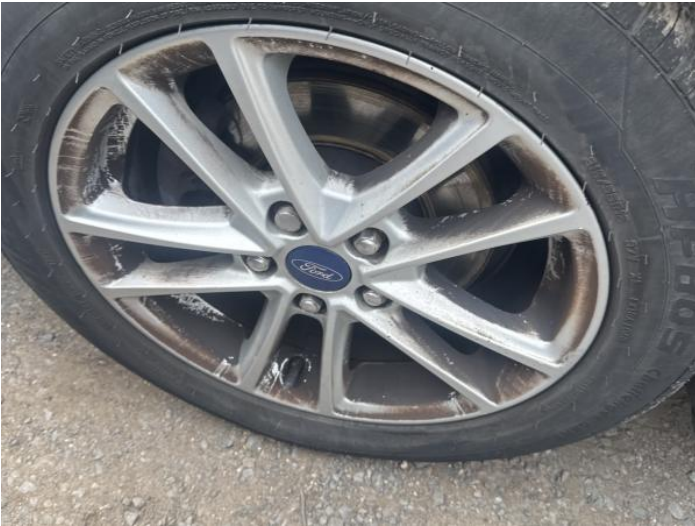
16: Wheel nsf
Scratched
Over 50mm

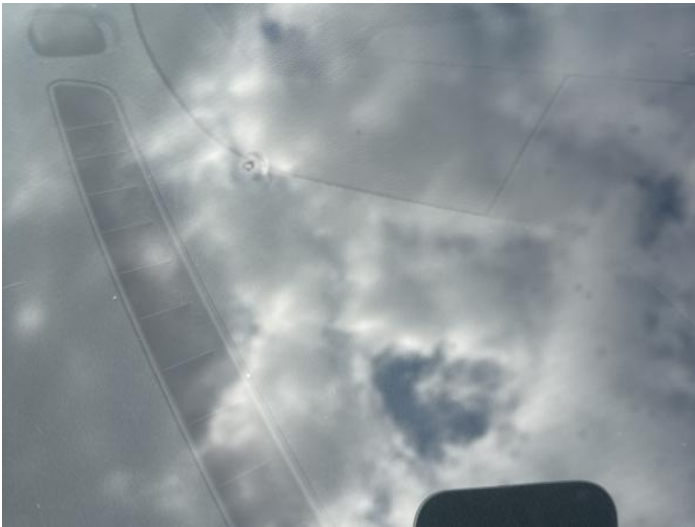
17: Screen Front
Chipped
UpTo 10mm
