VEHICLE INSPECTION REPORT

YS19ZXL

Seat Arona 1.0 TSI SE Technology [EZ] 5dr

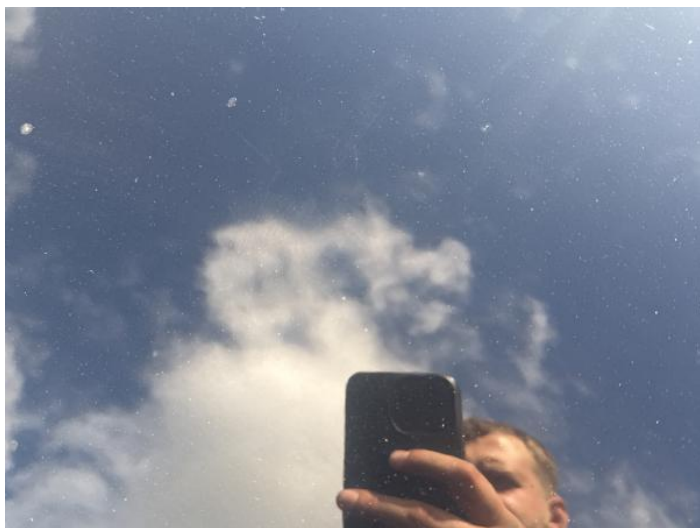
1: Bonnet
Chipped
Multiple Chips

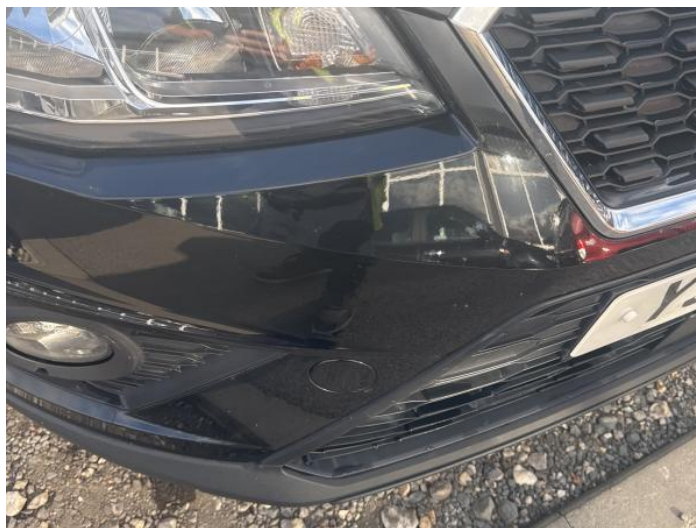
2: Bumper Front
Chipped
Multiple Chips

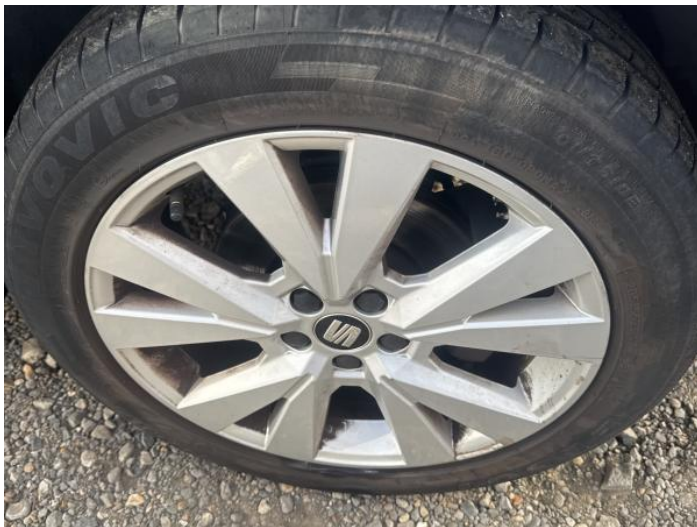
3: Wheel osf
Scratched
Over 50mm

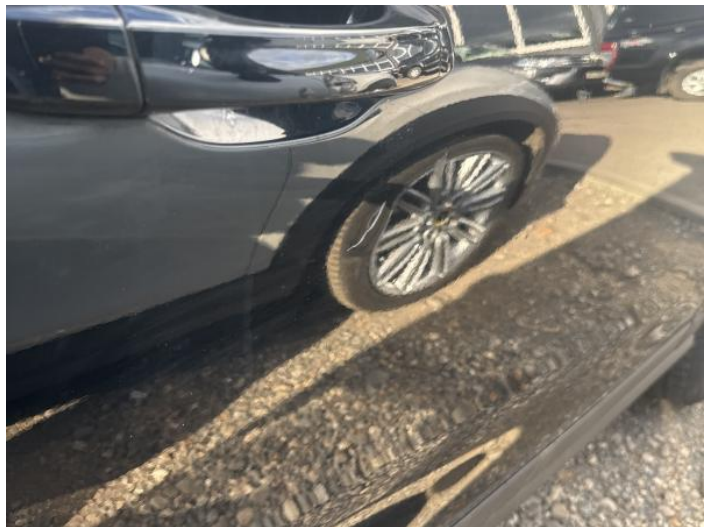
4: Door osf
Dented
With Paint Damage

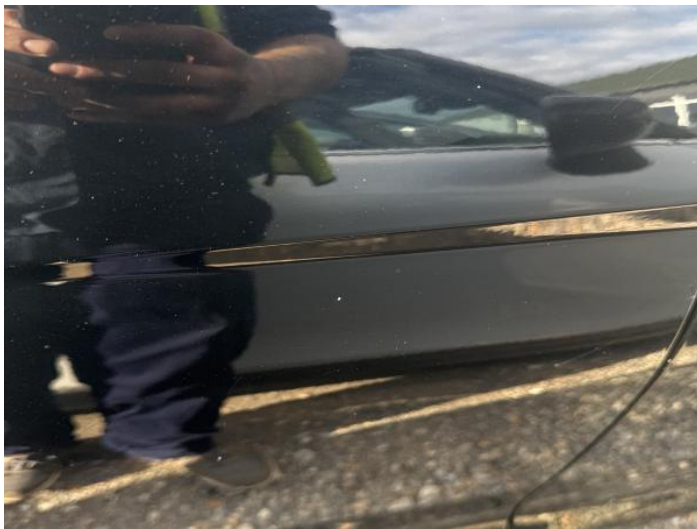
5: Door osr
Chipped
1 To 5

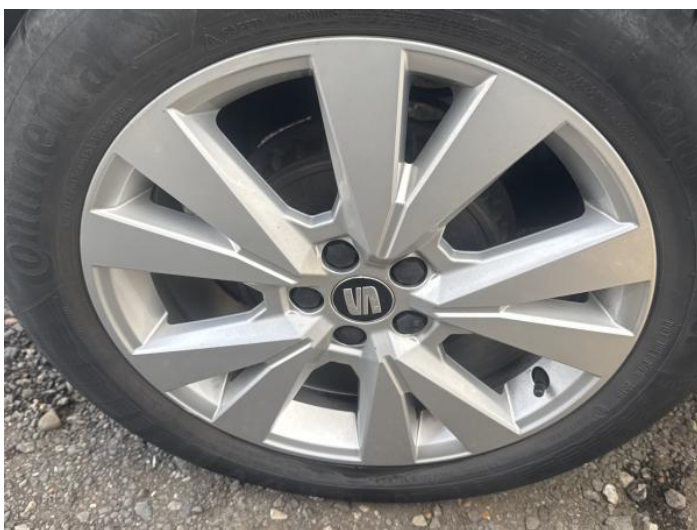
7: Wheel osr
Scratched
Over 50mm

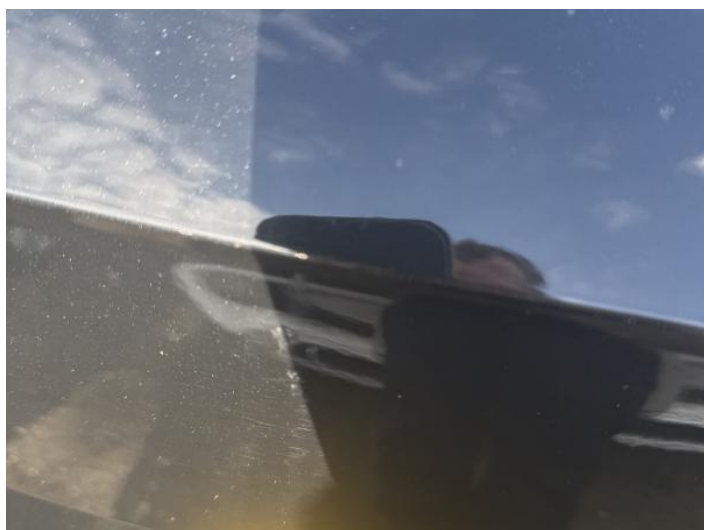
8: Boot Lid
Chipped
1 To 5

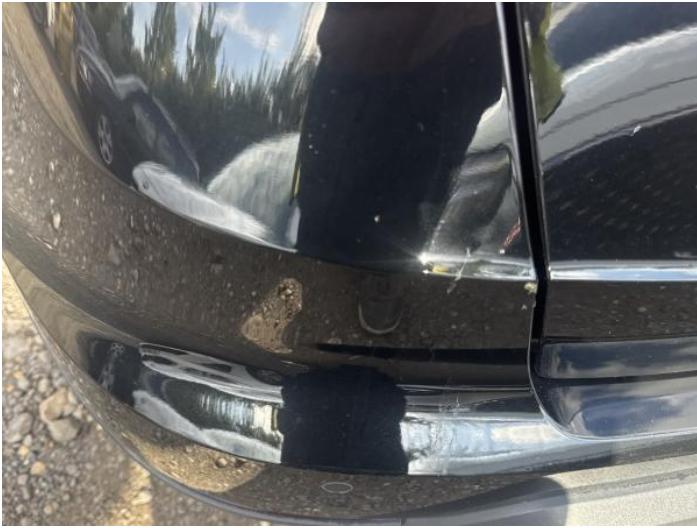
9: Bumper Rear
Chipped
Multiple Chips

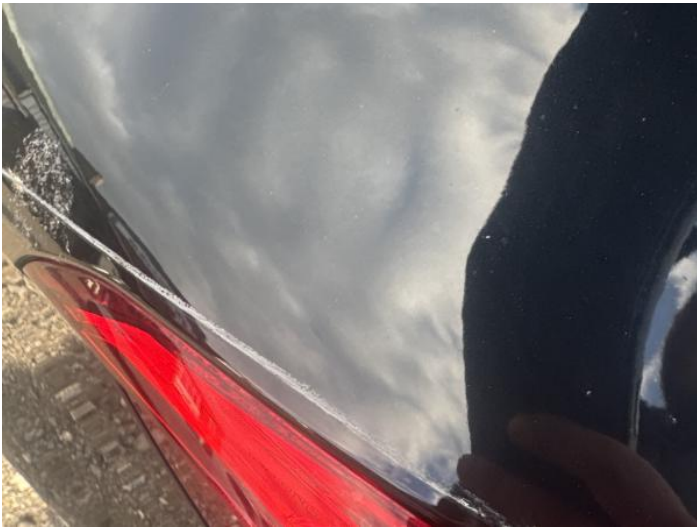
11: Qtr Panel nsr
Scratched
Over 25mm Thru Paint

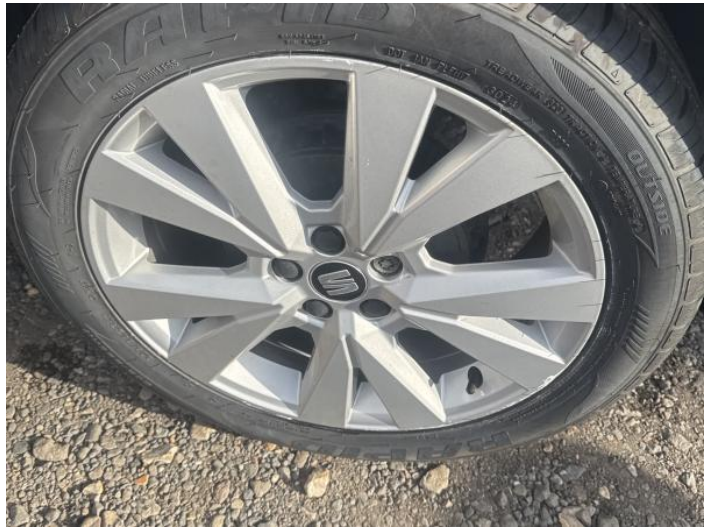
12: Wheel nsr
Scratched
Up To 50mm

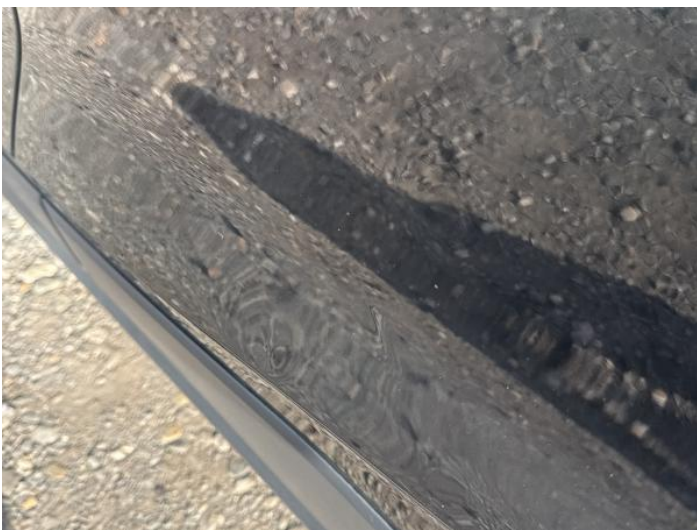
13: Door nsr
Dented
Over 30mm
