# VEHICLE INSPECTION REPORT

**GY23FVM**

## Vauxhall Mokka 1.2 Turbo 100 GS 5dr

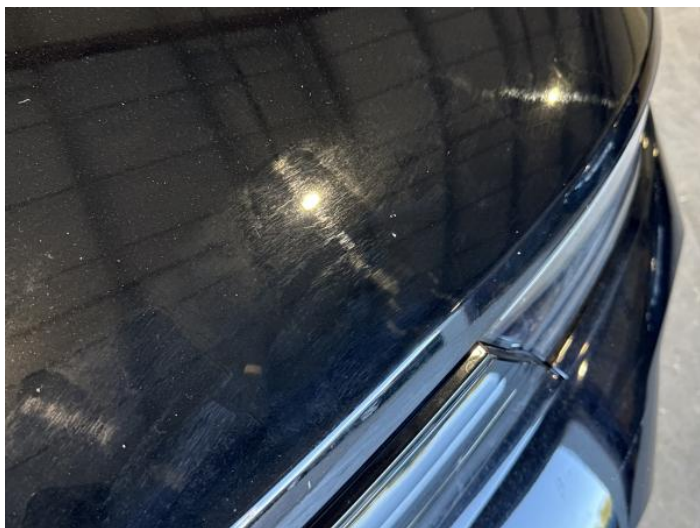
1: Bonnet  
Chipped  
1 To 5

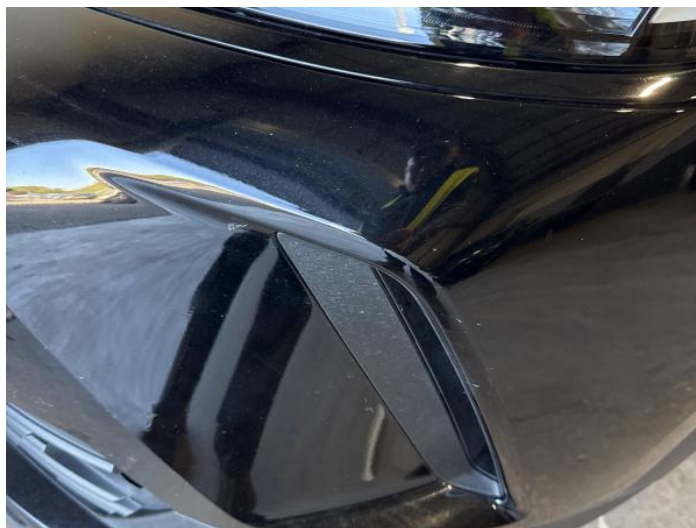
2: Bumper Front  
Scratched  
25 to 100mm Thru Paint

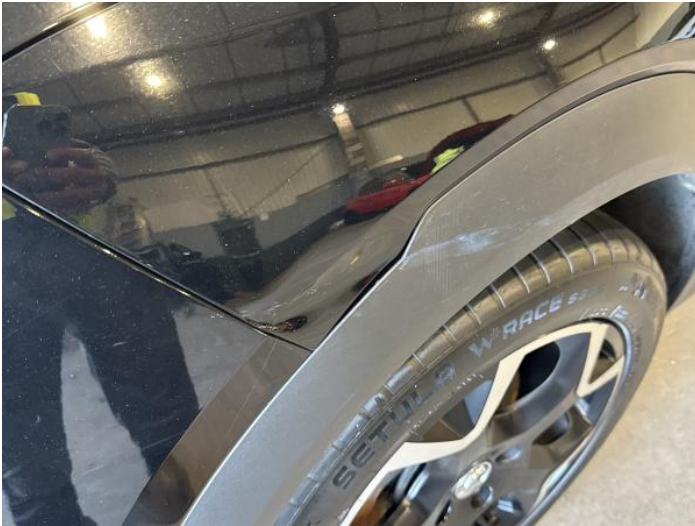
3: Wing nsf  
Dented  
Over 30mm

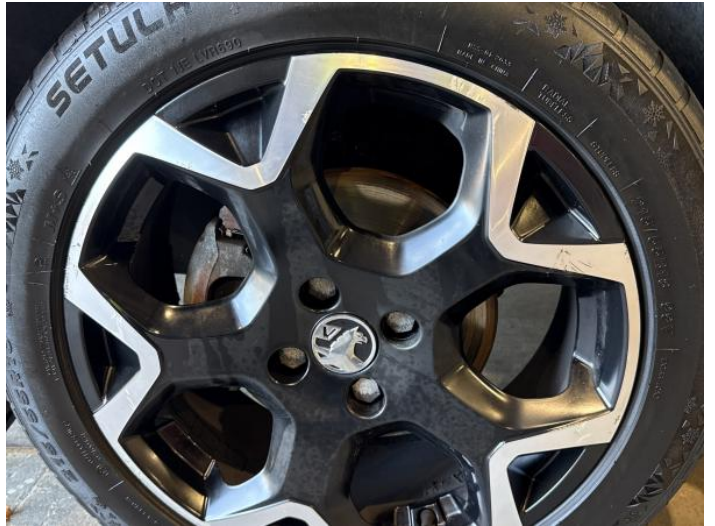
4: Wheel nsf  
Scratched  
Over 50mm

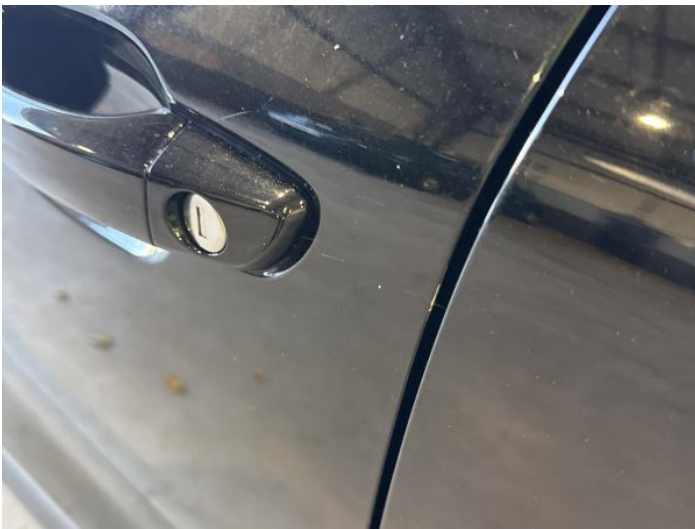
5: Door nsf  
Chipped  
Edge Chip

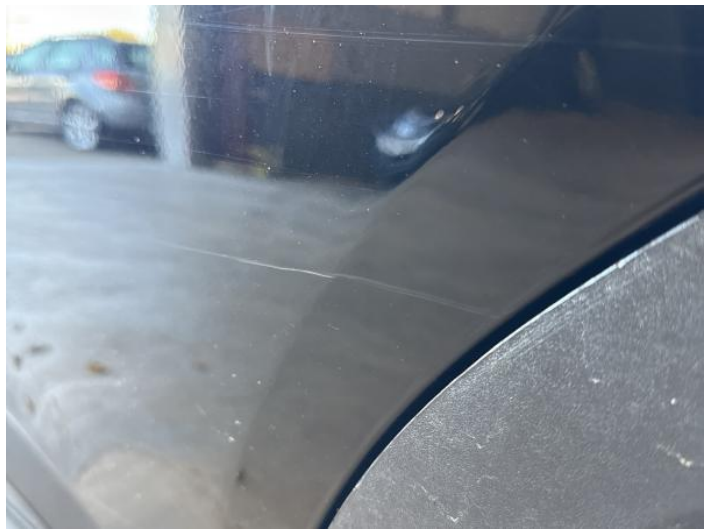
6: Door nsr  
Scratched  
Over 25mm Thru Paint

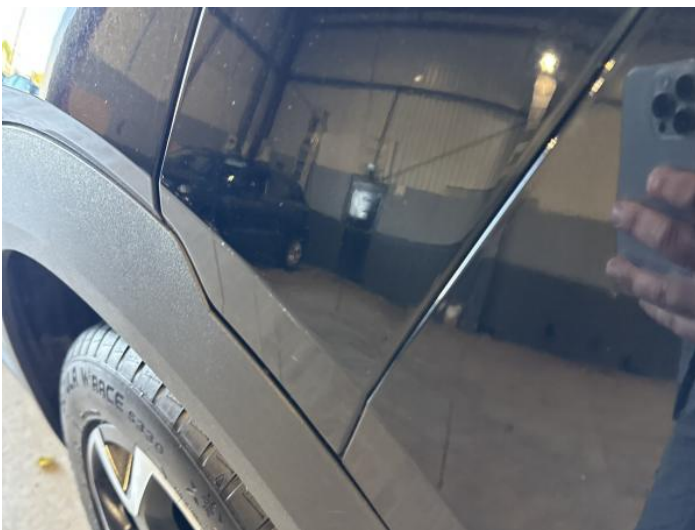
7: Qtr Panel nsr  
Chipped  
1 To 5

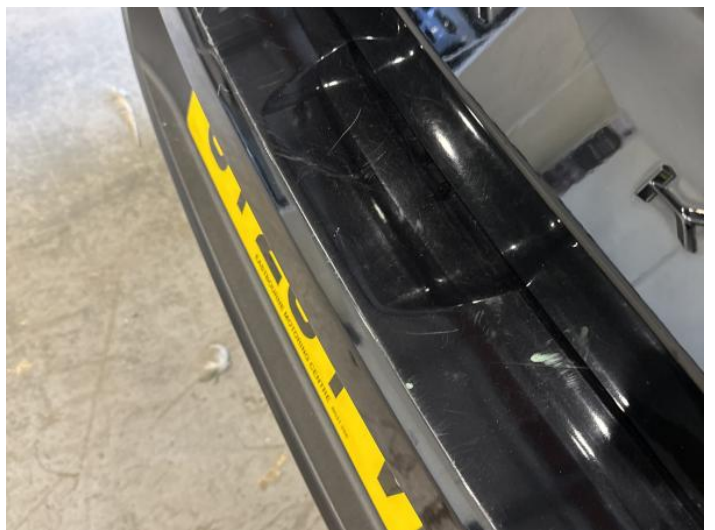
8: Bumper Rear  
Scratched  
25 to 100mm Thru Paint

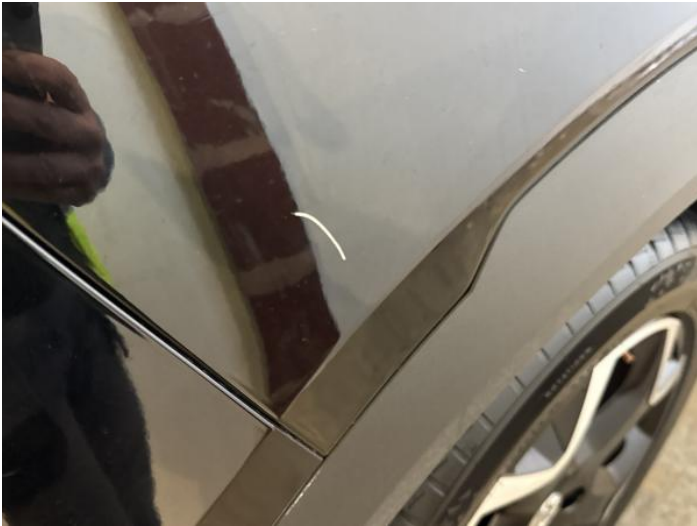
9: Qtr Panel osr  
Dented  
With Paint Damage

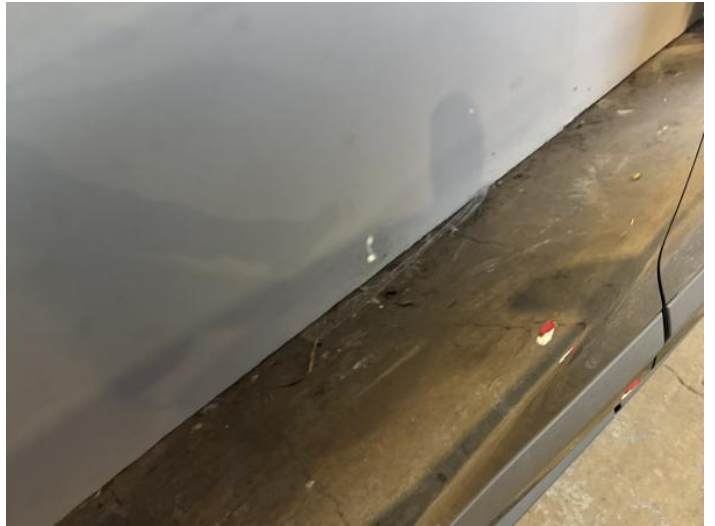
10: Door osr  
Scratched  
UpTo 25mm Thru Paint

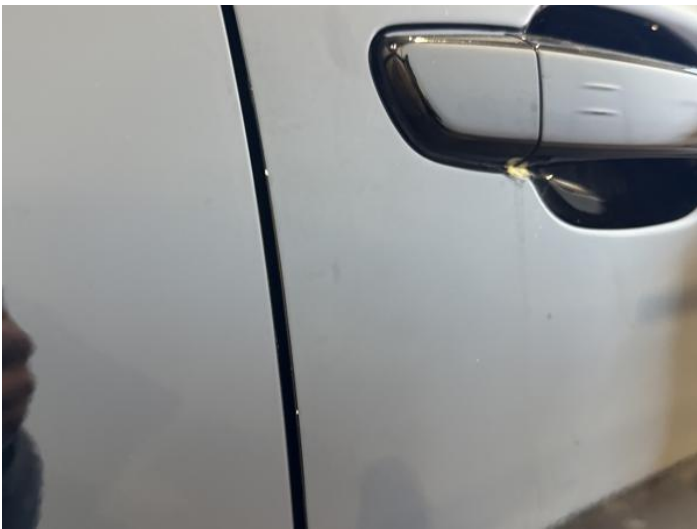
11: Door osf  
Chipped  
Edge Chip

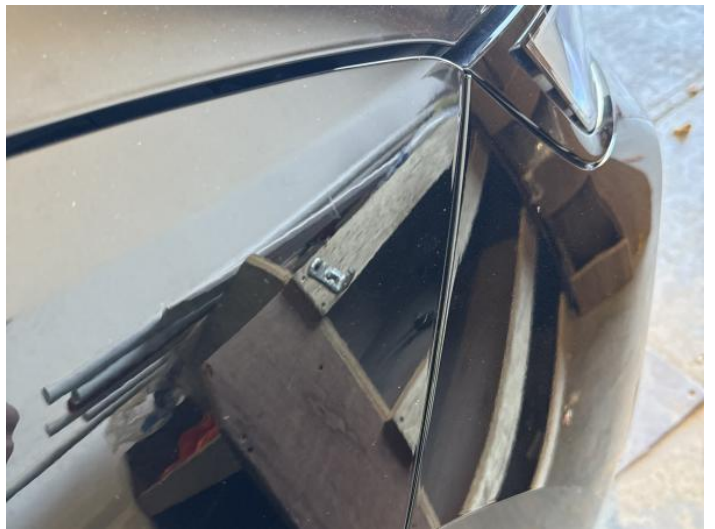
12: Wing osf  
Scratched  
UpTo 25mm Thru Paint

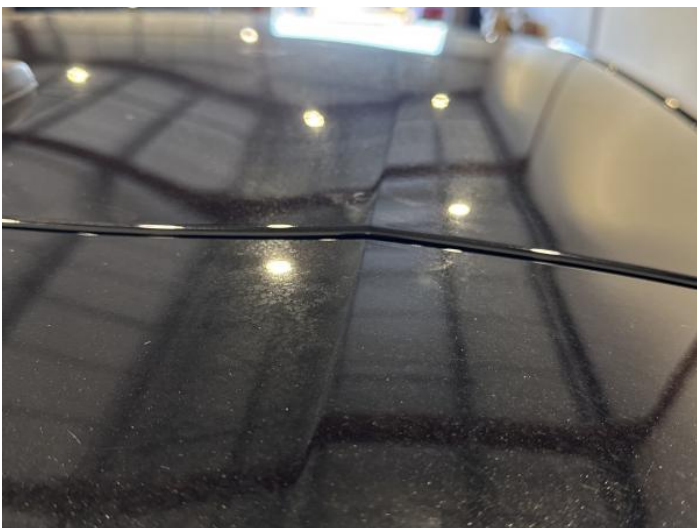
13: Roof  
Dented  
Between 10mm + 30mm
