# VEHICLE INSPECTION REPORT

NA64ACV

## BMW M6 M6 4dr DCT

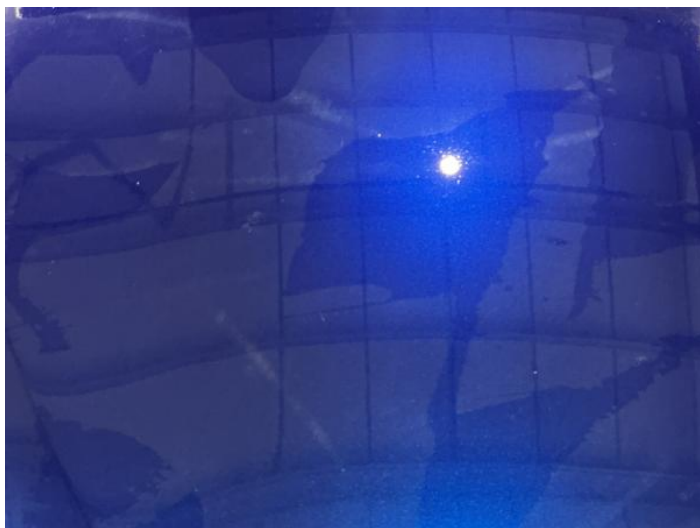
1: Bonnet  
Chipped  
Multiple Chips

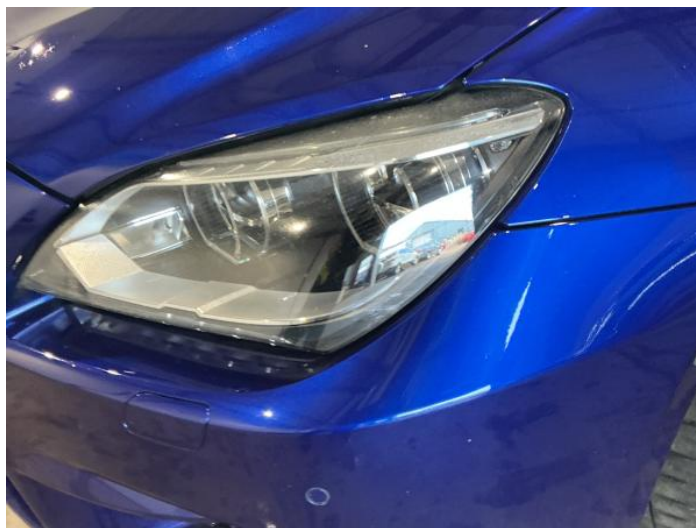
2: Bumper Front  
Chipped  
Multiple Chips

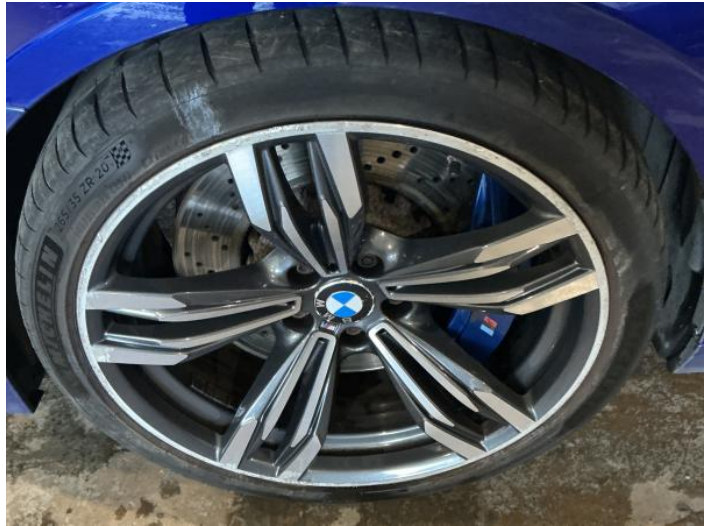
4: Wheel nsf  
Scratched  
Over 50mm

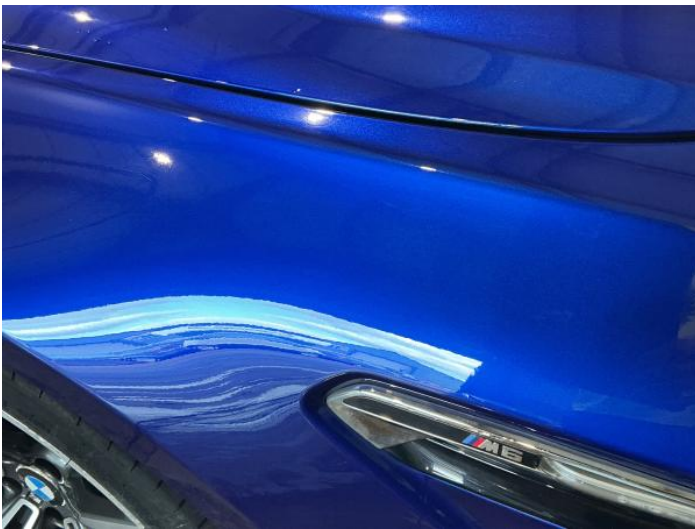
5: Wing nsf  
Chipped  
1 To 5

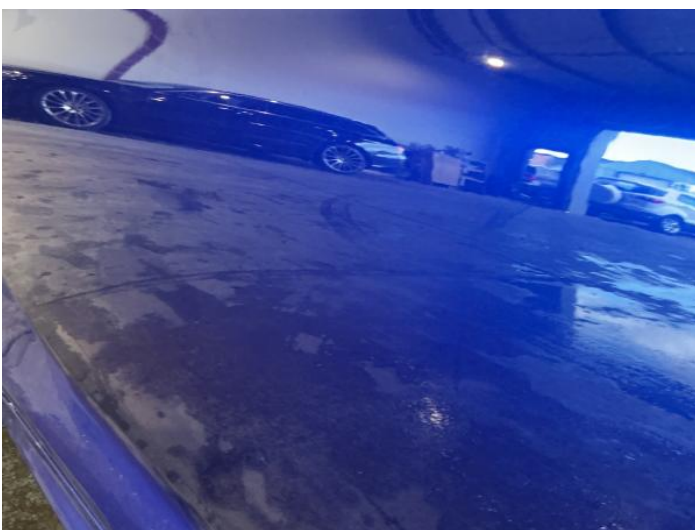
7: Door nsf  
Chipped  
1 To 5

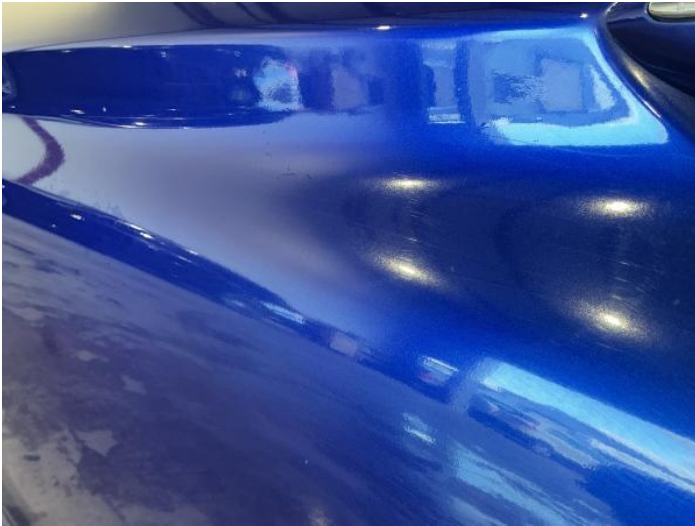
9: Door nsr  
Poor Previous Repair  
Poor Paint

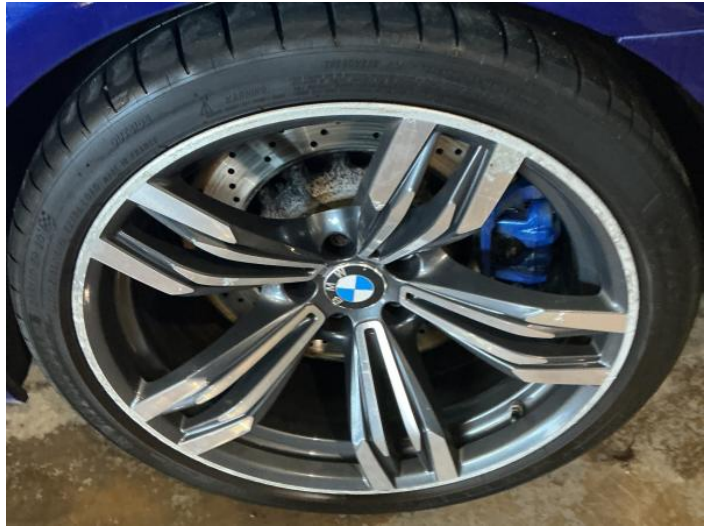
10: Wheel nsr  
Scratched  
Over 50mm

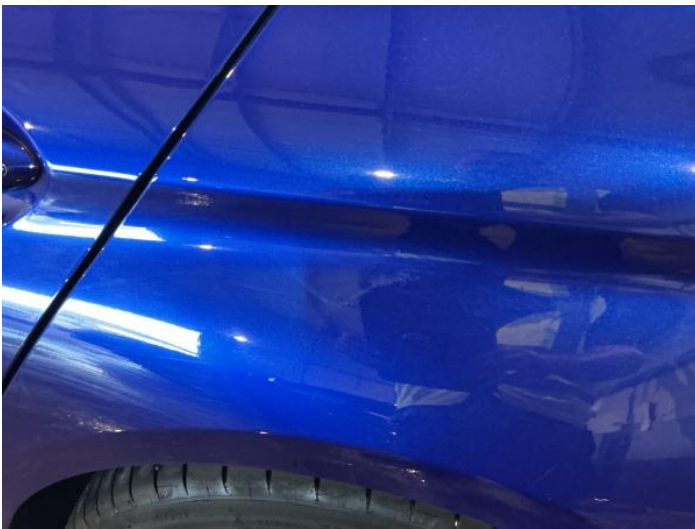
11: Qtr Panel nsr  
Poor Previous Repair  
Poor Paint

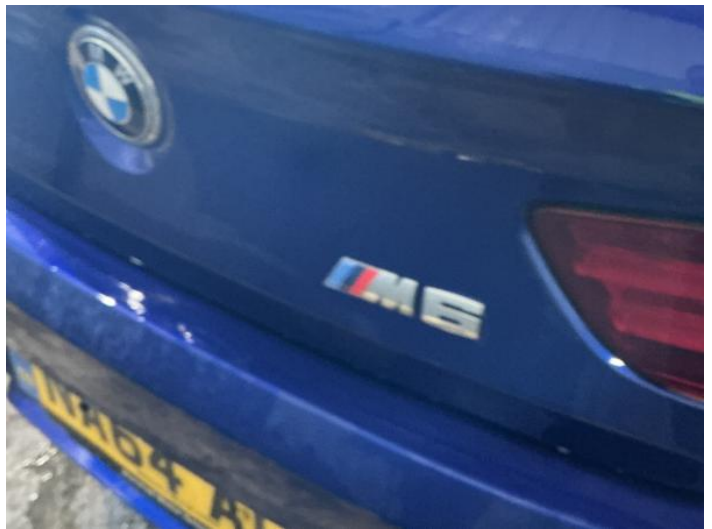
12: Bumper Rear  
Chipped  
Multiple Chips

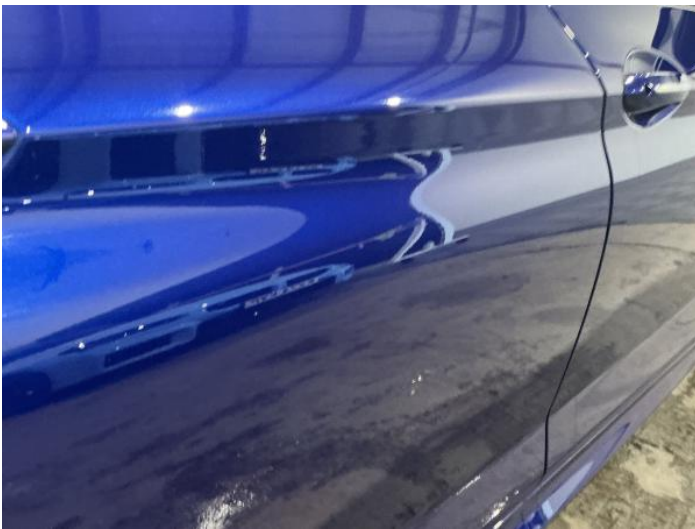
17: Door osr  
Chipped  
1 To 5

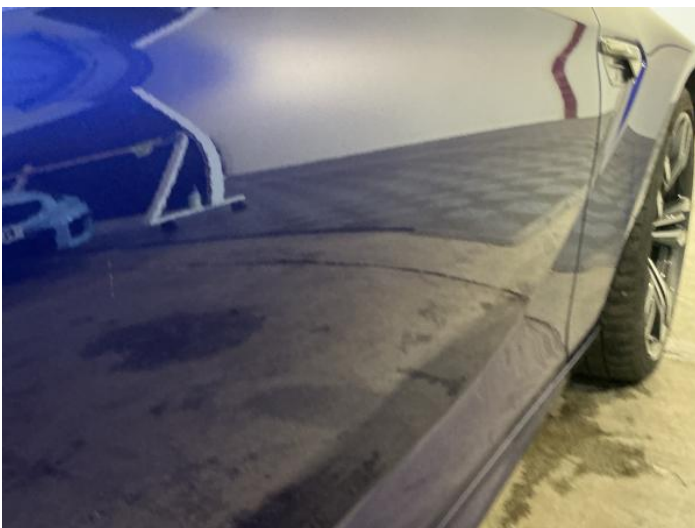
19: Door osf  
Chipped  
1 To 5

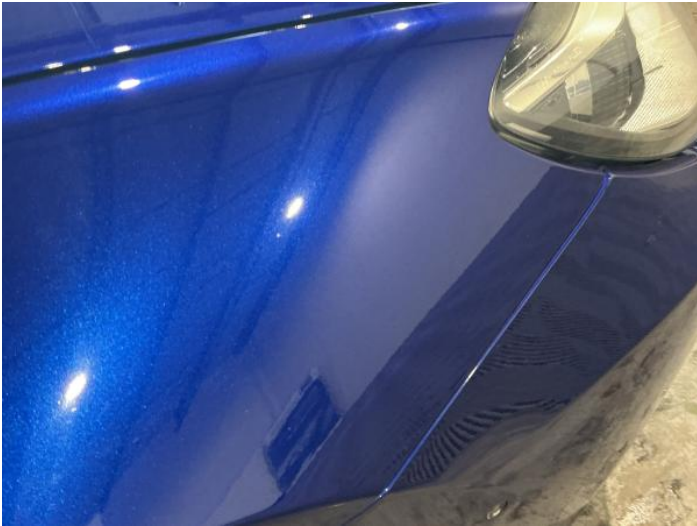
21: Wing osf  
Chipped  
1 To 5

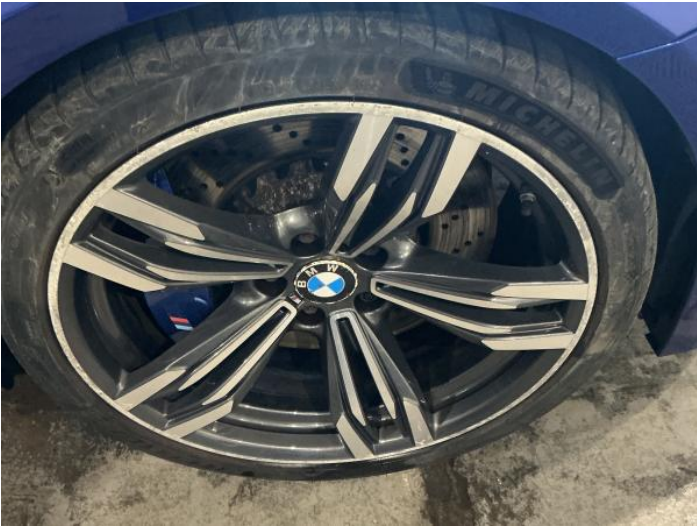
22: Wheel osf  
Scratched  
Over 50mm

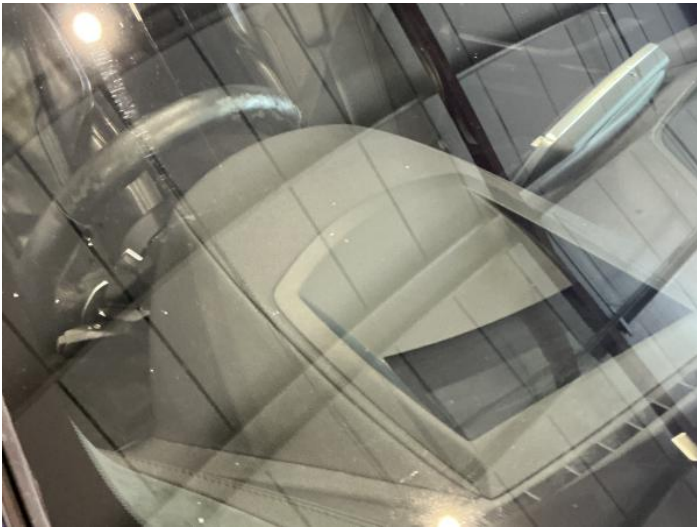
23: Screen Front  
Chipped  
UpTo 10mm
