# VEHICLE INSPECTION REPORT

**GU62URH**

## Volvo XC90 2.4 D5 [200] SE 5dr Geartronic

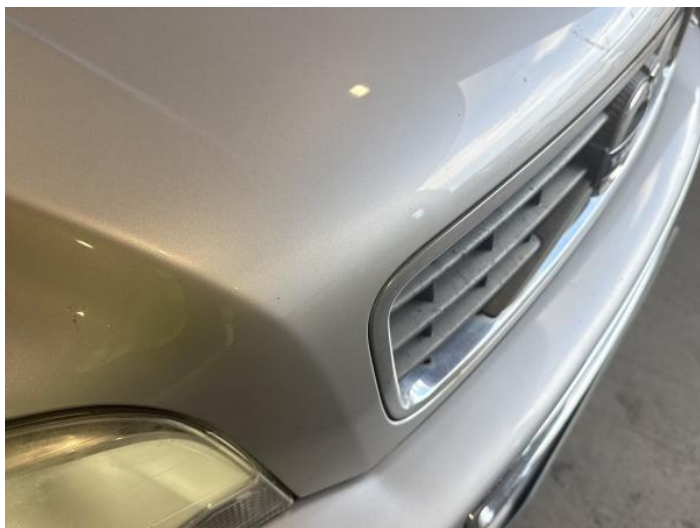
1: Bonnet  
Chipped  
Multiple Chips

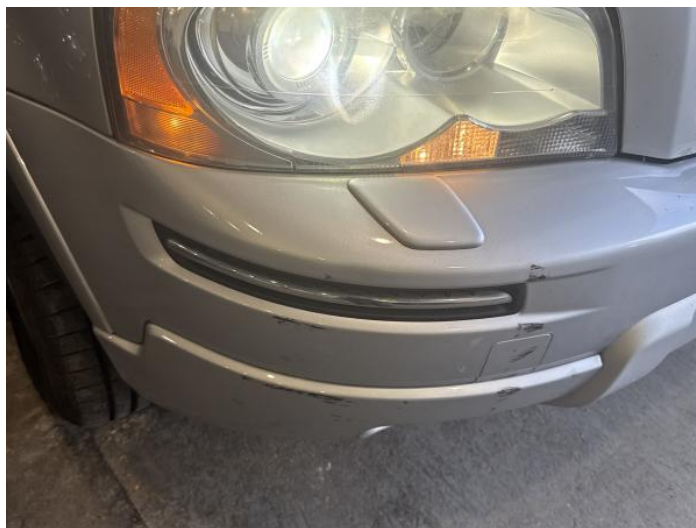
2: Bumper Front  
Scratched  
25 to 100mm Thru Paint

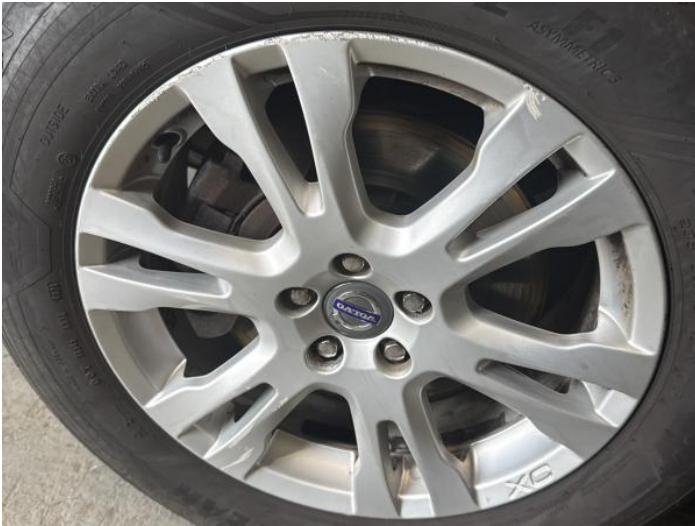
3: Wheel nsf  
Scratched  
Over 50mm

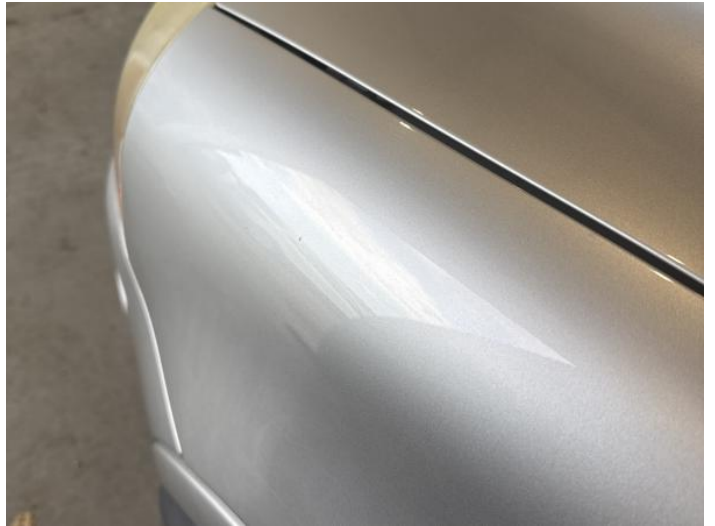
4: Wing nsf  
Chipped  
1 To 5

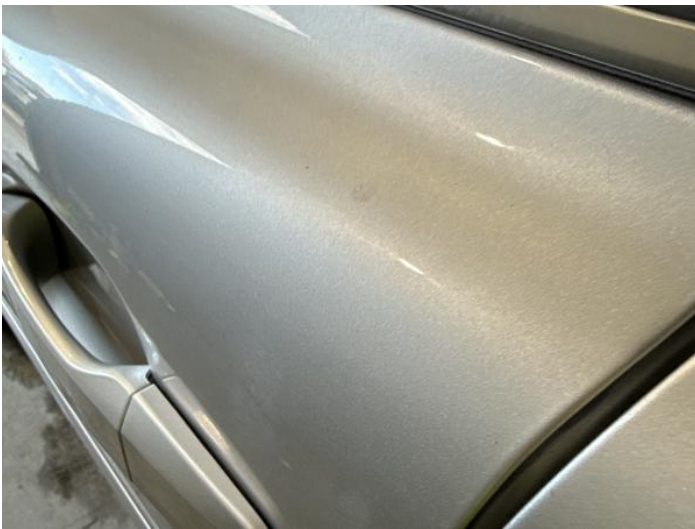
5: Door nsf  
Dented  
Between 10mm + 30mm

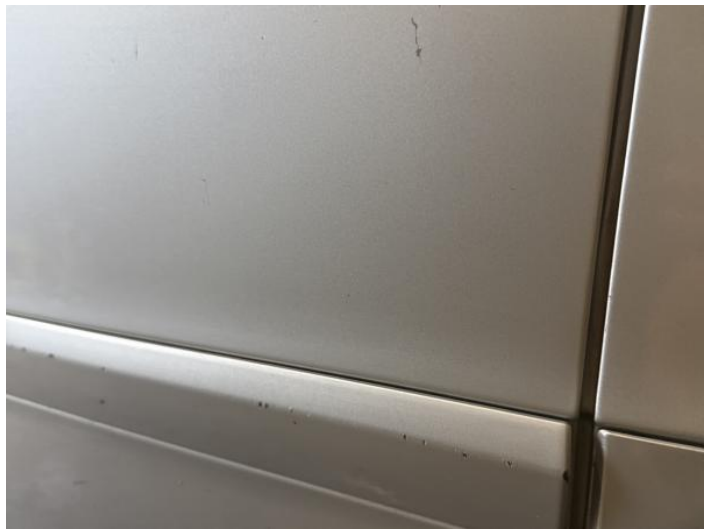
6: Door nsf  
Scratched  
UpTo 25mm Thru Paint

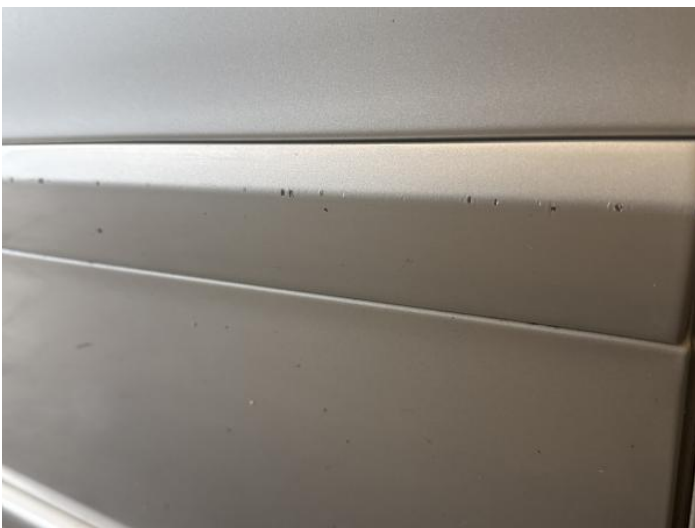
7: Door Moulding nsf  
Scratched (Painted)  
Over 25mm Thru Paint

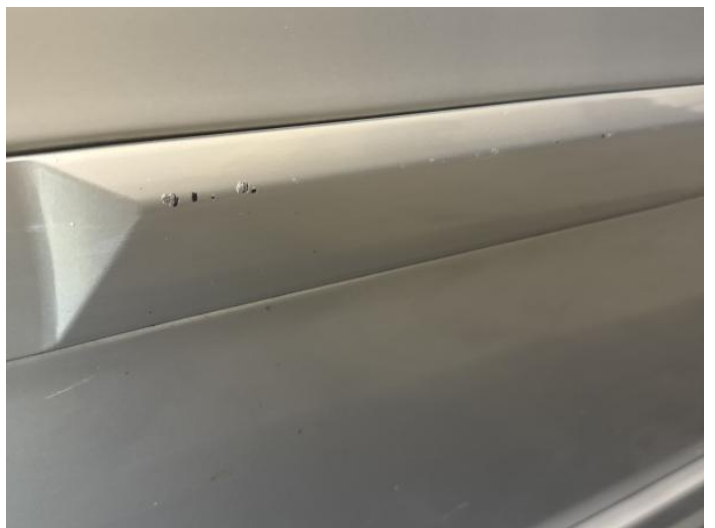
8: Door Moulding nsr  
Scratched (Painted)  
Over 25mm Thru Paint

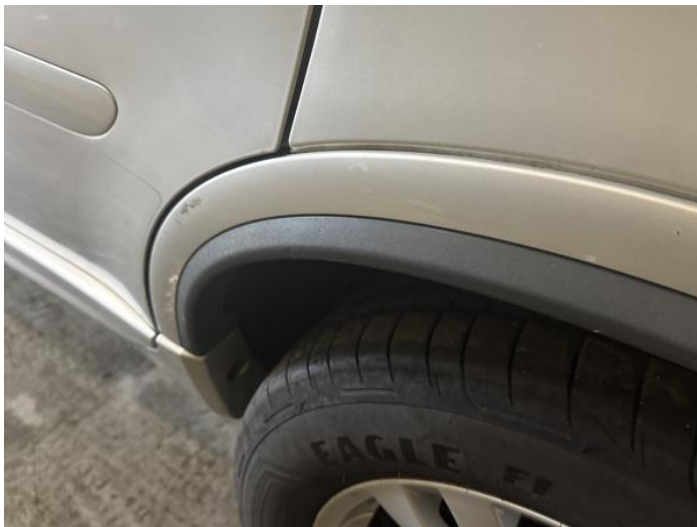
9: Qtr Panel Arch Extension ns  
Scratched (Painted)  
Over 25mm Thru Paint

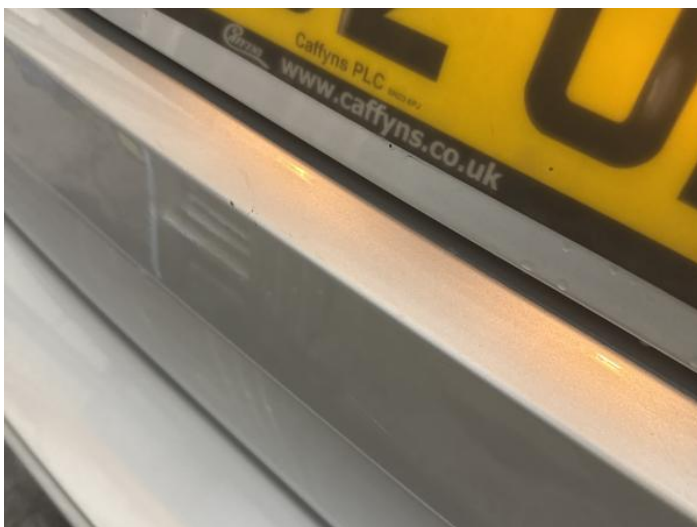
11: Tailgate  
Scratched  
UpTo 25mm Thru Paint

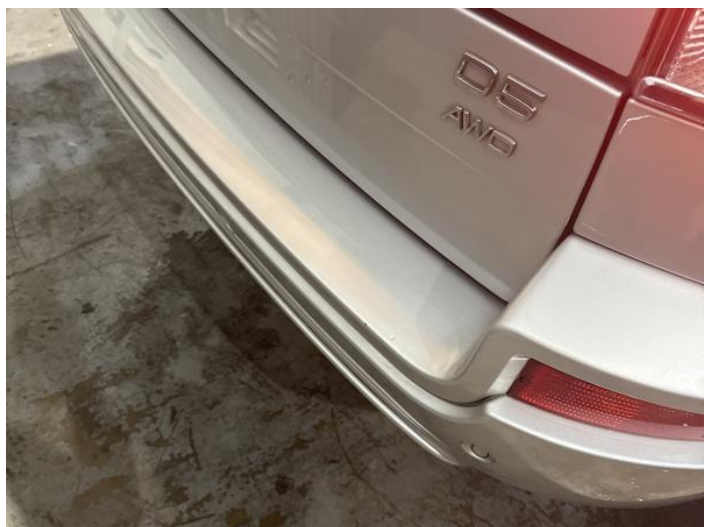
12: Bumper Rear Moulding  
Scratched (Painted)  
Over 25mm Thru Paint

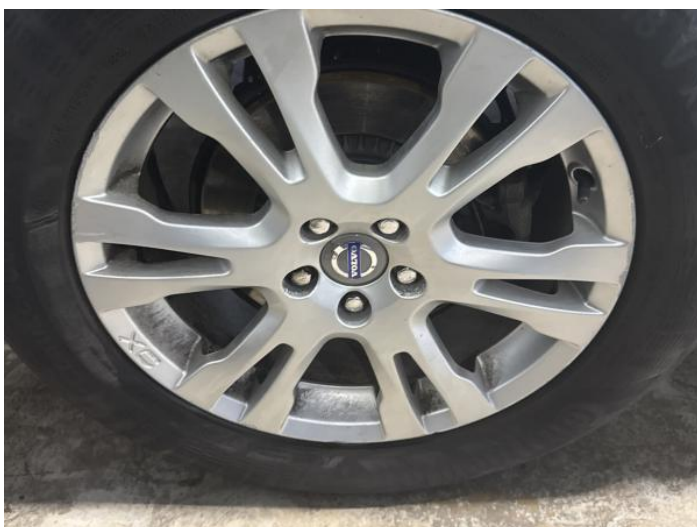
13: Wheel osr  
Scratched  
Over 50mm

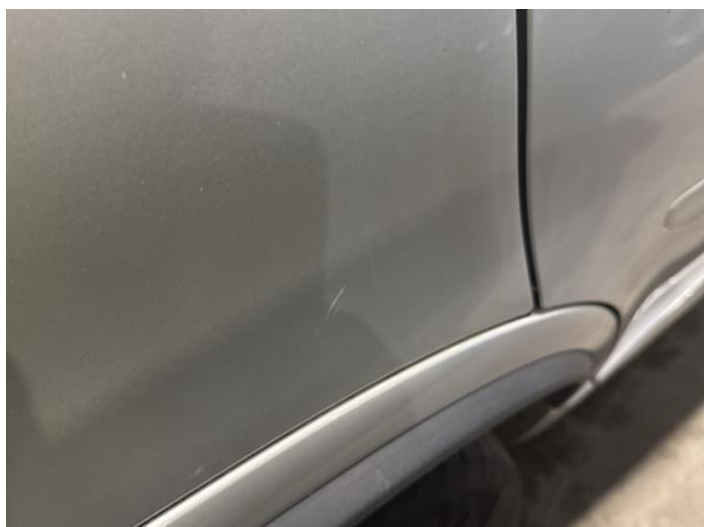
14: Qtr Panel osr  
Scratched  
UpTo 25mm Thru Paint

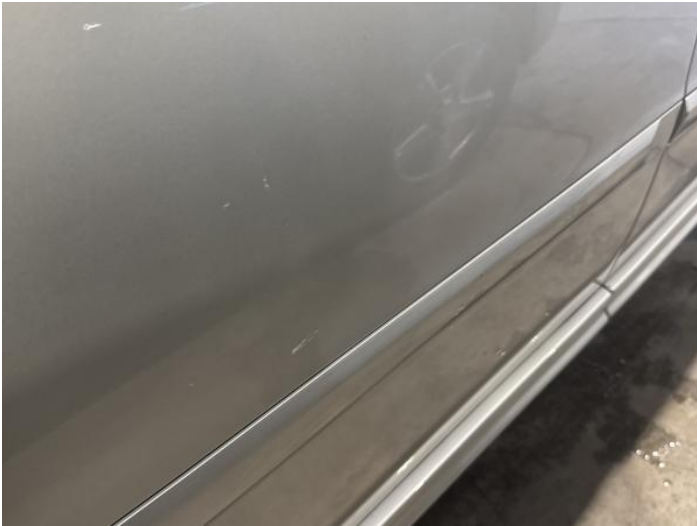
15: Door osr  
Scratched  
Over 25mm Thru Paint

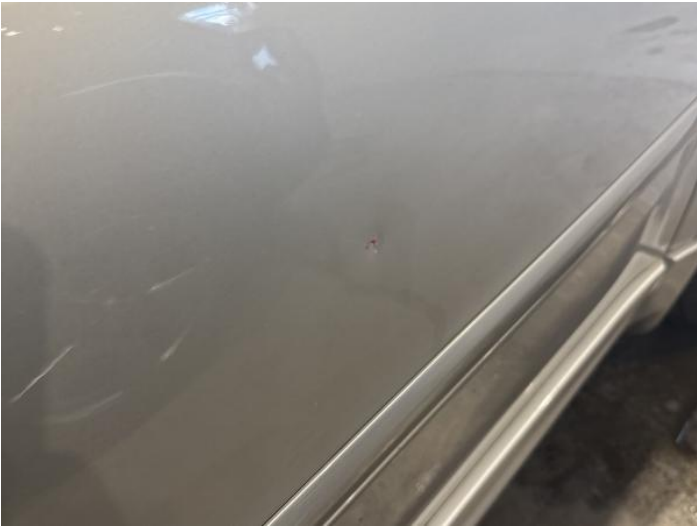
16: Door osf  
Dented  
2 Or Less UpTo 10mm

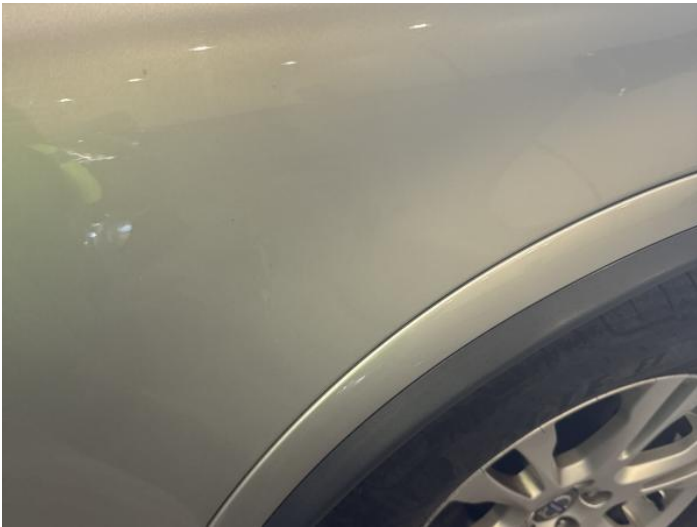
17: Wing osf  
Scratched  
Over 25mm Thru Paint

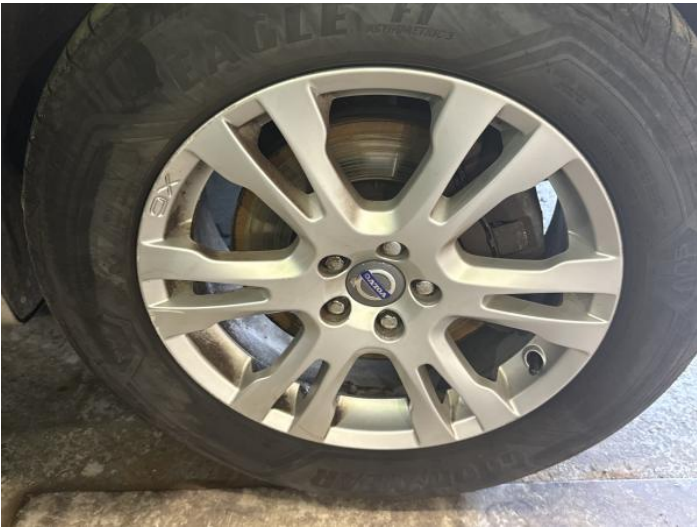
18: Wheel osf  
Scratched  
Over 50mm
