# VEHICLE INSPECTION REPORT

**HY08NWD**

## Volkswagen Tiguan 2.0 TDi SE 5dr

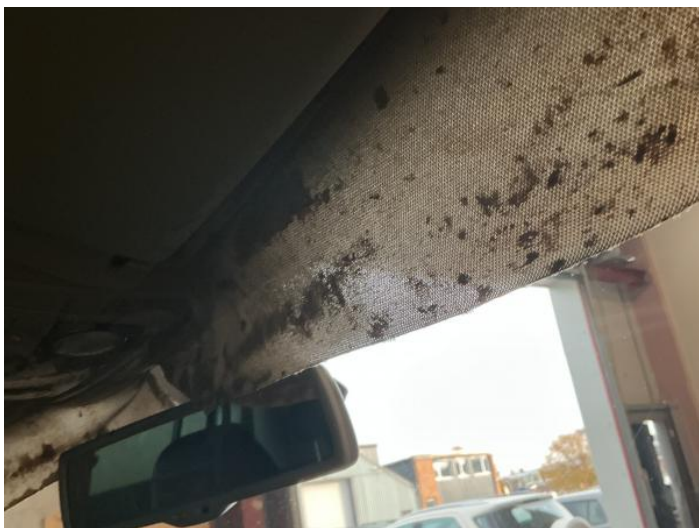
Roof lining dropped

1: Roof Lining  
Torn  
Over 3mm

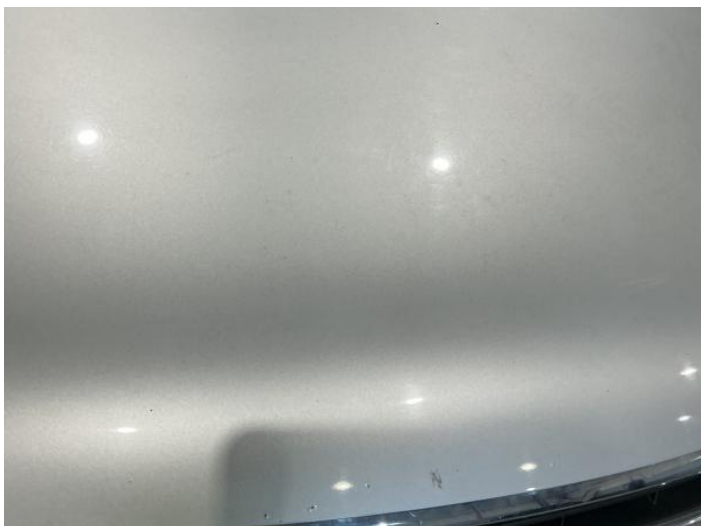
3: Bonnet  
Chipped  
Multiple Chips

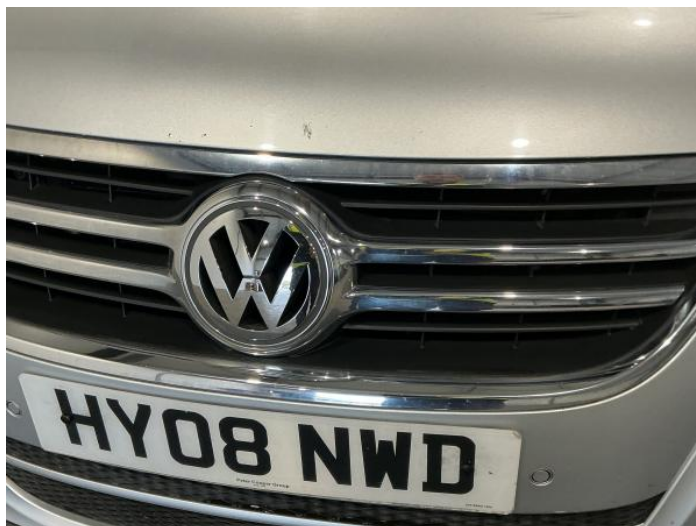
4: Bumper Front  
Poor Previous Repair  
Paint Flake

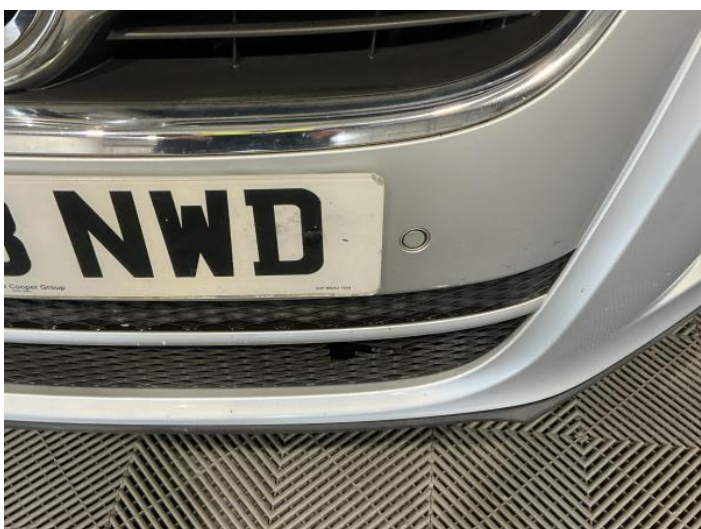
5: Bumper Front Grill  
Broken  
Replace

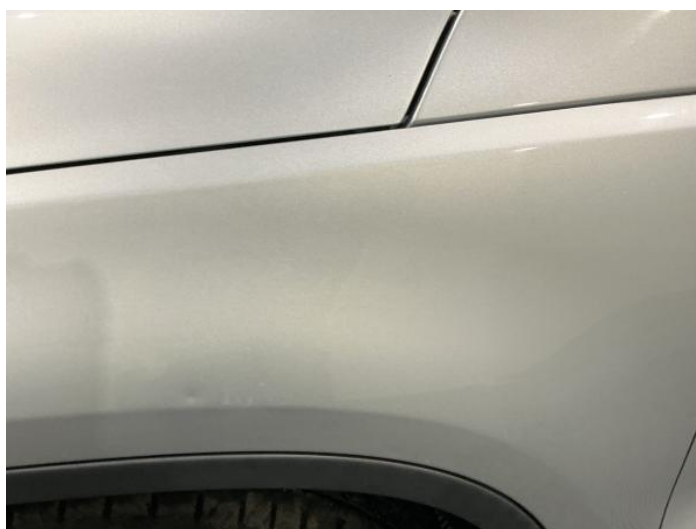
6: Wing nsf  
Dented  
Between 10mm + 30mm

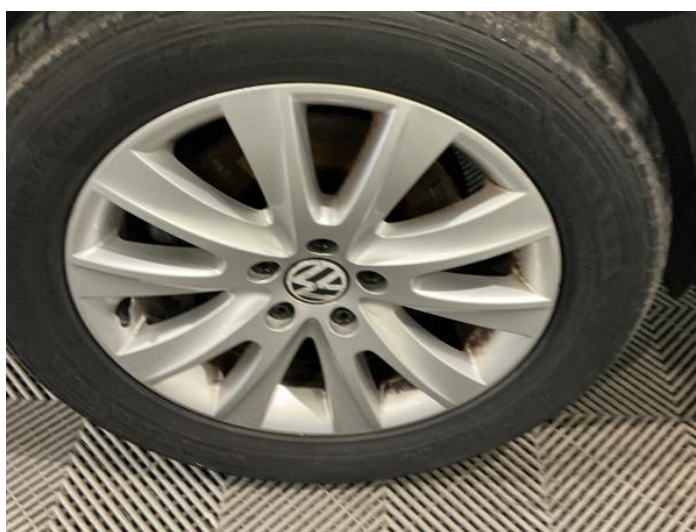
8: Wheel nsf  
Scratched  
Over 50mm

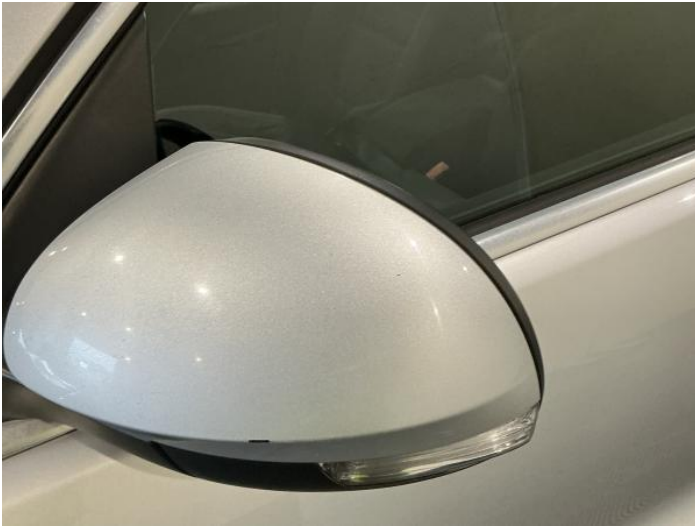
9: Door Mirror Assy nsf  
Scratched (Painted)  
UpTo 25mm Thru Paint

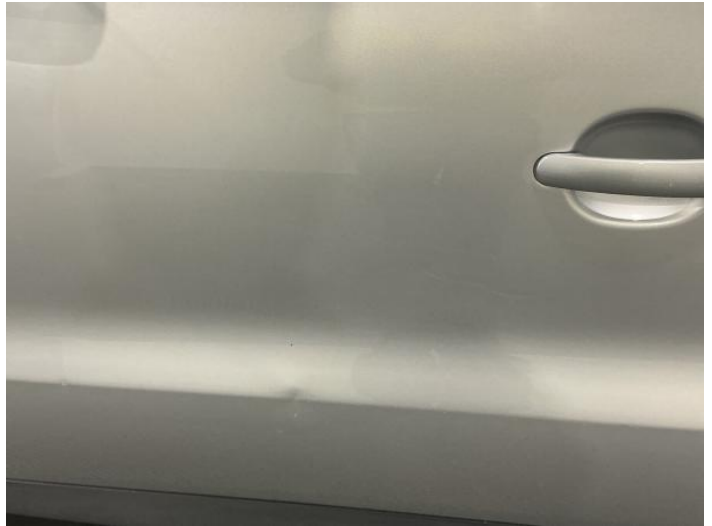
10: Door nsf  
Dented  
With Paint Damage

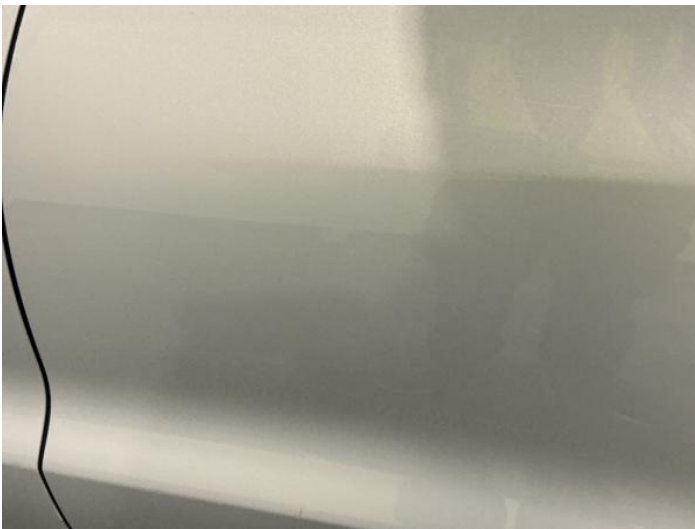
11: Door nsr  
Dented  
With Paint Damage

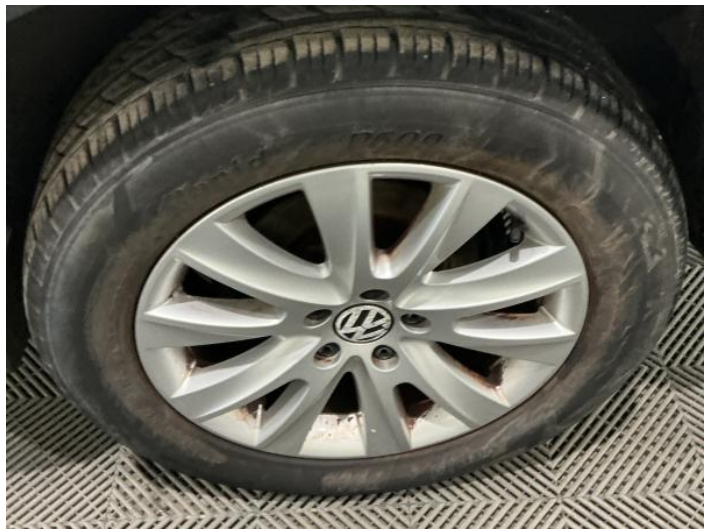
12: Wheel nsr  
Scratched  
Up To 50mm

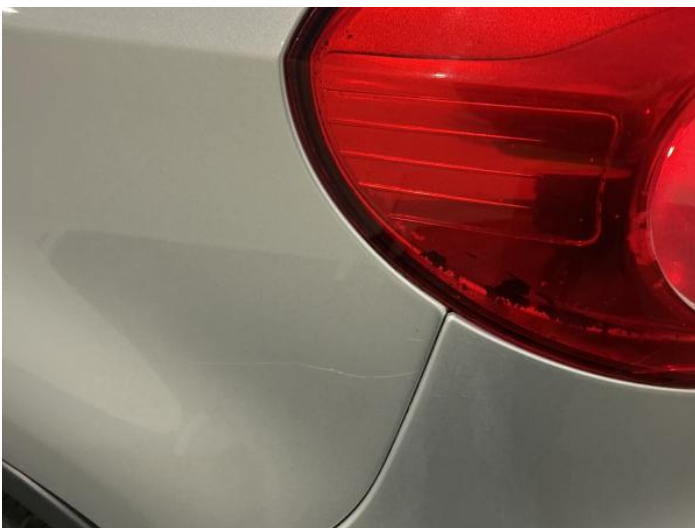
13: Qtr Panel nsr  
Scratched  
Over 25mm Thru Paint

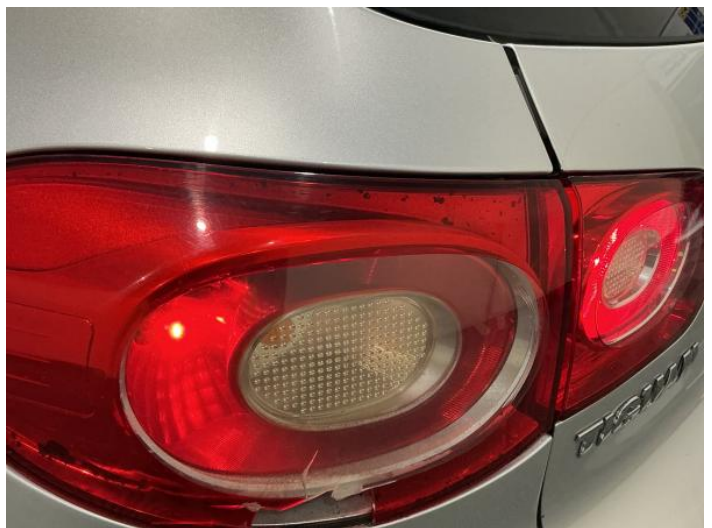
14: Lamp nsr  
Broken  
Replace

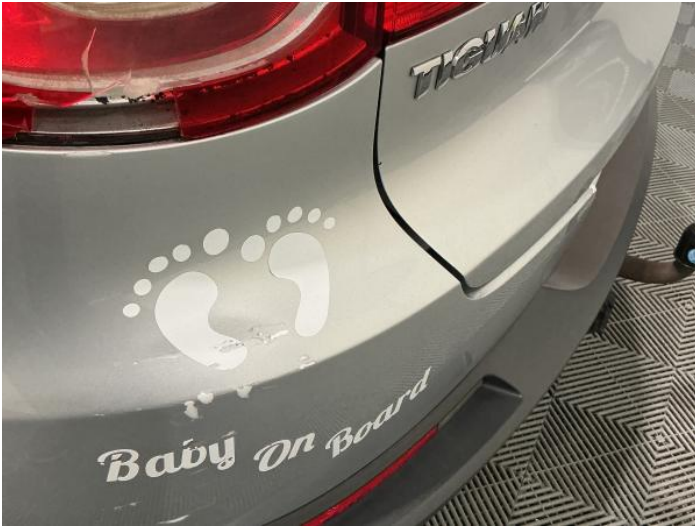
15: Bumper Rear  
Dented  
With Paint Damage

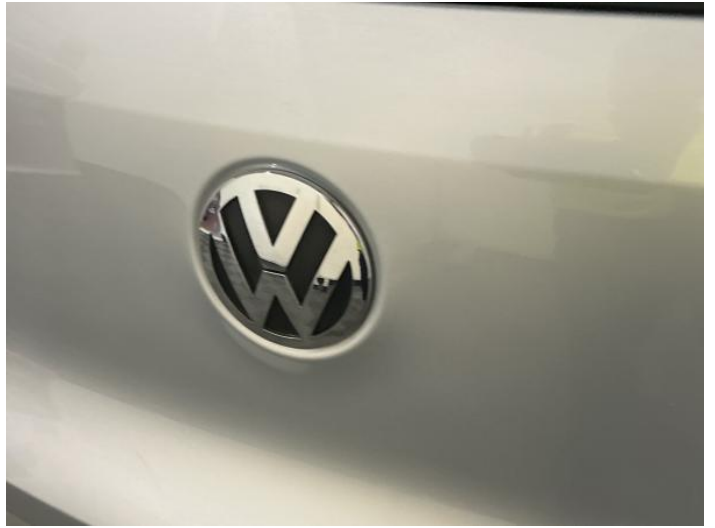
16: Boot Lid  
Chipped  
1 To 5

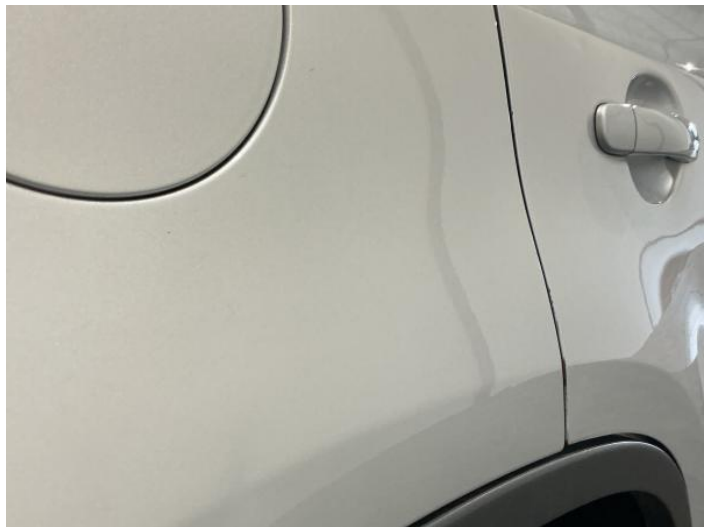
18: Qtr Panel osr  
Dented  
Over 30mm

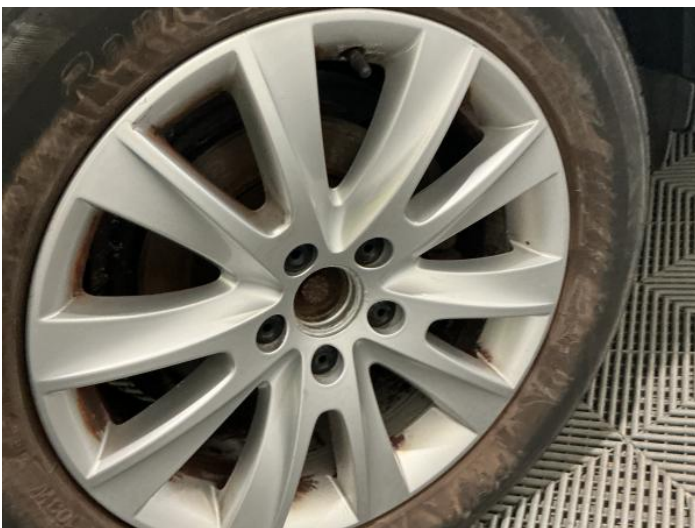
19: Wheel osr  
Scratched  
Up To 50mm

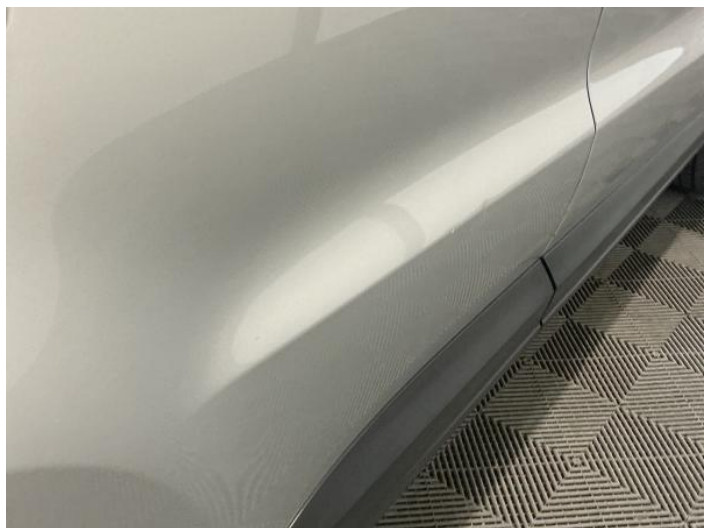
20: Door osr  
Dented  
With Paint Damage

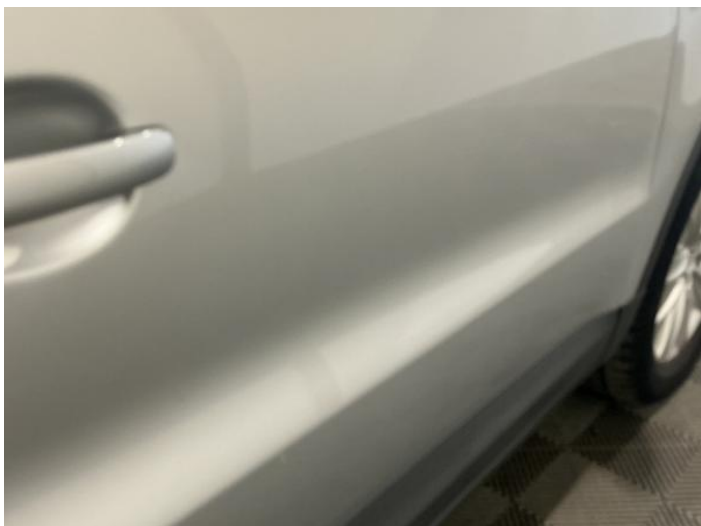
21: Door osf  
Dented  
With Paint Damage

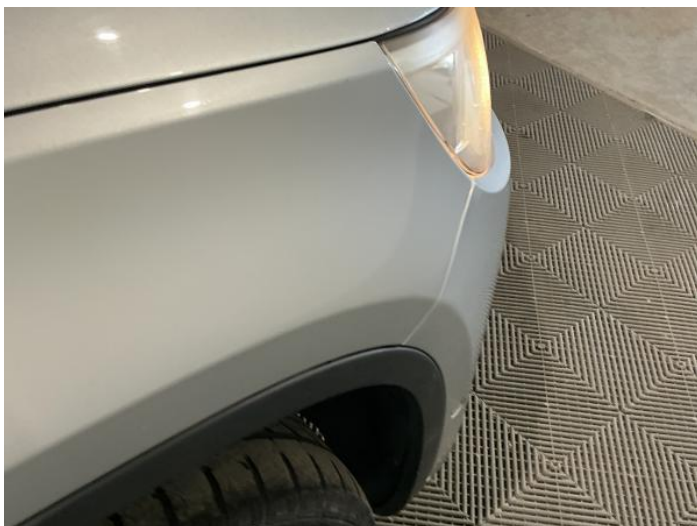
22: Wing osf  
Chipped  
1 To 5

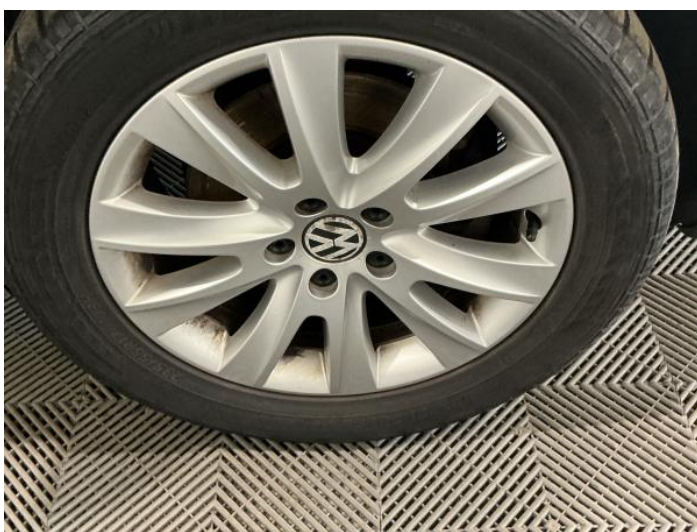
24: Wheel osf  
Scratched  
Up To 50mm

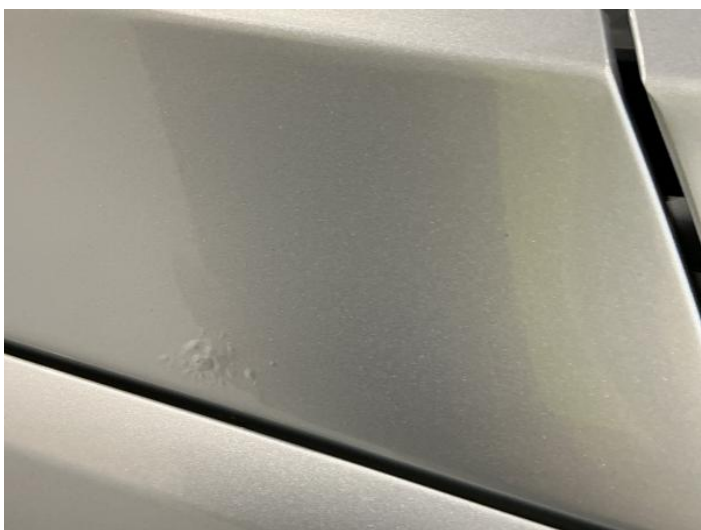
25: A Post os  
Rusted  
UpTo 5mm

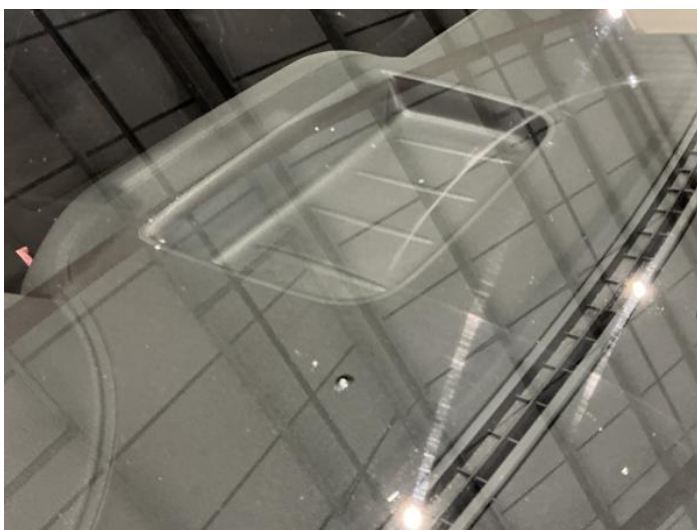
26: Screen Front  
Chipped  
UpTo 10mm

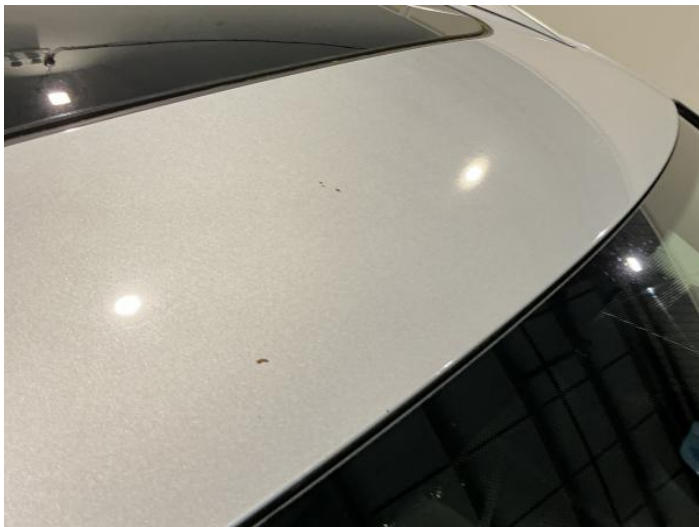
27: Roof  
Chipped  
1 To 5
